FACILITY COMPLIANCE AUDIT REPORT
Division of Waste Management
Solid Waste Section

Date of Audit: 21 April 2011

Craven County Landfill
 7400 Old Highway 70
 New Bern, NC

Closed: Unlined MSW Landfill

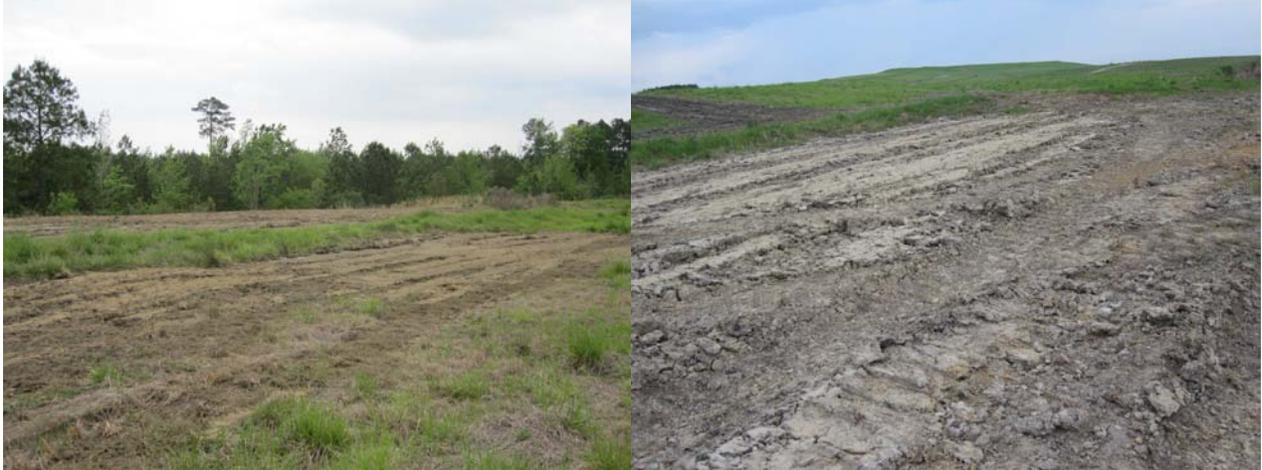
- 1) **15A NCAC 13B .0505 OPERATIONAL REQUIREMENTS FOR SANITARY LANDFILLS (5)(b)**
 Surface water shall not be impounded over or in waste. **Resolved.** The areas noted as impounding surface waters have been filled and graded. No ponding of surface water was noted during this audit.

Areas of settlement filled and graded to promote positive drainage of surface waters

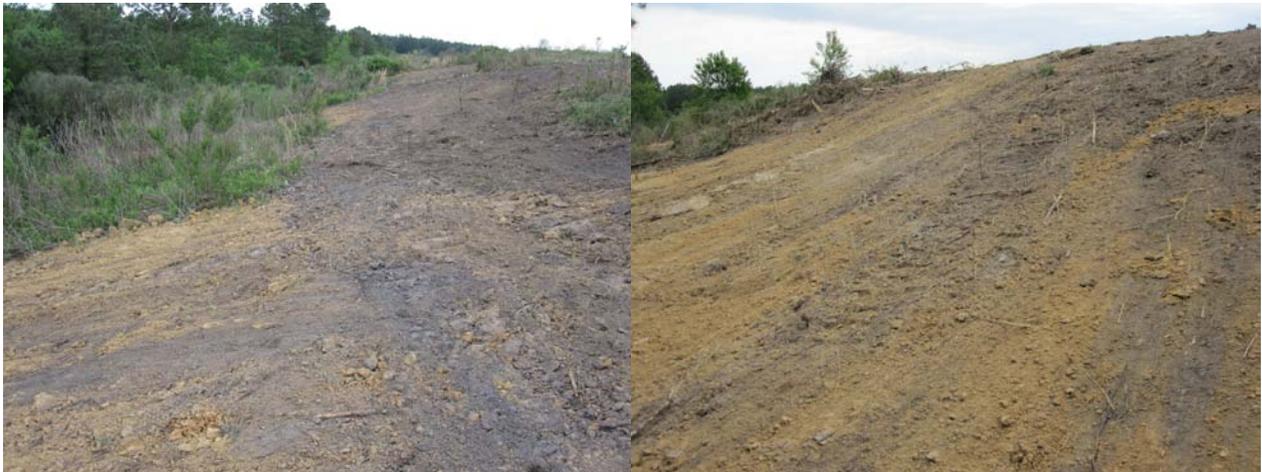
- 3) **15NCAC 13B .1627 CLOSURE AND POST-CLOSURE REQUIREMENTS FOR MSWLF FACILITIES (d)(1)(A)** Maintaining the integrity and effectiveness of any cap system, including making repairs to the cover as necessary to correct the effects of settlement, subsidence, erosion, or other elements, and preventing run-on and run-off from eroding or otherwise damaging the cap system. **Unresolved.** The repaired areas have yet to be seeded and mulched to establish a groundcover suitable to prevent erosion of your landfill cap system.

Repair of eroded areas on eastern sideslope

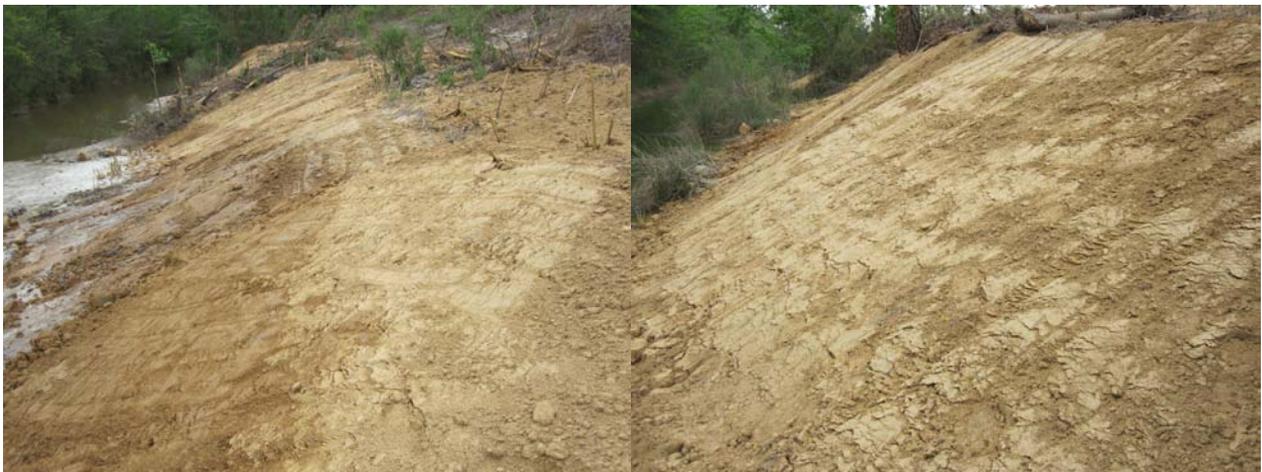
- 2) **15A NCAC 13B .0505 OPERATIONAL REQUIREMENTS FOR SANITARY LANDFILLS (7)(c)**
 Leachate shall be contained on-site or properly treated prior to discharge. **Resolved.** The landfill cap has been repaired in the areas along the eastern sideslope and no leachate was noted seeping from these areas.

Repair of leachate seeps on eastern sideslope above stormwater basin
