**FACILITY COMPLIANCE AUDIT REPORT**  
**Division of Waste Management**  
**Solid Waste Section**

**Date of Audit:** 13 May 2011

Craven County Landfill  
 7400 Old Highway 70  
 New Bern, NC

Partial; follow up audit to review corrective measures taken in response to 25-03, 032111NOV

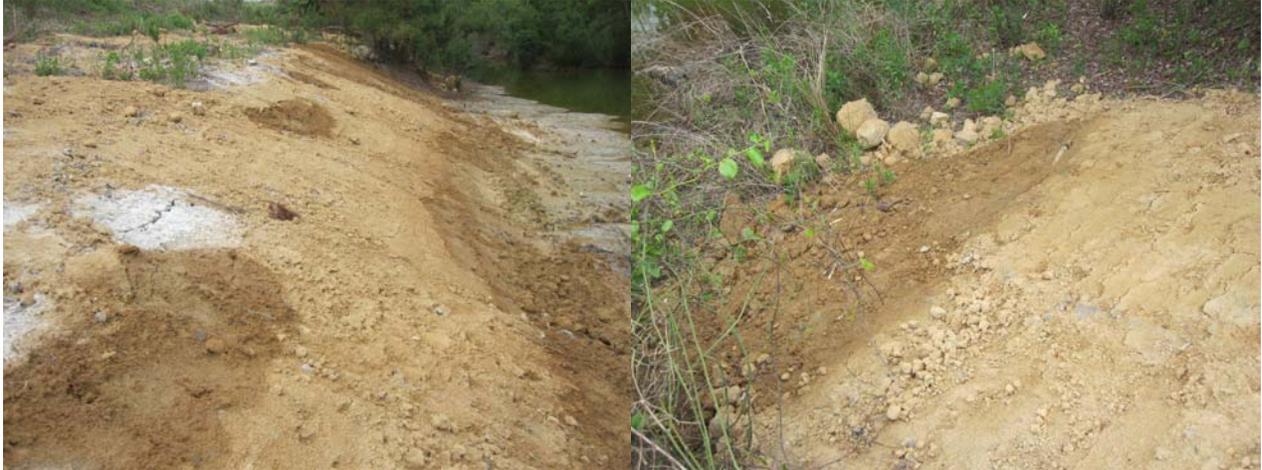
- 6) Edge-of-waste markers have been installed and are being maintained at the facility.
- 7) Several of the repaired areas appear to have begun to seep leachate. \*Please monitor these areas and continue repair actions as needed to prevent the release of leachate from this facility.

Areas of continued leachate seepage (note dark sections of cover soil)

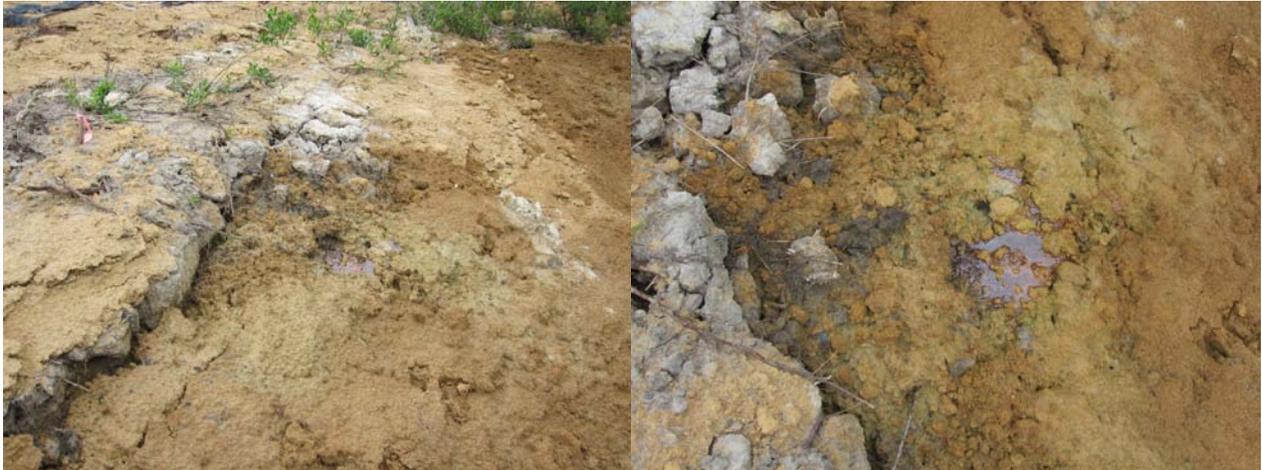
Leachate seeps in repaired sections

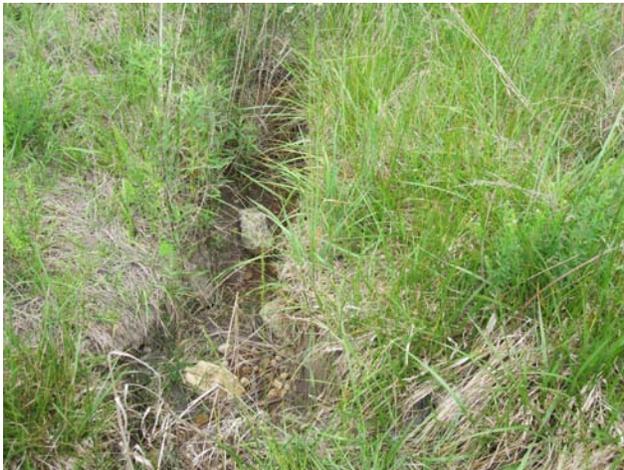
- 8) An eroded area was noted at the toe of the north sideslope. \*Please repair this area to prevent uncontrolled runoff of surface waters from further damaging your landfill cap system.

Washout at toe of northern sideslope

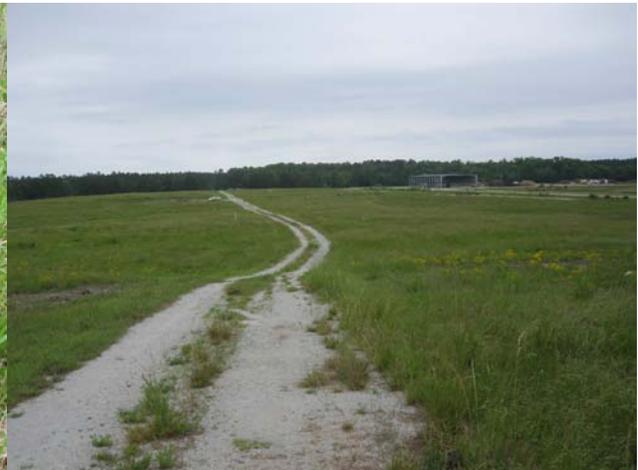
Facility access road and overall well established cover crop
