FACILITY COMPLIANCE AUDIT REPORT
Division of Waste Management
Solid Waste Section

Date of Audit: 9 June 2011

Craven County Landfill
 7400 Old Highway 70
 New Bern, NC

Partial; follow up audit to review corrective measures taken in response to 25-03, 032111NOV

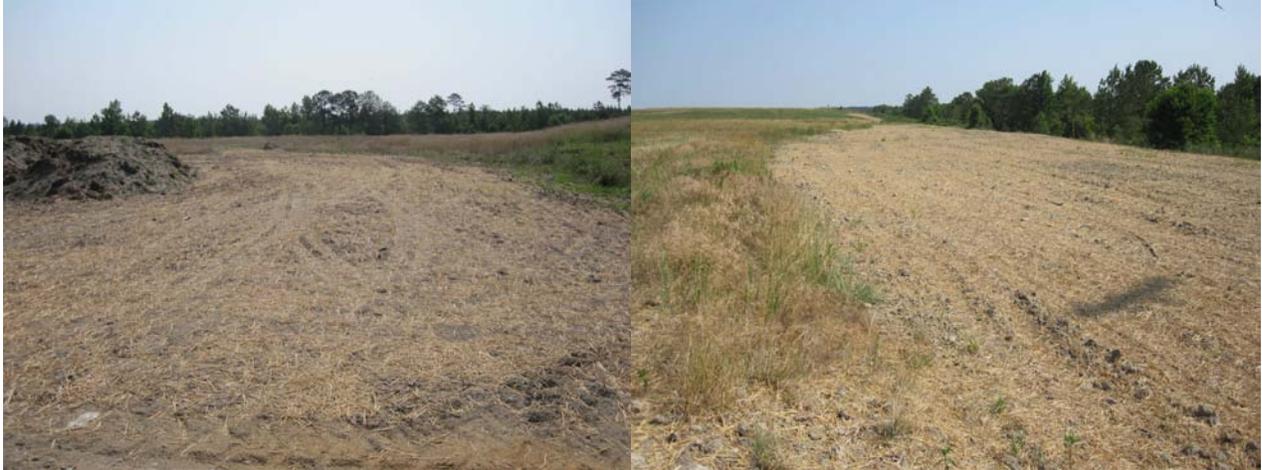
Repaired areas seeded and mulched to establish an effective cover crop

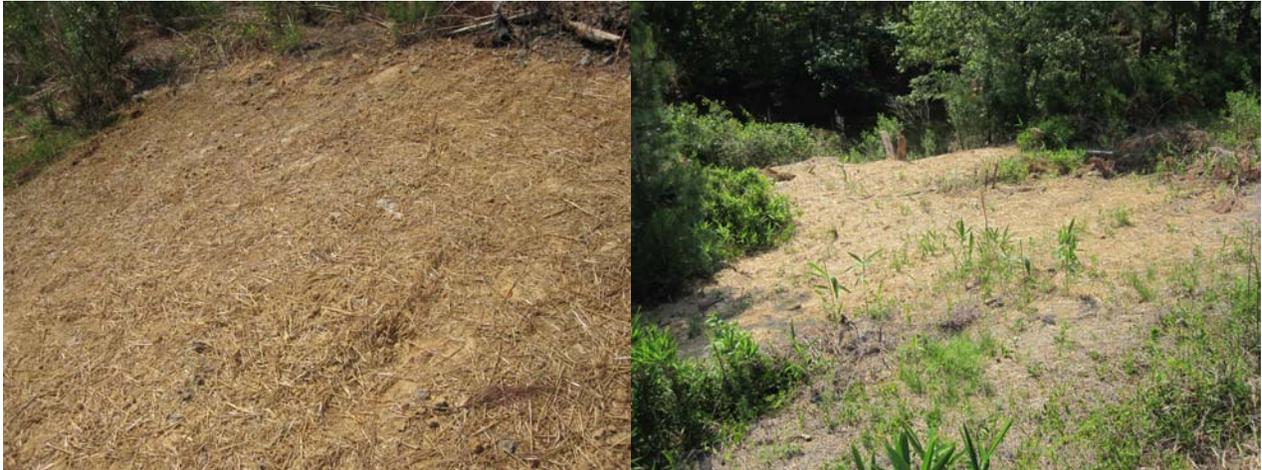
Repaired areas seeded and mulched to establish an effective cover crop
