**FACILITY COMPLIANCE AUDIT REPORT**  
**Division of Waste Management**  
**Solid Waste Section**

Date of Audit: 12 November 2009Date of Last Audit: 8 August 2008**FACILITY NAME AND ADDRESS:**

Cieszko Construction Company LCID Landfill  
 NC Hwy 101 Havelock, NC

Comprehensive

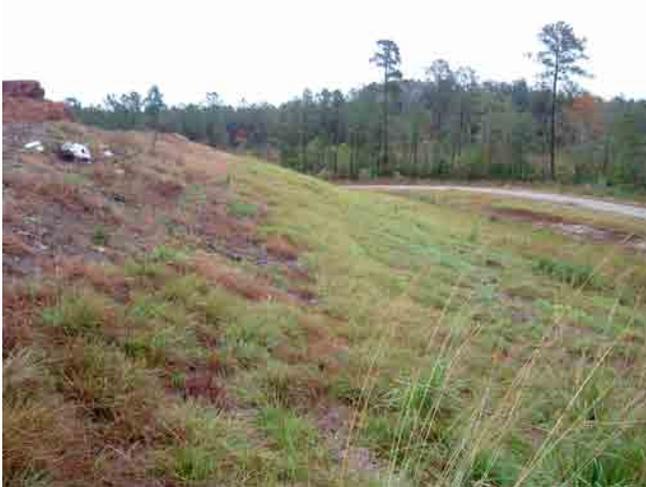
- 6) There are several small areas along the southern and eastern sideslopes of the landfill where the cover crop is too sparse to prevent erosion. Please re-seed and mulch these areas to establish a cover crop suitable to prevent erosion of your cap system. \*Seeding and mulching operations need to be underway in these areas within 30 days of the receipt of this Audit Report.

Sparse patches on southern sideslope

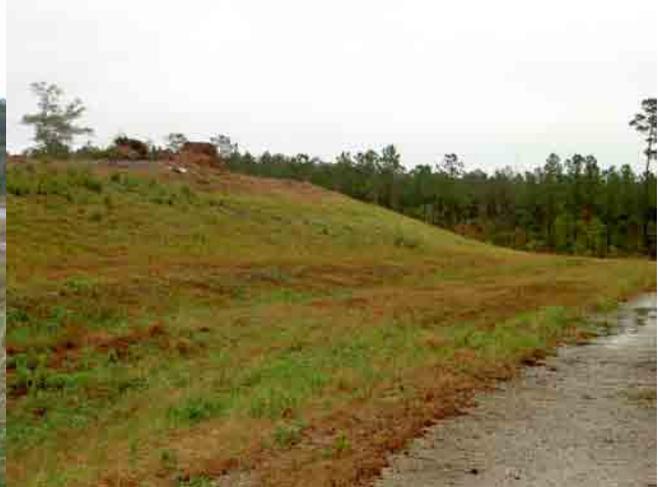
Cover on sideslope Access road

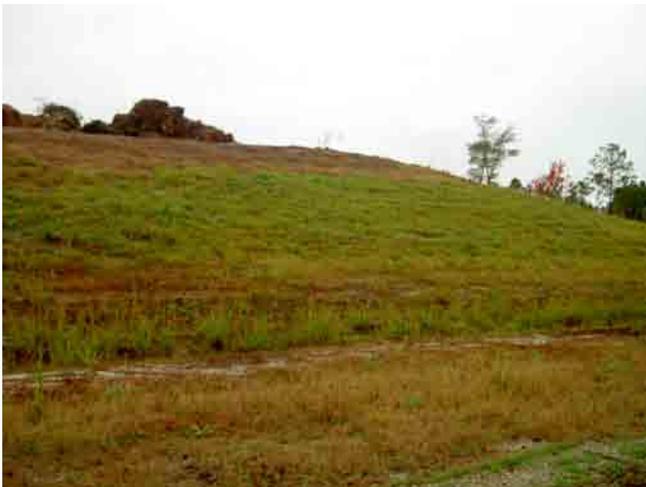
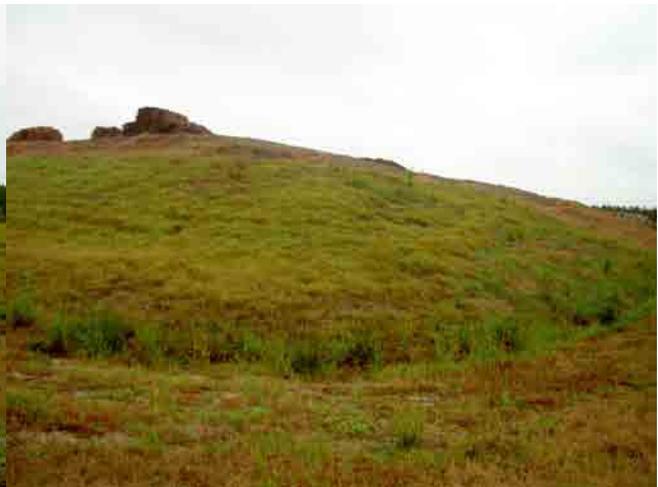
Cover on sideslope below working face

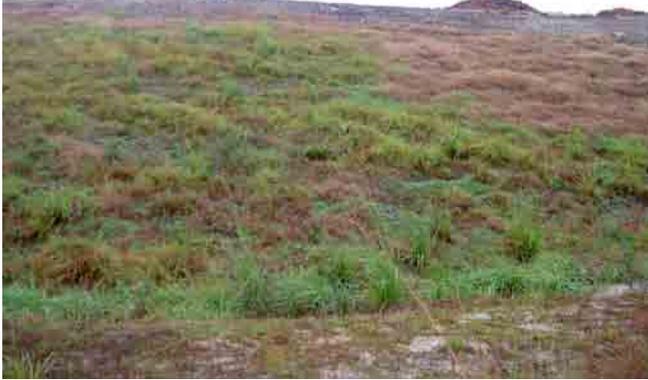
Cover on eastern sideslope below working face

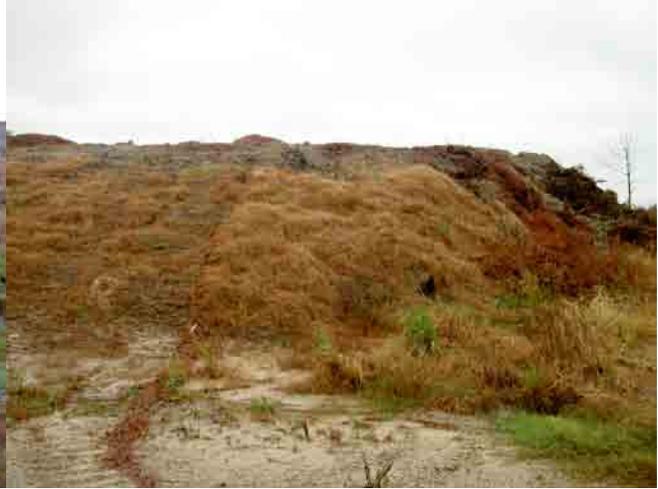
Northeast corner of landfill below working face

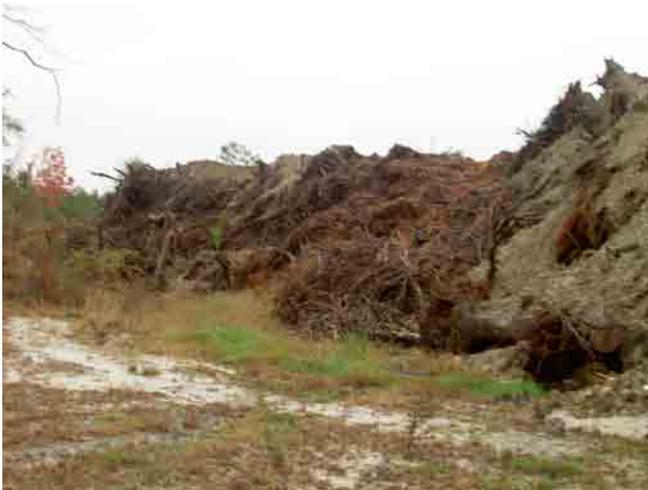
- A compact, clearly defined working space is not being maintained.
- The sideslopes of the landfill have not been graded, covered and maintained at a 3:1 slope with a groundcover established suitable to prevent erosion.
- The waste disposal area is not being covered monthly or upon reaching one acre in size.
- Property buffers and waste boundaries have not been marked.

Northern sideslope needing compaction, cover, grading

- 1) Install markers delineating the landfill waste footprint boundary and all required buffers as listed in 15A NCAC 13B .0564 (9).
- 2) Compact, cover, and grade all the exposed waste on the northern sideslope at a 3:1 slope and establish a groundcover suitable to prevent erosion.
- 3) Ensure that all sideslopes are covered and graded at a 3:1 slope and establish a groundcover suitable to prevent erosion.
- 4) Reduce the working face to not more than ½ acre in size and ensure that operations are restricted to a clearly defined area.

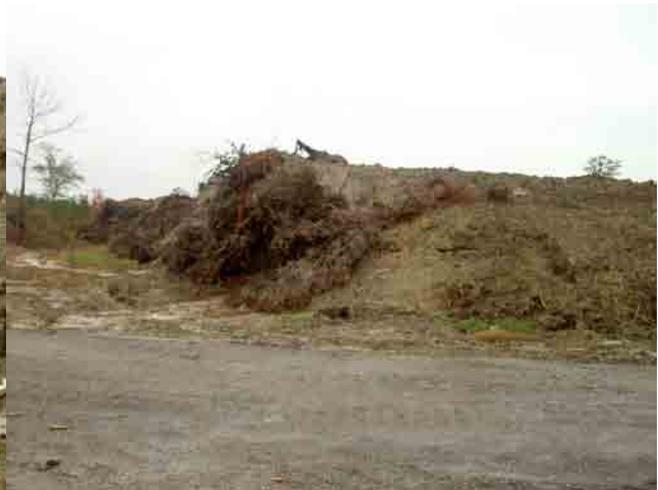
Northwest corner of landfill looking down north sideslope
