**FACILITY COMPLIANCE AUDIT REPORT**  
**Division of Waste Management**  
**Solid Waste Section**

**Date of Audit:** 6 April 2011

Dare County Landfill  
 NC Hwy 64 W  
 East Lake, NC

Comprehensive Audit

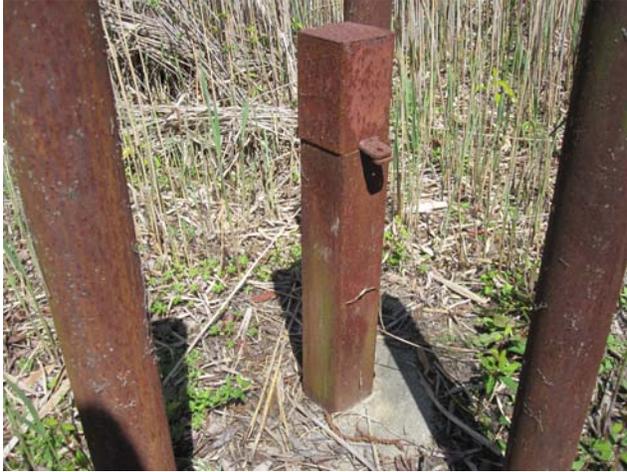
GW Monitoring well needing installation of lock and label

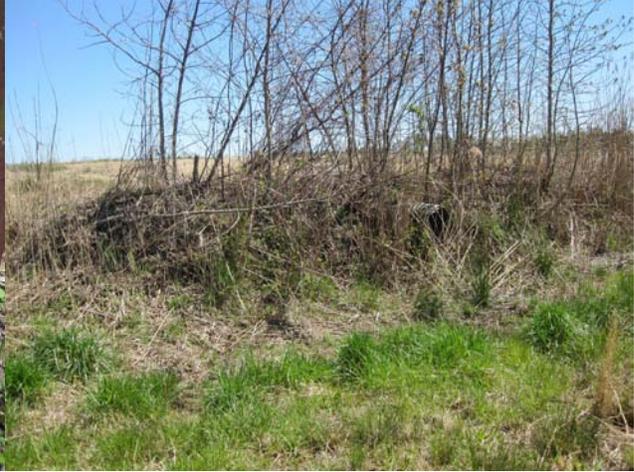
- 10) Trees and other woody vegetation have been allowed to grow on the western sideslope of the upper lift. \*Please remove all trees and woody growth from the landfill. Grade all the cleared areas at a slope not greater than 3:1, seed, and mulch to establish a groundcover suitable to prevent erosion of the landfill cap system.

Brush and woody vegetation on western sideslope needing removal

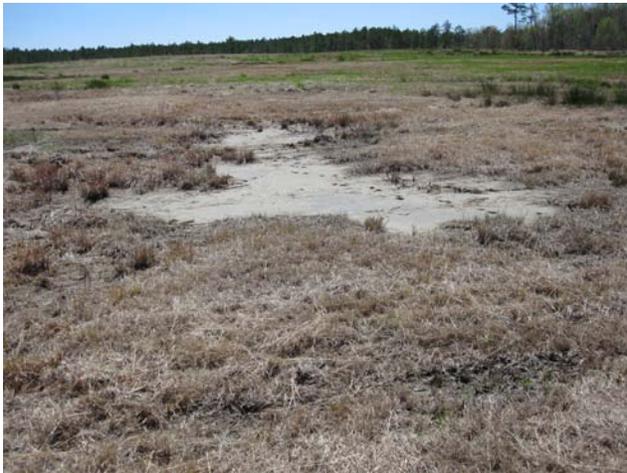
- 7) Highly visible edge-of-waste markers have been installed and are being maintained throughout the facility.
- 8) Overall, the landfill has a well established and maintained cover crop of native warm season grasses. However, several areas were noted as lacking sufficient cover to prevent erosion of your landfill cap system. \*Within thirty days of receipt of this audit report, please repair these areas by grading, seeding, and mulching to establish a groundcover suitable to prevent erosion of you landfill cap system. All repaired areas should be graded at a slope not greater than 3:1.

Area of sparse cover in need of repair

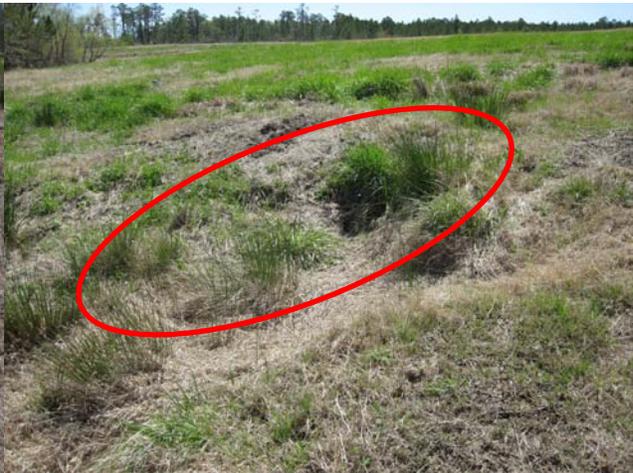
- 9) Small areas of erosion were noted at various places throughout the landfill sideslopes. Overall, the erosion was minor however, if left unaddressed, serious erosion could result. Two areas of significant erosion were noted in the eastern sideslope of the northern cell near the dog leg adjacent to the surface water pond. \*Within thirty days or receipt of this audit report, please repair these eroded areas by grading, seeding, and mulching to establish a groundcover suitable to prevent erosion of you landfill cap system. All repaired areas should be graded at a slope not greater than 3:1.

Area of settlement and erosion in need of repair

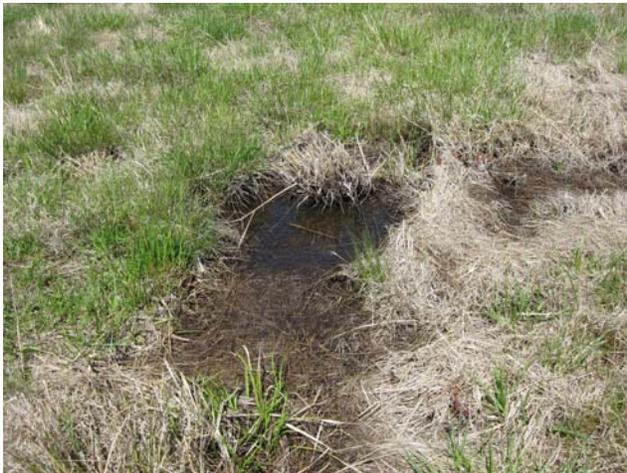
- 11) Areas of differential settlement were noted throughout the landfill. Many of these areas of settlement are significant enough to cause the impoundment of surface waters on the landfill cap. \*Within thirty days of receipt of this audit, please fill and grade these areas to provide for the positive drainage of surface waters from the landfill cap system. All filled areas should be graded at a slope of not greater than 3:1, seeded, and mulched to establish a groundcover suitable to prevent erosion of your landfill cap system.

Surface water impounded on landfill cap

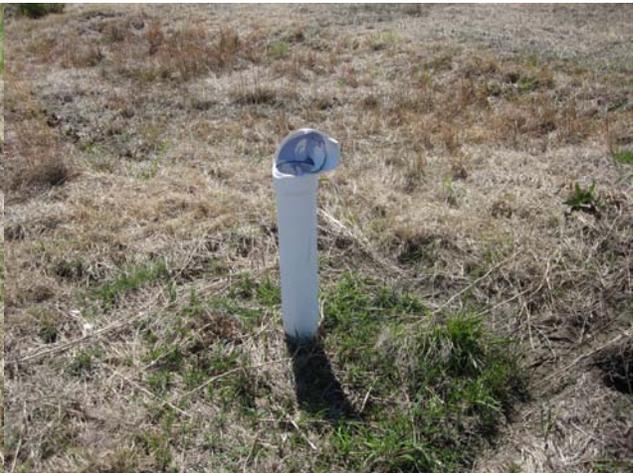
- 12) Landfill gases are managed through a passive venting system. The gas vents were reviewed during this audit. The gas vent adjacent to the dogleg on the eastern sideslope has been damaged by maintenance equipment. \*Within thirty days of receipt of this audit report, please repair this vent by replacing the pvc elbow.

Landfill gas vent in need of repair
