RE: Leachate Release
Davidson County Landfill Phase 2
Thomasville, North Carolina

Photo Documentation – Davidson County Phase 2 Leachate Release 6-8-09
Richardson Smith Gardner and Associates, Inc.

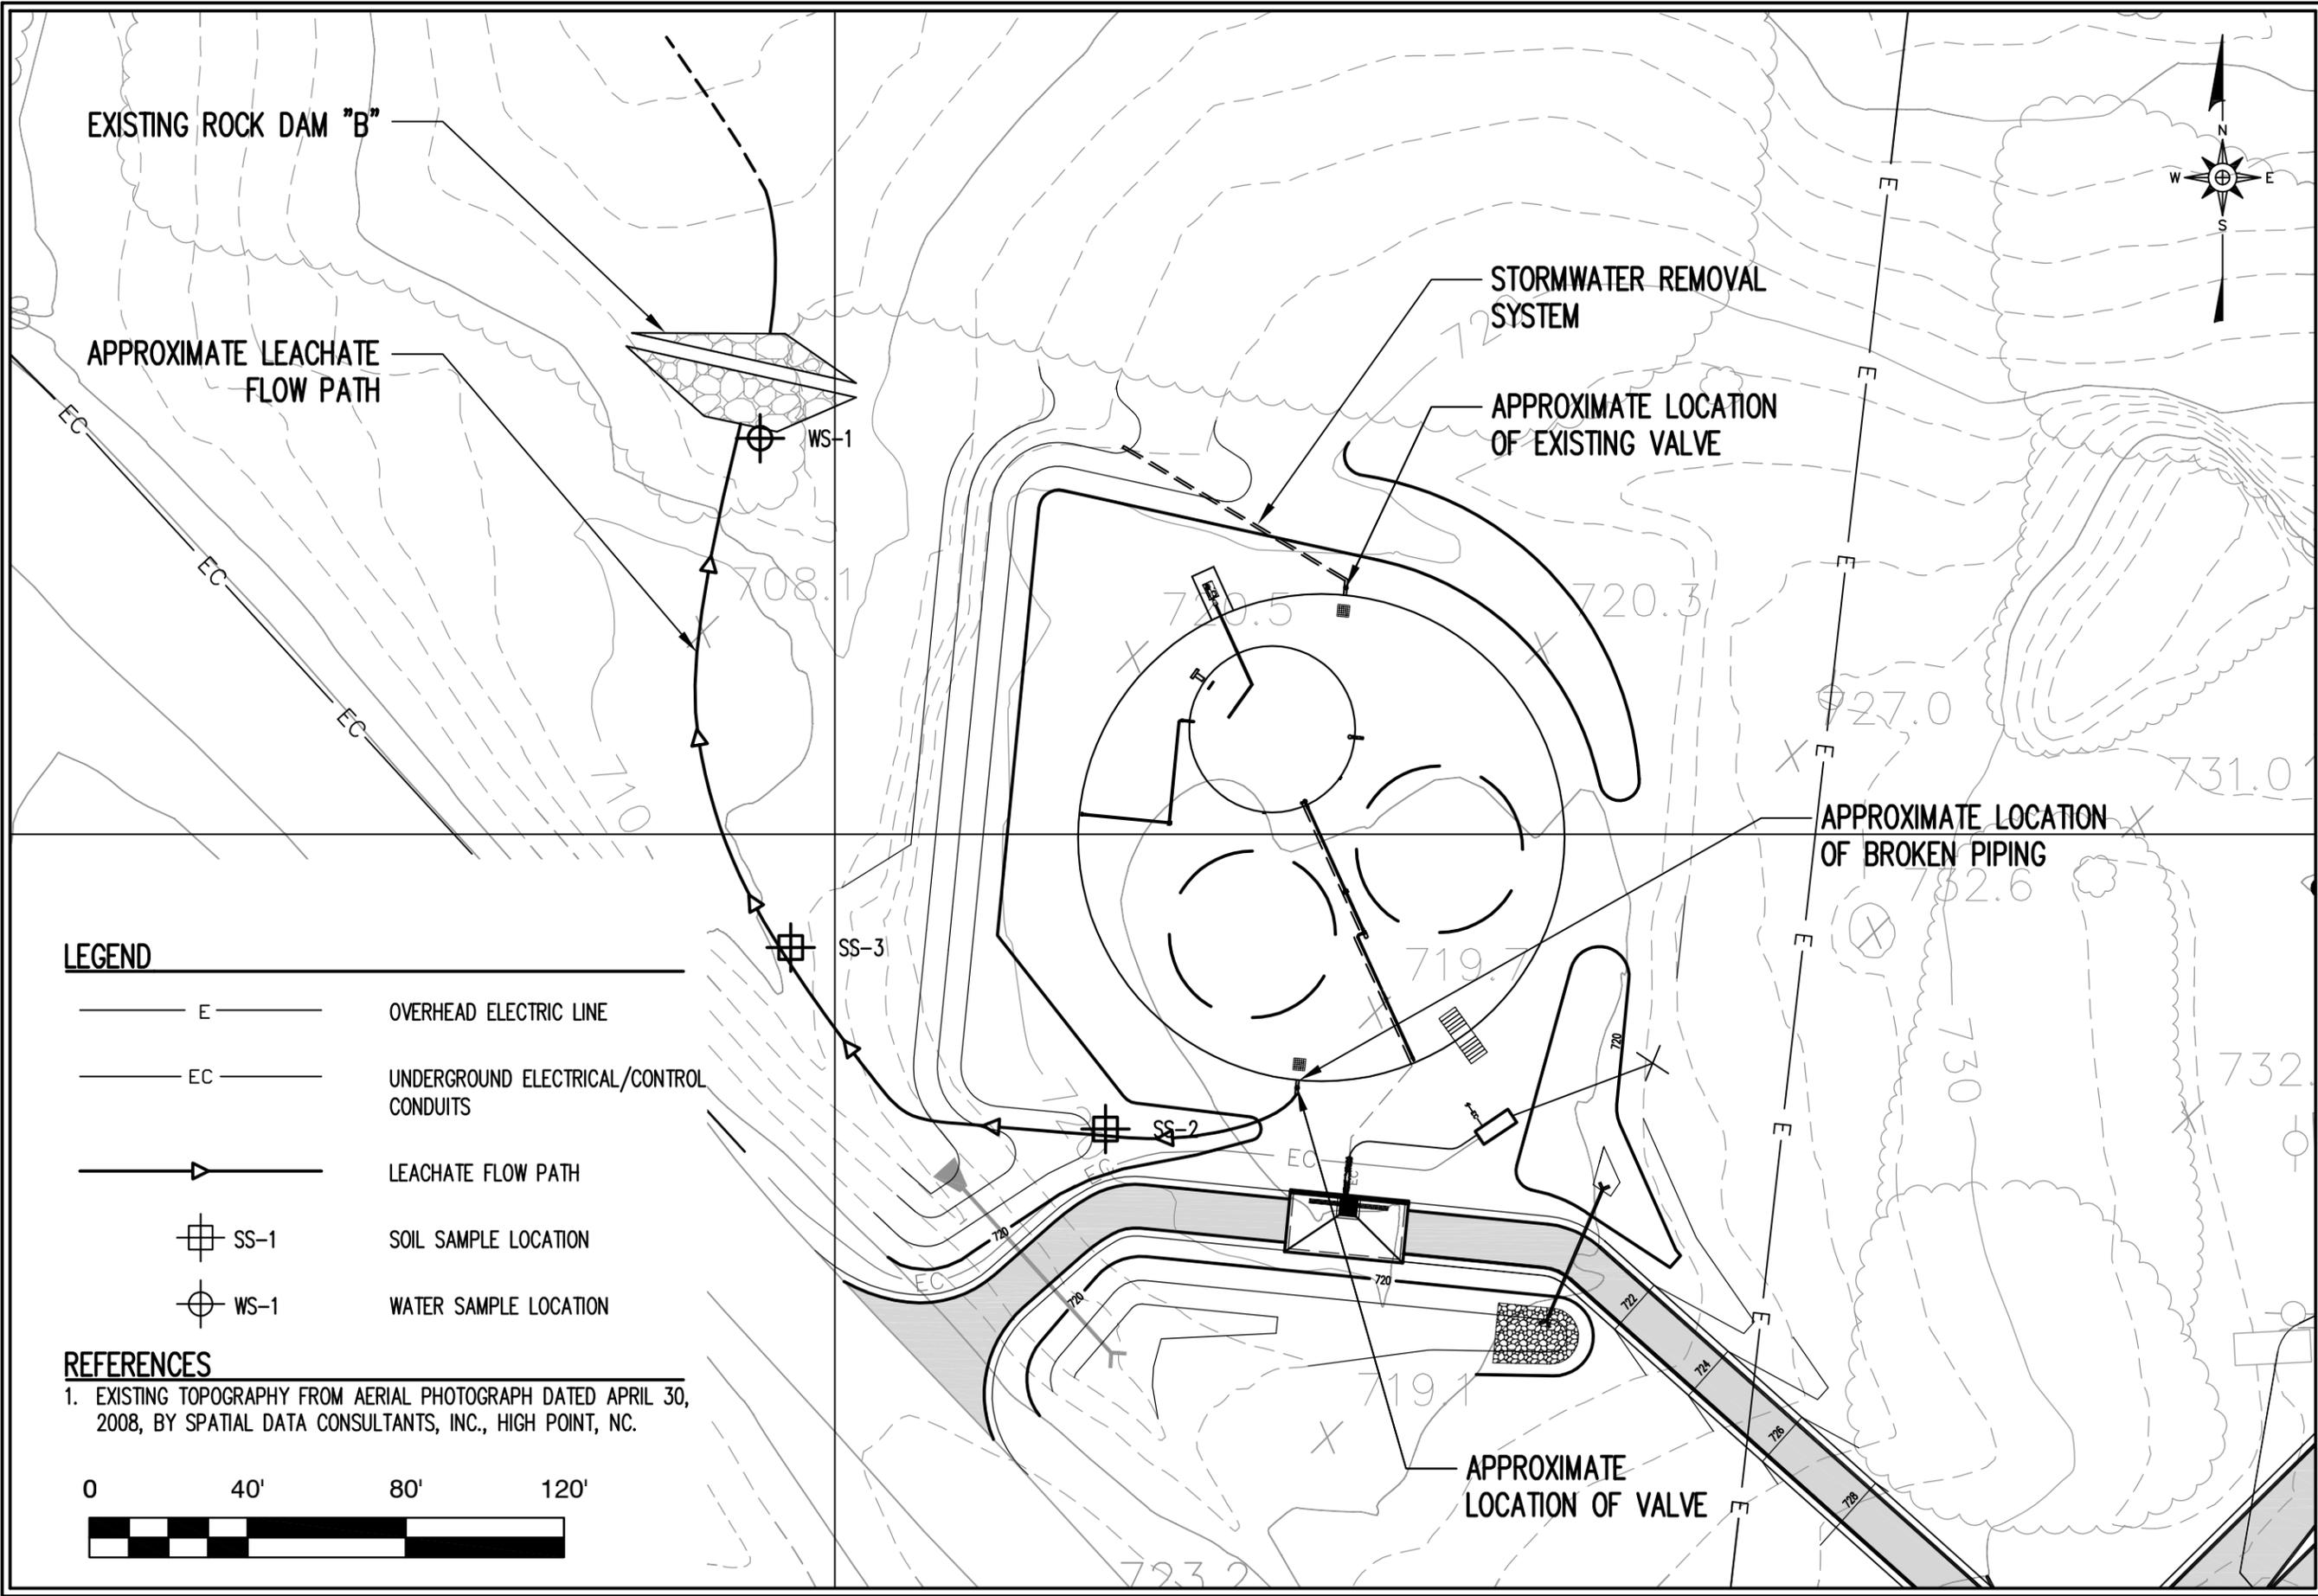
LEACHATE DISCHARGE
6-8-09 DETAILS

The release was discovered at approximately 8:30 a.m. on the morning of Monday June 8th. Upon discovery, Davidson County began hauling leachate from the secondary containment and NCDENR field inspector, Hugh Jernigan was called to visit the site. Davidson County personnel also constructed a dam to limit the flow of leachate toward existing Rock Dam “B”. The location of the leak and the flow path of leachate are shown on the attached **Figure 1**.

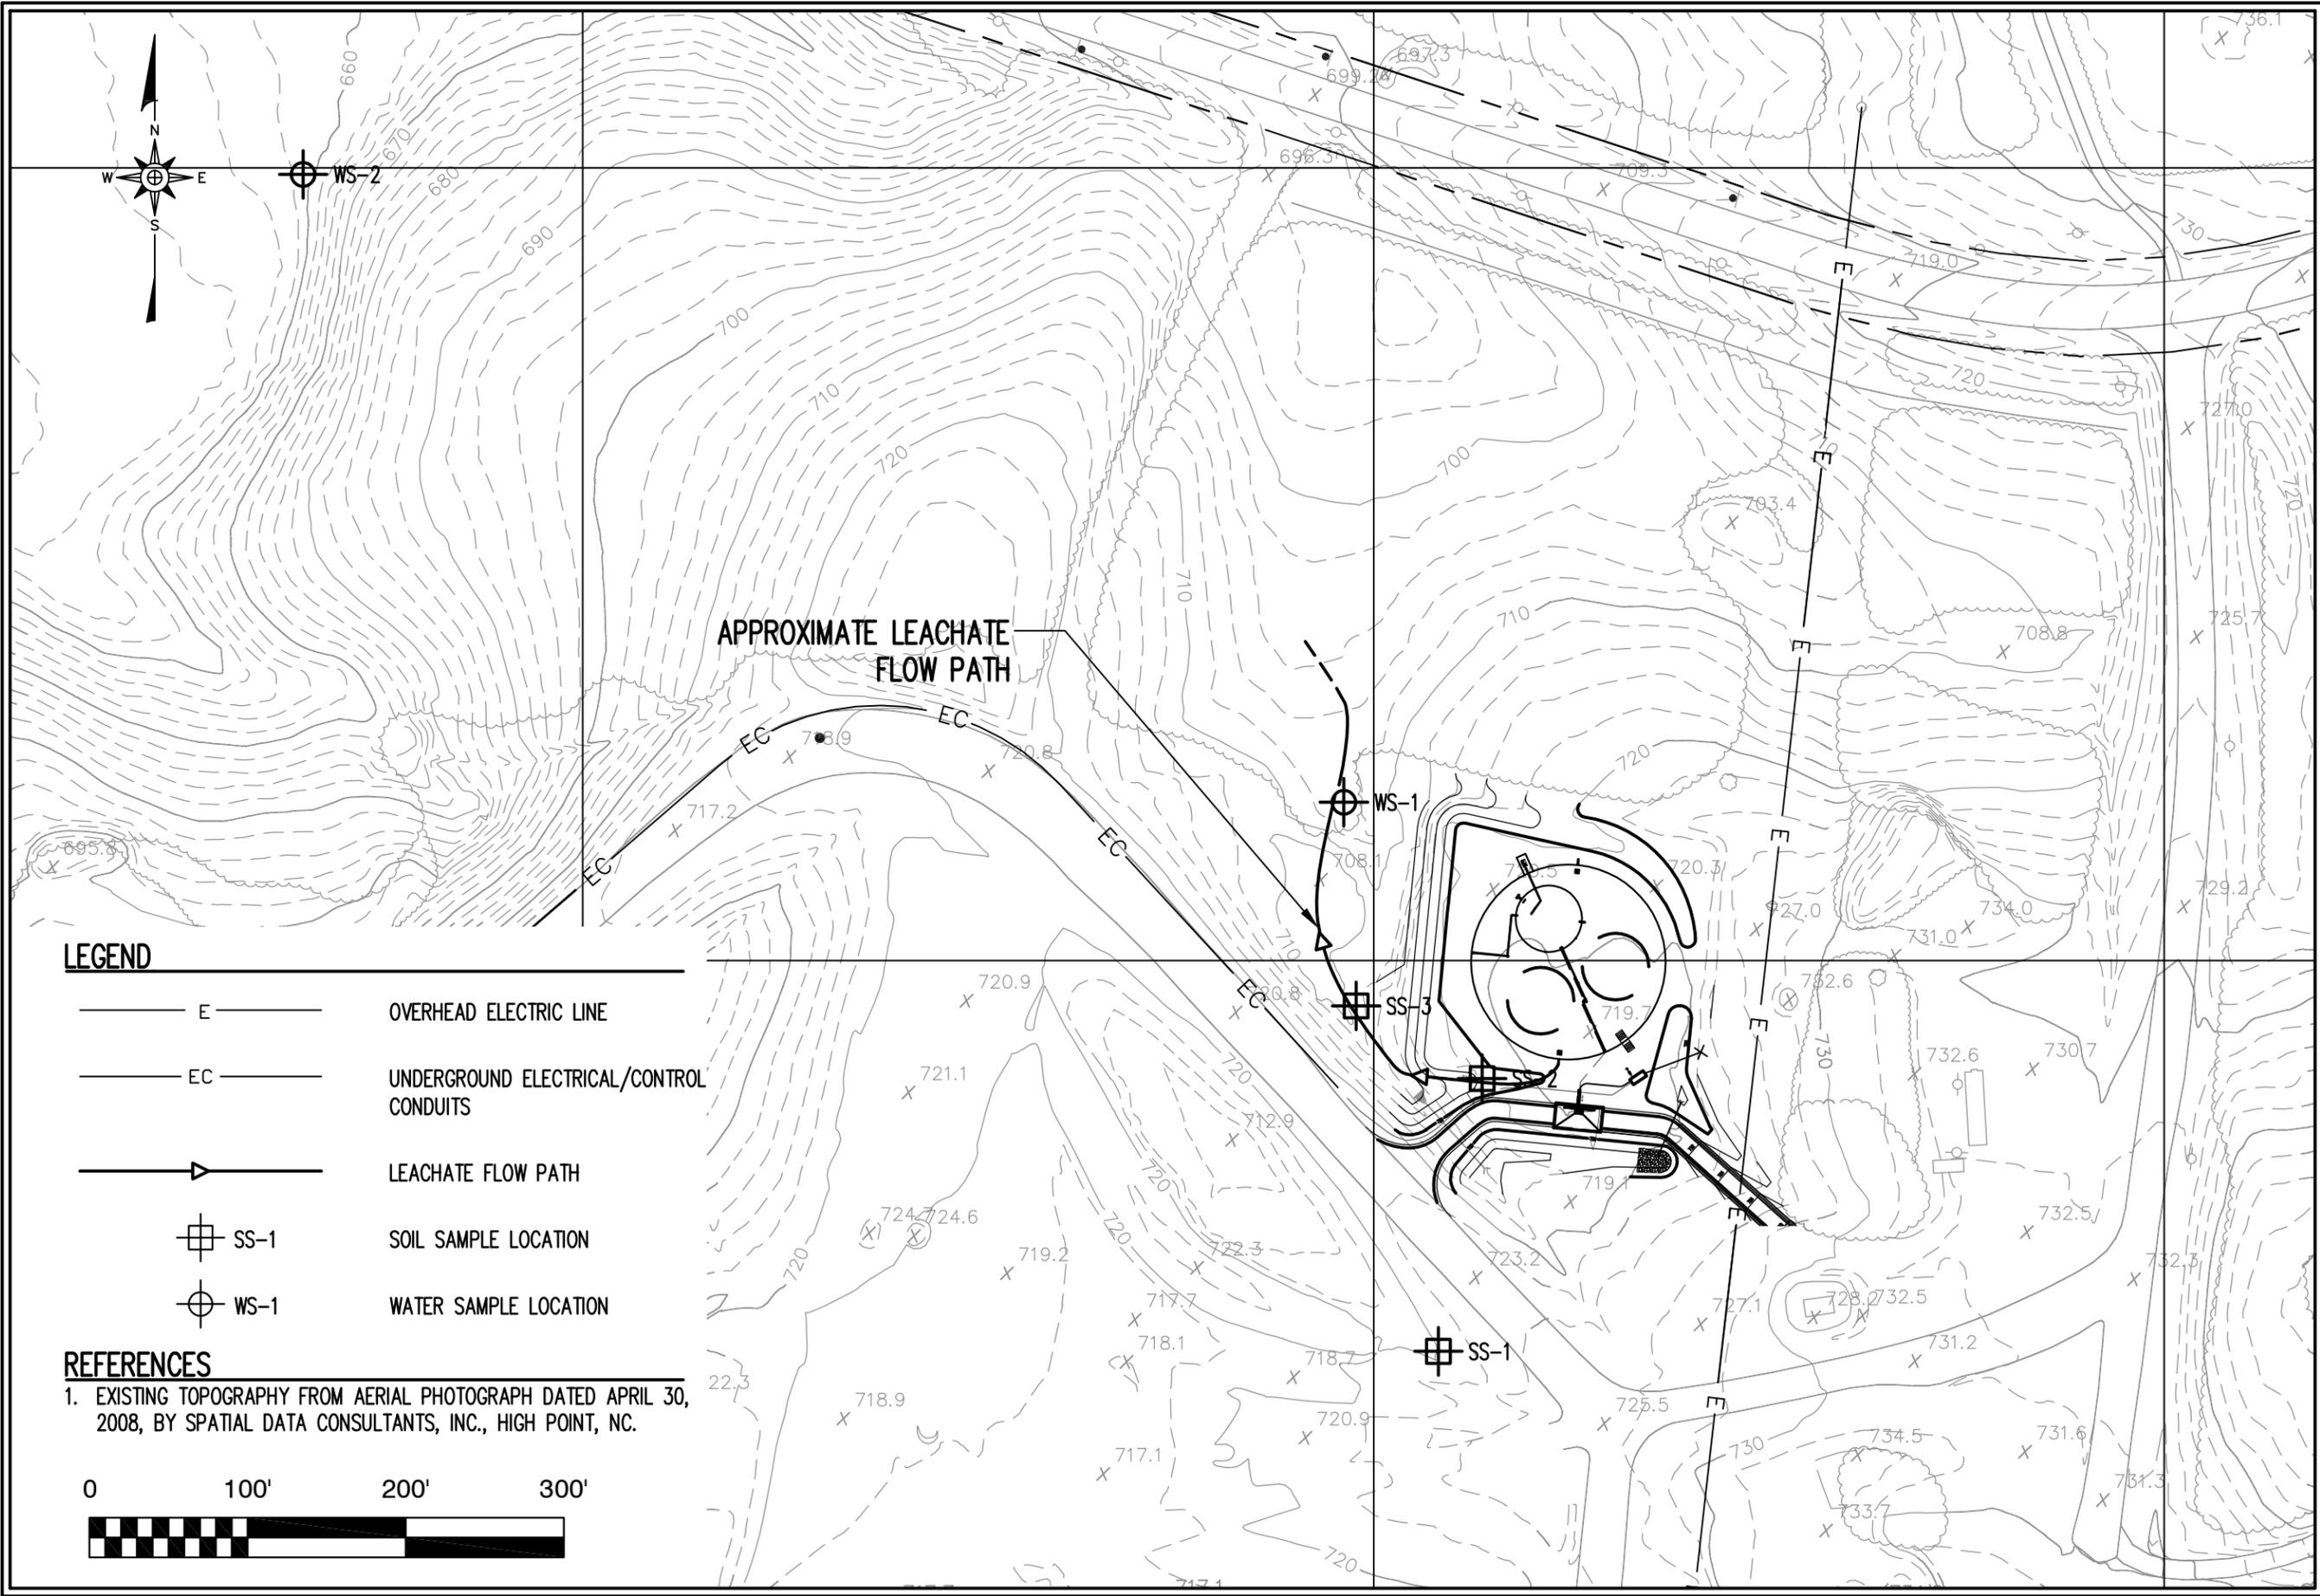
**LEACHATE RELEASE 6-8-09
 SOIL AND WATER
 SAMPLING LOCATIONS**

On June 11th, 2009, I returned to the site to collect three soil samples, two water samples and a leachate sample. The sampling locations are shown on the attached **Figure 2**. Soil Sample #1 was collected as a background sample for comparison purposes. Soil Sample #2 was collected near the leachate release area, while Soil Sample #3 was collected further down the flowpath near Rock Dam B. It should be noted that these samples were collected after the obviously stained soils had been removed from the area.

Two water samples were also collected. One (WS #1 shown on **Figure 2**) was collected in the shallow water that remained at Rock Dam B. Again, live tadpoles were noted in the water during sampling. The second water sample (WS #2 shown on **Figure 2**) was collected from an ephemeral stream in the floodplain of Rich Fork Creek. We are currently awaiting the results of these samples. The analytical report will be forwarded under separate cover.

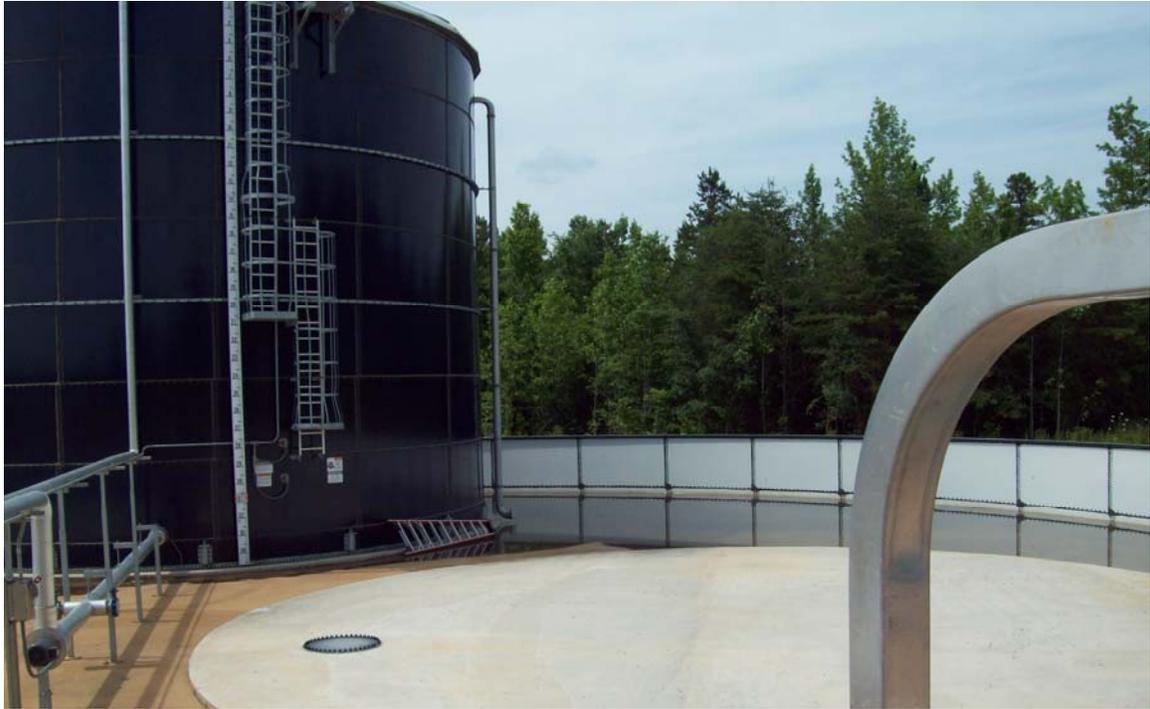
As you are aware, the Davidson County Landfill (Phase 2) experienced a leachate release on/about June 8th, 2009. This release was due to two issues that have since been corrected. Initially, the “tank full” switch that is designed to turn off the Area 1 leachate pumps in the event that the leachate tank is full malfunctioned. This malfunction allowed the Area 1 leachate pumps to continue to pump leachate into the full tank. This caused leachate to be released into the secondary containment area via the tank overflow piping.

Photo #1: Leachate tank – Northeast side of secondary containment area holding leachate as designed, while southwest side leaked.

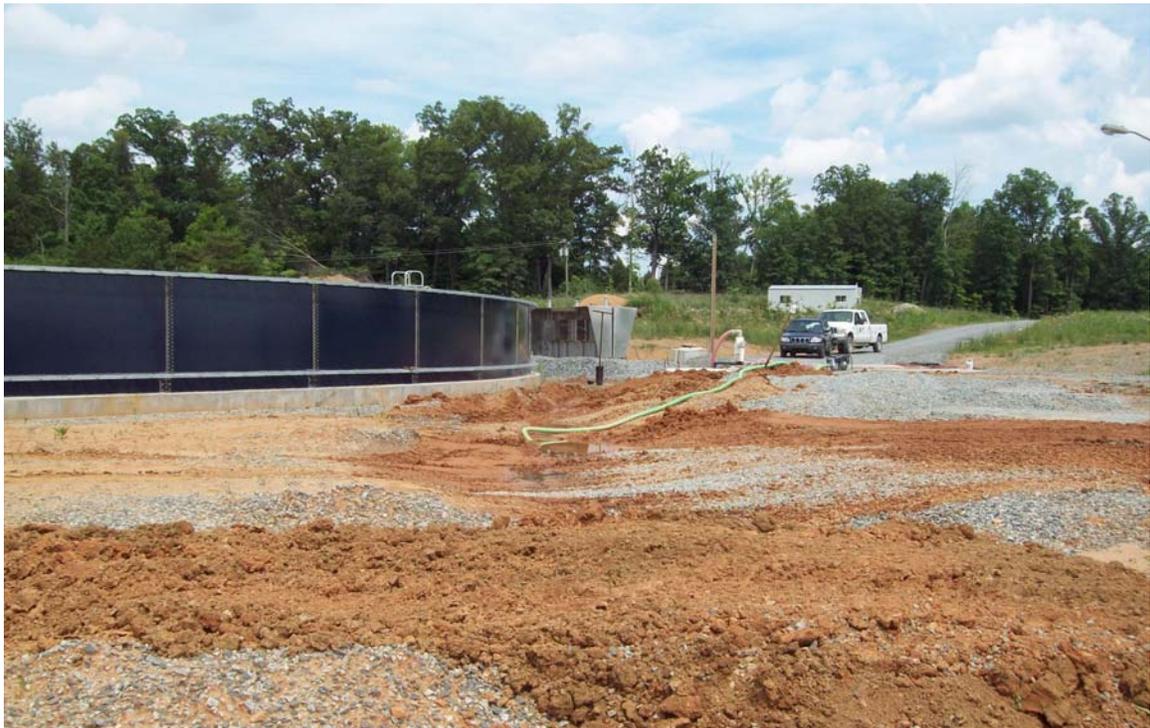
staining were seen along the flow path from the release point to Rock Dam B (see Photographs #2 – 6 in Attachment A). Minimal staining appeared to reach Rock Dam B (Photograph #7) and live tadpoles were noted in the water trapped at the rock dam.

Photo #2: View to the east showing the dammed area to hold leachate in the ditch. Green hose indicates where leachate was pumped from. Approx. 50 gal. were recovered from this area. Soil Sample #2 collected in the area where the green hose and pump are in the center of the photograph.

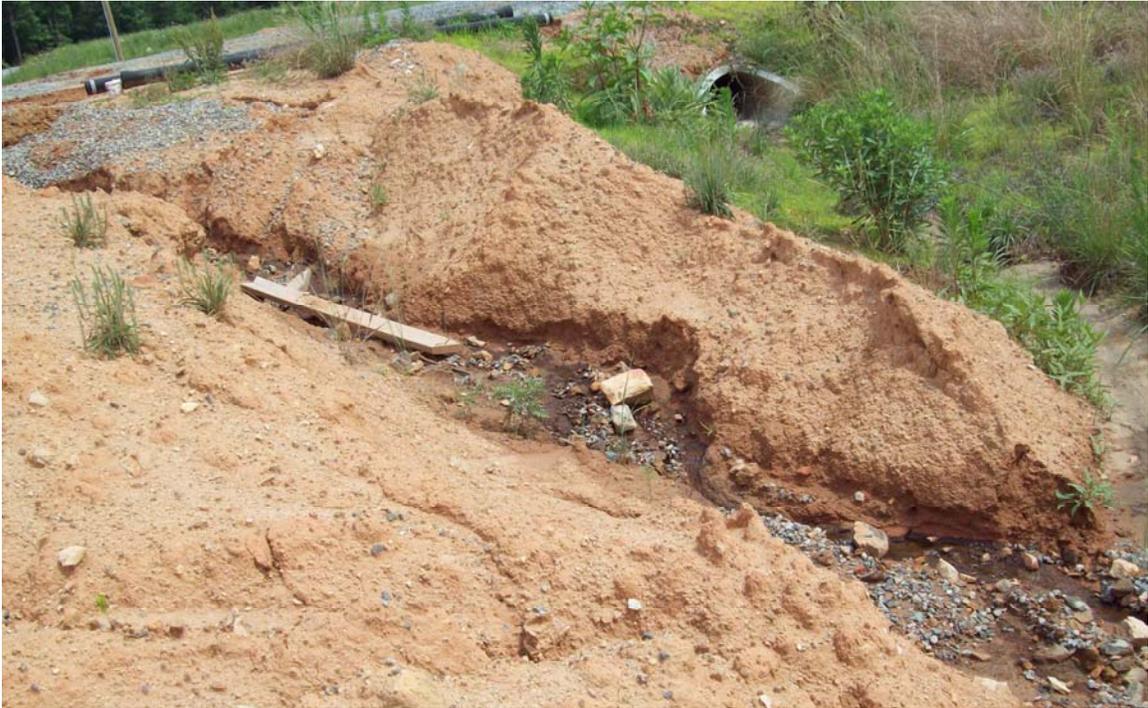
Photo #3: Flowpath of leachate toward Rock Dam “B”.

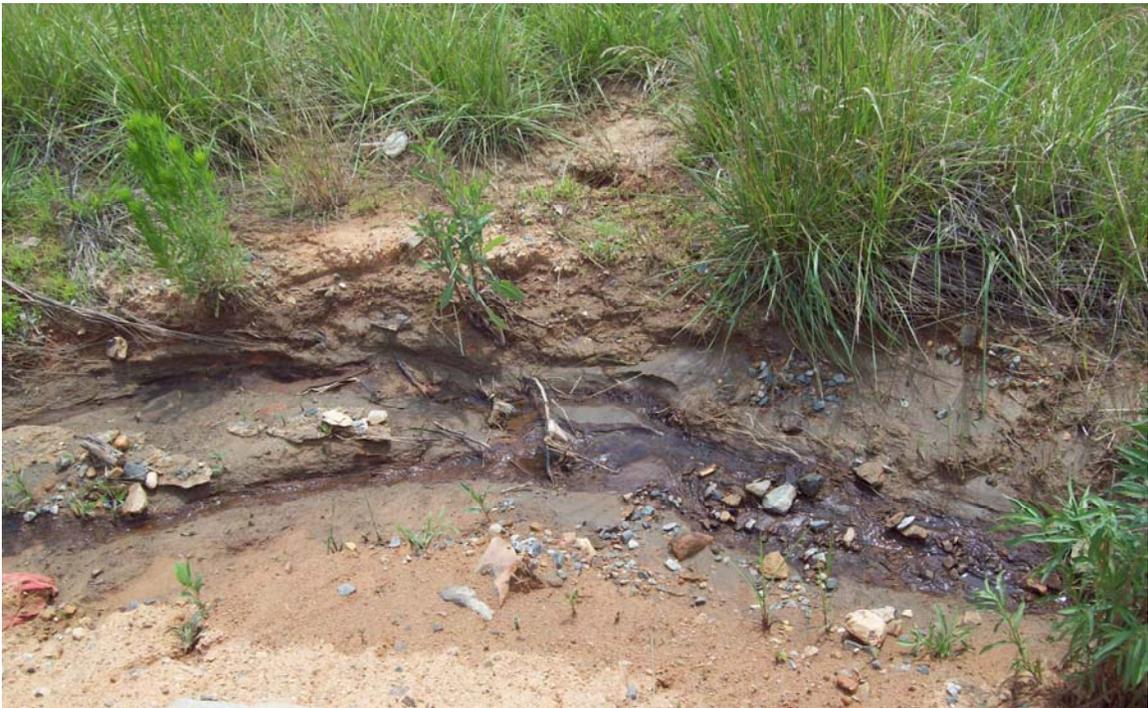
Photo #4: Flowpath of leachate toward Rock Dam “B”.

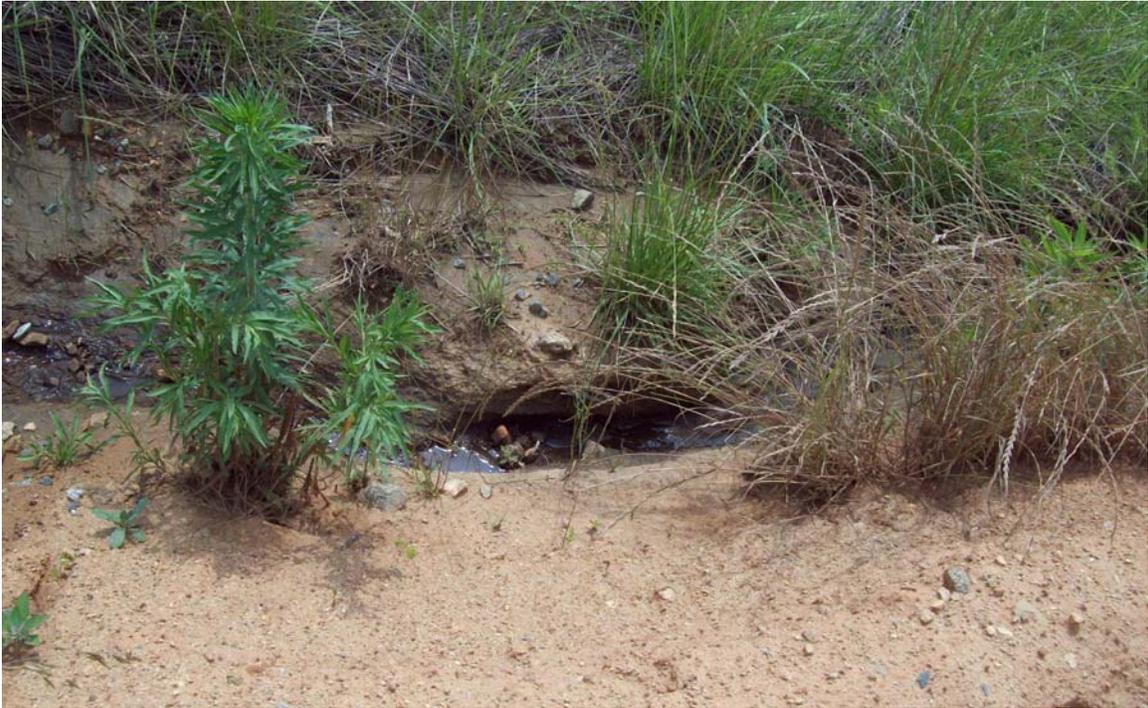
Photo #5: Flowpath of leachate toward Rock Dam “B”.

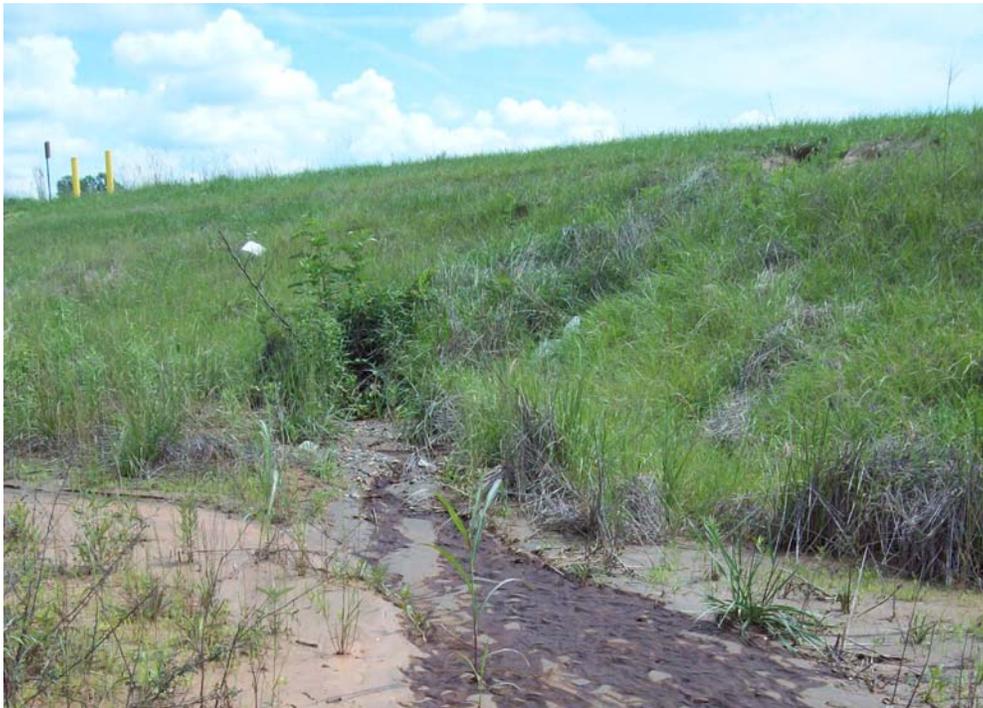
Photo #6: View to the southeast showing staining from leachate along flowpath toward Rock Dam “B”.

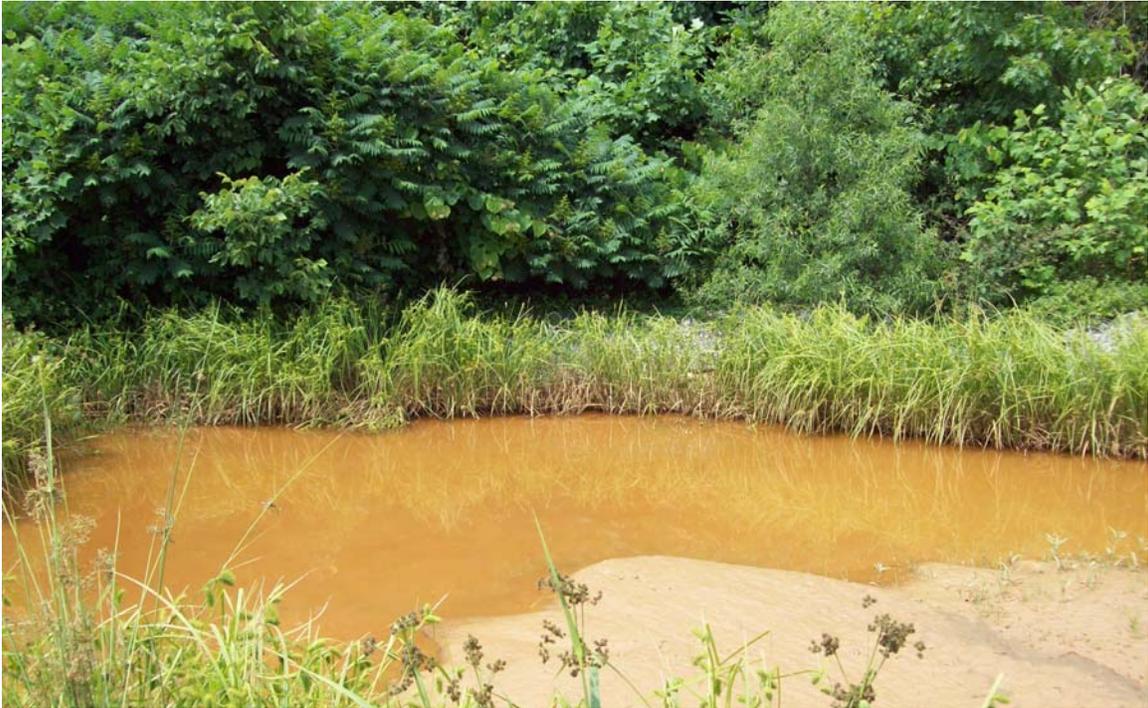
Photo #7: Rock Dam “B”. Minimal staining reached this location. Most of the water from this area (approx. 100 gal.) was removed on 6/9/09.

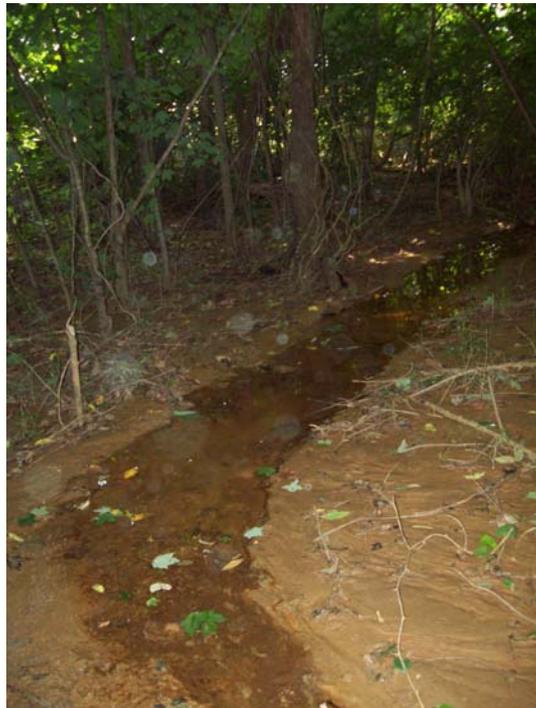
Inspection of the area downstream of Rock Dam B indicated low-flow conditions with most of the flow path being 6-inches wide or less. In one area immediately downstream of the rock dam an area with flow that was 2-feet wide was noted. This area quickly “fingered” into smaller flow paths which coalesced into a 6-inch flow approximately 50 feet downstream from the rock dam (see Photographs #8 and #9). Approximately 150 feet downstream from the rock dam, conditions were found to be wet across a large area; however, this appeared to be more natural wetlands than an area impacted by flow. Several flow paths were noted and all appeared to be clear with no indication of impact from leachate.

Photo #8: Downstream of Rock Dam “B”. Low flow is evident. Flow path is approximately 2-feet wide at the widest point. Most of the flow is 6-inches wide or less.

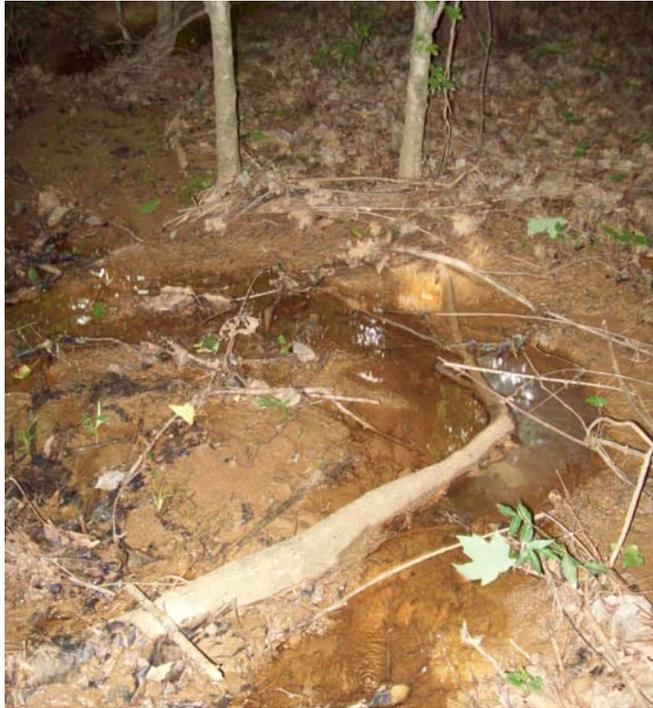
Photo #9: Flowpath approximately 200 feet downgradient from the outlet of Rock Dam “B”. Flow in this area is approximately 6-inches across.

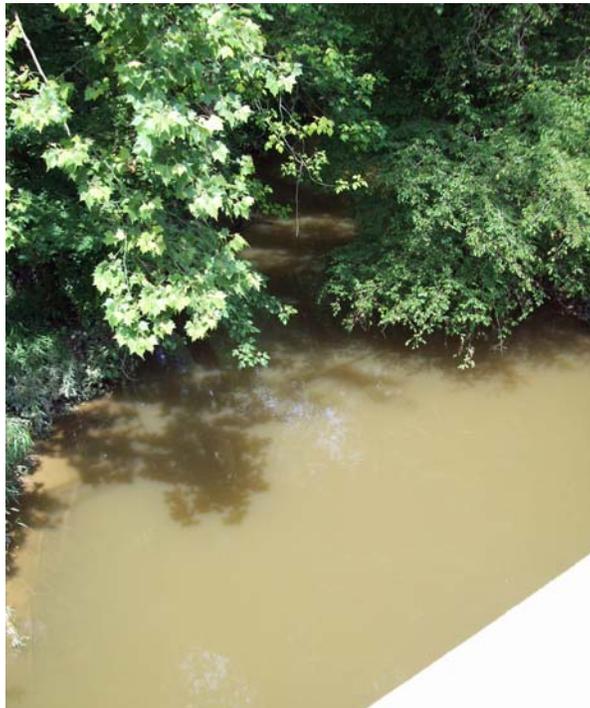
The receiving stream (Rich Fork Creek) is located approximately ¼ mile from where the release occurred (see Photographs #10 and #11). There was no indication that the leachate release reached this receiving water.

Photo #10: View of receiving stream (Rich Fork Creek) upstream of bridge on Old Hwy. 29 (facing northeast). Stream is approx. ¼ mile from leachate tank location.

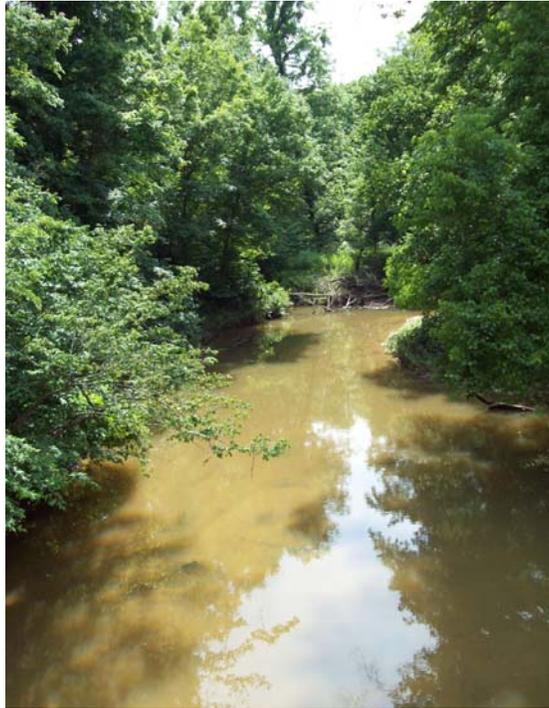
Photo #11: View of receiving stream (Rich Fork Creek) to the southwest from bridge on Old Hwy 29. No evidence of leachate reaching this stream was observed.

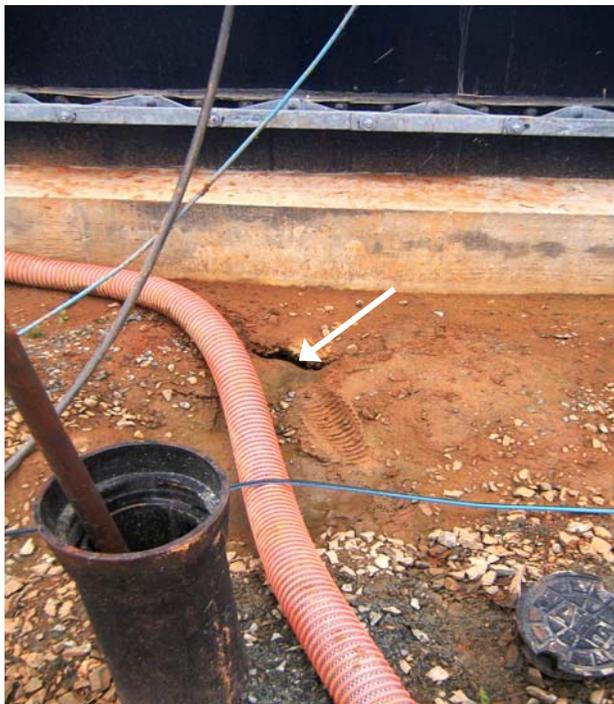
Apparently, during construction of the tank system, the valve that was designed for storm water removal from the southwestern half of the secondary containment area was bumped by a backhoe. Although there was no visible damage at the valve, apparently this incident caused a breach in the piping between the southwestern secondary containment sump and the valve. This breach in the piping allowed the release of leachate from the secondary containment.

Between June 8th and June 11th, Davidson County personnel continued to pump leachate from Rock Dam B and remove any obviously stained soils from along the flow path. During work at the secondary containment sump on June 11th, the breach in the piping between the sump and the valve box was noted. At this time the breach in the soil adjacent to the piping was also noted (see photograph #12). On June 11th the piping was plugged and the sump was partially filled with concrete above the elevation of the plugged pipe. County personnel decided that any future removal of water from this half of the secondary containment area would be done using a portable pump that would be placed in the sump.

Photo#12: View of area where leak occurred. The dark line in the soil adjacent to the hose at the center of the photograph (see arrow) is where the leachate leaked out of the breach in the pipe connecting the valve (foreground) to the sump located within the secondary containment area. Photo taken June 11, 2009.

Davidson County has performed all remedial measures that are warranted at this time. All leachate has been removed from the secondary containment and hauled to the local wastewater treatment plant. The pipe breach has been plugged and the sump partially filled with concrete
