**FACILITY COMPLIANCE AUDIT REPORT**  
**Division of Waste Management**  
**Solid Waste Section**

**Date of Audit:** 10/12/10

Stone Park Court Transfer Station  
 148 Stone Park Court  
 Durham, NC

Comprehensive Audit

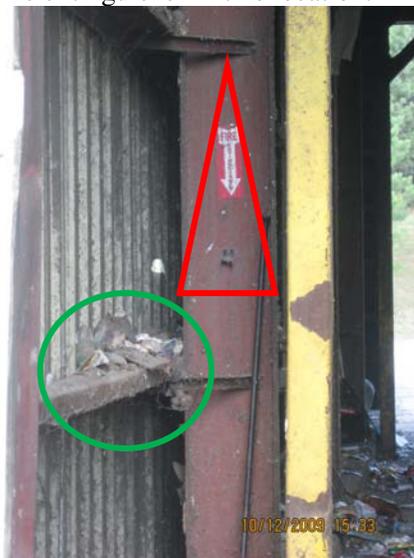
- 12) No blowing litter was observed at the time of inspection
  - 13) Fire control equipment is in place on the walls beside the tipping floor. The fire extinguishers were fully charged. Monthly checks on the existing extinguishers were being recorded on the tags. A label and hook for a fire extinguisher is in the MSW side tunnel (near the exit), however; the fire extinguisher was missing as pictured below (red triangle). Please replace and properly maintain a fire extinguisher in this location.

- 14) The horizontal beams along the drop tunnels contained accumulated waste (see green circle in picture of comment #13). **Waste should be placed in a transfer trailer at the end of each working day and should not remain in building. Please complete regular cleanings to remove accumulated waste that may become lodged on beams or small crevices.**

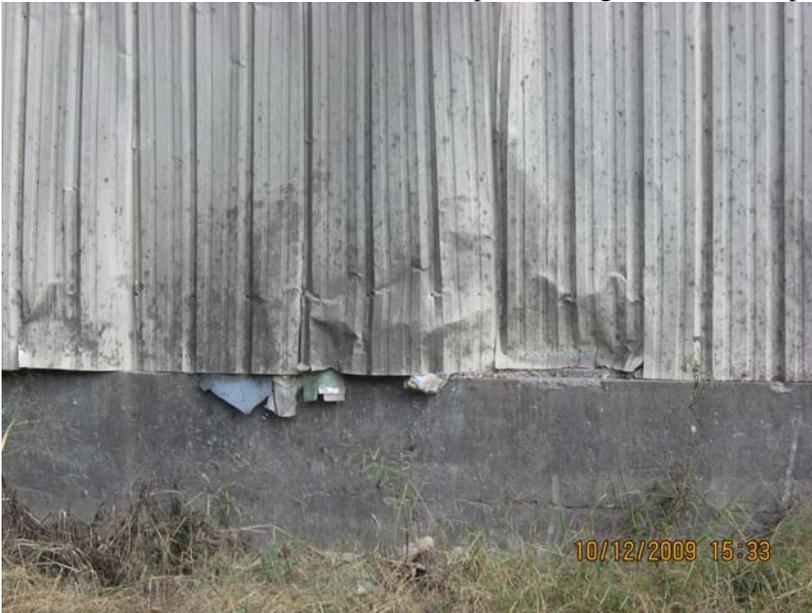
- 16) The back of the building contained many areas where the sheet metal has become loose allowing material to become lodged in the void (picture below). **Waste Industries should repair the rear wall so that all waste remains fully contained inside the transfer station.** It is recommended that the rear exterior wall be included as part of a regular routine inspection of the facility.
