FACILITY COMPLIANCE AUDIT REPORT
Division of Waste Management
Solid Waste Section

Date of Audit: December 29, 2010

Currin Landfill
 Coley Road
 Durham County, NC

Comprehensive Audit

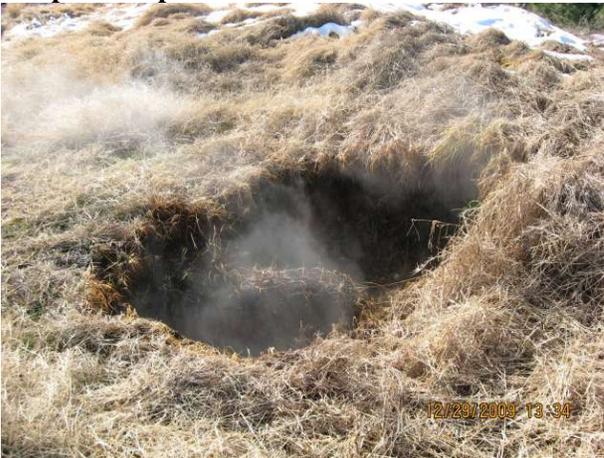
- 5) At the time of inspection the facility was secured by a locked gate.
- 6) I observed a cave-in (approximately 5 ft. by 3 ft.) on the top of the landfill in the southeast corner (picture below) emitting steam. A second area of cracks in the cover also emitting steam was observed in the northwest corner of the landfill. **The cave-in/cracks should be filled with soil, graded, and seeded by February 14, 2011. Documentation (pictures) of the repairs should be entered into the operating record and forwarded to me upon completion.**

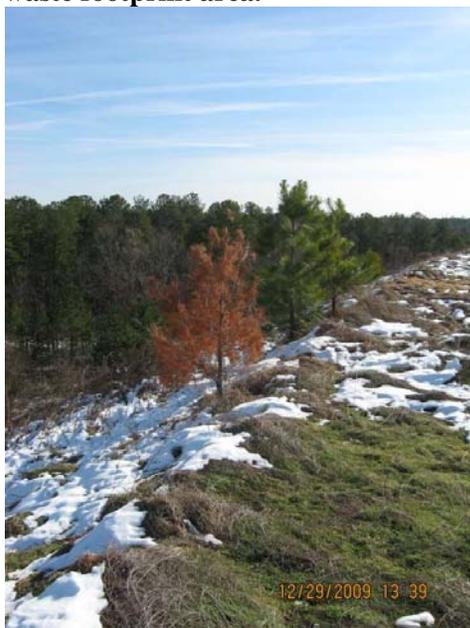
- 7) Trees are starting to grow on the cover of the landfill (picture below). **In order to provide proper visual inspections of the landfill and maintain the integrity of the soil cover, these trees should be removed from the waste footprint area.**
