FACILITY COMPLIANCE AUDIT REPORT

Date of Audit: September 13, 2010**Date of Last Audit:** July 14, 2003**FACILITY NAME AND ADDRESS:**

Barnhill Contracting-Asphalt Plant LCID
 10826 NC 97 West
 Rocky Mount, North Carolina

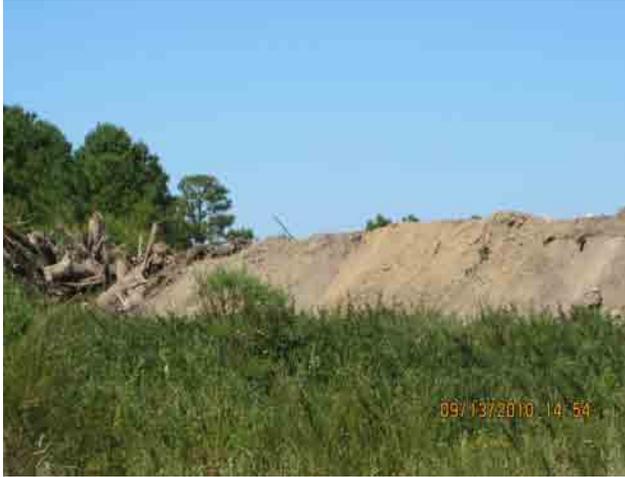
View of the western slope of the landfill, facing north

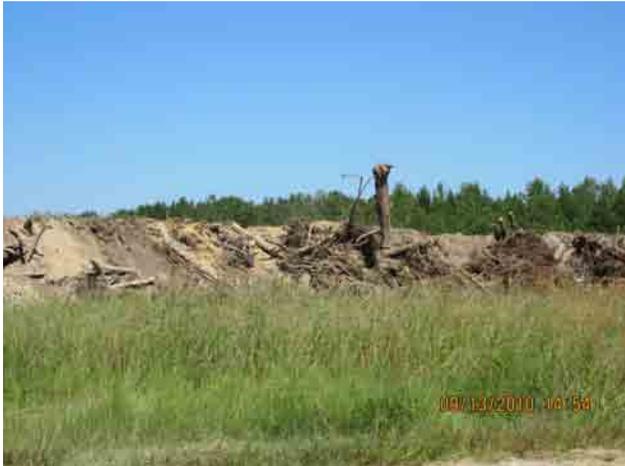
View of the southern slope of the landfill facing north

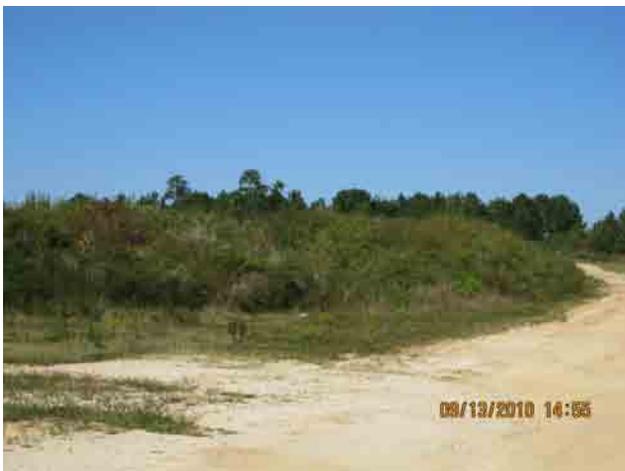
View of the eastern slope of the landfill, facing north

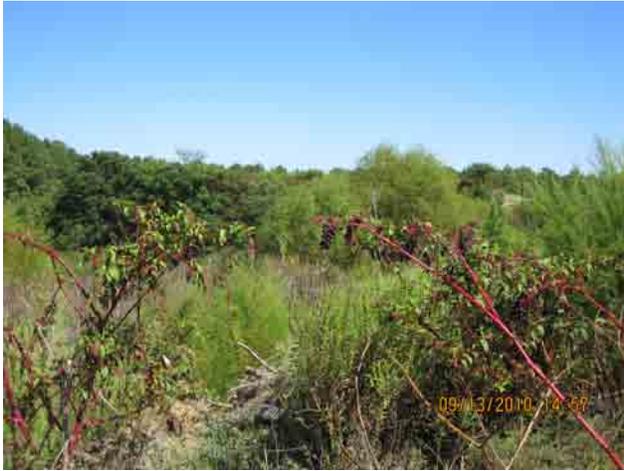
View of the northern slope of the landfill facing east

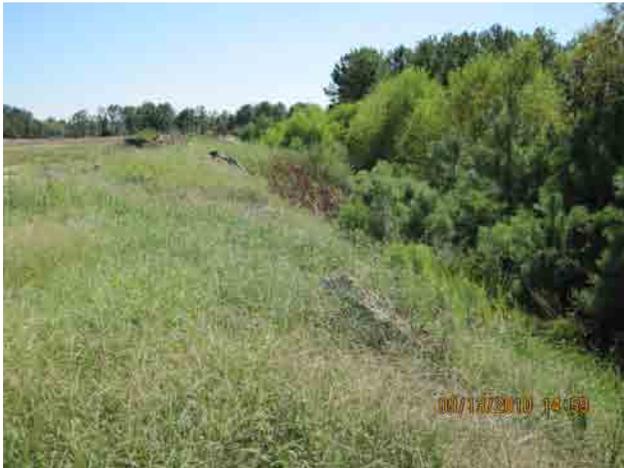
View of the western slope of the landfill facing south

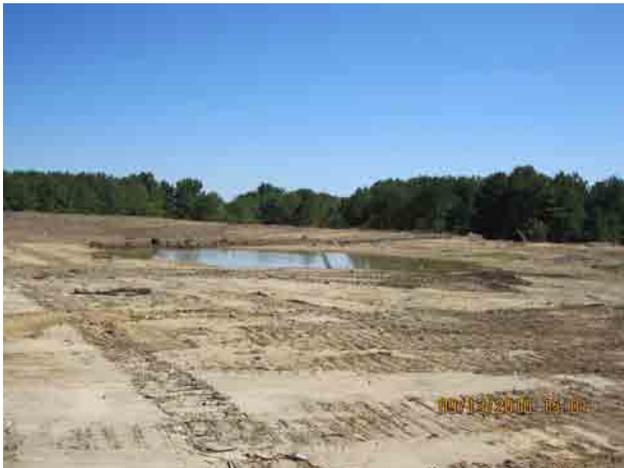
View of impounded water on the surface of the landfill on the southern side.

- 1) Make sure all erosion control devices are inspected weekly as required in the permit.
- 2) Make sure that the annual inspection is conducted of the perimeter of the site for any indication of methane disturbances as required in the permit.
- 3) The area where water has been impounded needs to be graded so that water does not pond.
- 4) The cover is generally good.
- 5) The road is all weather construction and is in good repair.
- 6) The signage is good.
- 7) Access control is by a gate, there was no evidence of illegal dumping.
- 8) Make sure all sedimentation and erosion control structures required in the permit are constructed as required.
