FACILITY COMPLIANCE AUDIT REPORT
Division of Waste Management
Solid Waste Section

Date of Audit: 01/27/2010

Town of Canton Municipal Solid Waste Landfill
 State Road 1854
 Canton, NC 28716

PURPOSE OF AUDIT: COMPREHENSIVE

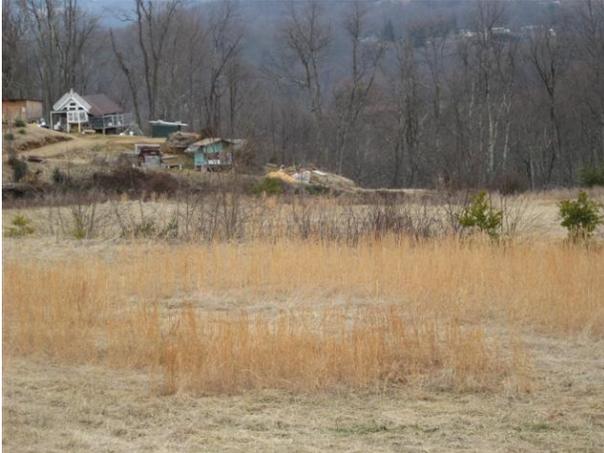
01/27/10

4. While the edge of waste was not clearly defined, it appeared as though some small trees had taken root on the cap. This landfill was closed under the .0500 Rules and the Post-Closure General Condition #4 states that: *the integrity and effectiveness of the final cover system and any permanent erosion control devices must be maintained. This could include making repairs to the cover as necessary to correct the effects of settlement, subsidence, erosion, or other events.*

The woody/tree growth is encroaching upon the cap system. As these types of root systems will most likely extend beyond the erosion layer into the impermeable layer of the cap (thus destroying the integrity of the cap system and creating a path for water into the landfill), and as trees both inhibit the proper mowing and necessary maintenance of the cap while impeding on the ability to visually inspect the cap integrity, **this woody shrub/tree growth must be eliminated. Any stumps and root systems of larger trees must be removed and the cap system repaired.**
