FACILITY COMPLIANCE AUDIT REPORT
Division of Waste Management
Solid Waste Section

Date of Audits: 08/12/09, 01/27/10, 07/20/10, 03/16/2011

Evergreen Packaging Industrial Landfill
 State Road 1550
 Canton, NC 28716

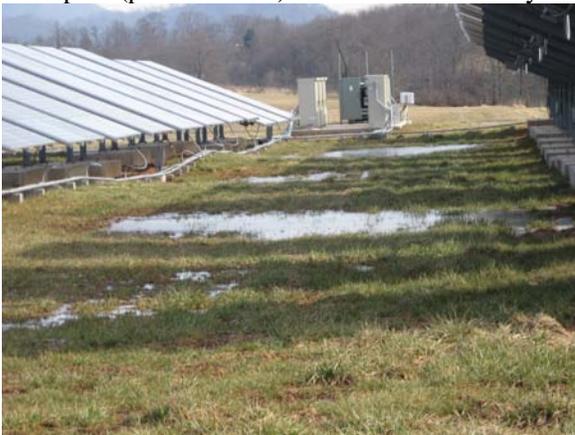
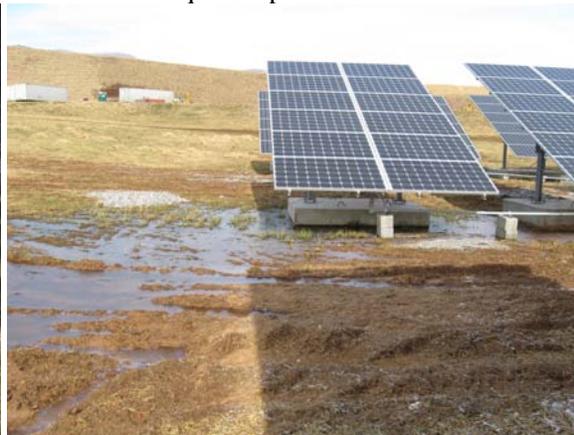
1. On site for partial facility inspection (A. Keller and J. Giauque).
2. Area 6B South – new Solar Array project close to completion (grand opening scheduled for 2/10). Observed low spots (pooled water) within the solar array field which will require repair and maintenance.

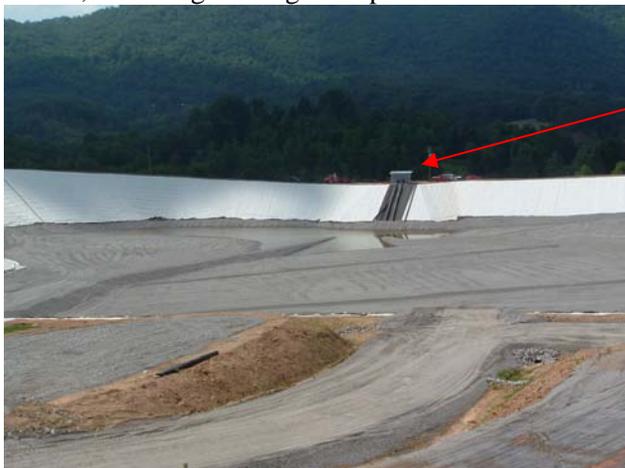
1. On site for partial facility inspection and Area 6D South Pre-Operations meeting. Present for Solid Waste Section: A. Keller and A. Gaither (SWS Permitting Branch Engineer). Present for Evergreen (partial list): J. Giaque, P. Dickens, G. Cote, and L. Williams.
2. The future addition of property to the Evergreen facility to increase buffer/borrow area was discussed.
3. Items left to complete (per Evergreen): grading of roadways to new cell, electrical hook-up of new pump station, reseeding/drainage completion.

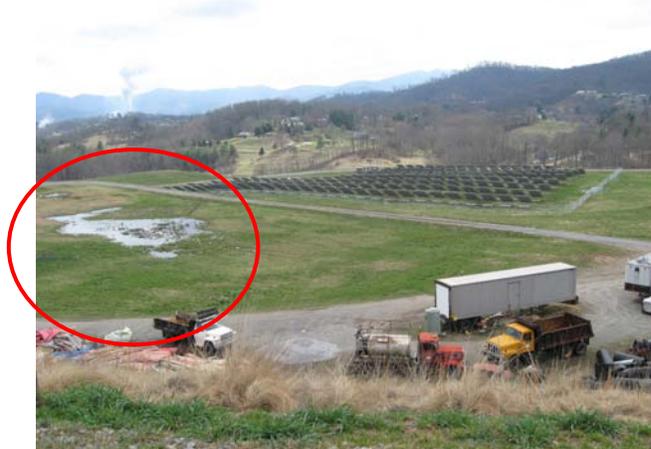
03/16/11

5. The solar field region appeared to have been improved since the 1/27/10 inspection (standing water). However, north of the solar fields (Area 6B North) some ponding/settlement was observed. It was stated (J. Giaque) that repairs in this area were scheduled following completion of work at leachate pond #1.
