**FACILITY COMPLIANCE AUDIT REPORT**  
**Division of Waste Management**  
**Solid Waste Section**

**Dates of Audit:** 06/29/11

Haywood County Municipal Solid Waste Landfill  
 State Road 1338, White Oak Community  
 Waynesville, N. C. 28786

Partial Audit

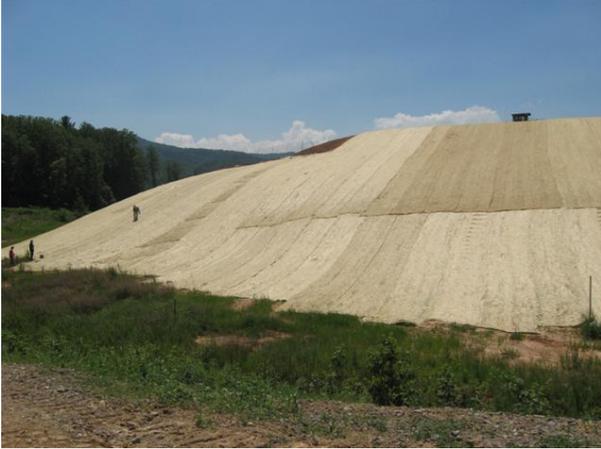
6/29/11

3. The operators were managing a small working face, compaction was ongoing, traffic flow was controlled with barriers and signs, and daily soil cover appeared adequate. Repair work to the active face side slopes was underway at the time of the inspection (seeding and matting).

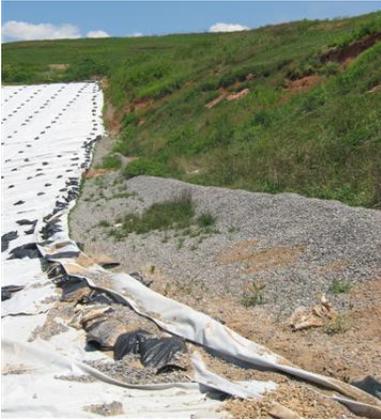
6/29/11

4. The intermediate cover at the Phase 3 liner to Phase 2 junction was inspected. No waste was visible and it appeared as though the area satisfied Rule requirements for intermediate cover. [15A NCAC 13B .1626 (2)(c) ...*minimum of one foot of intermediate cover*]

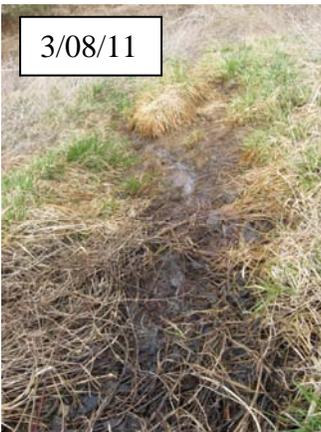
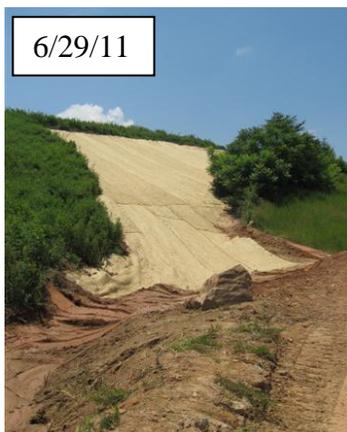
5. During the previous inspection a seep was observed on the north side of Phase 1 near the leachate pond. Also noted in this region was the encroachment of woody vegetation inside the marked edge-of-waste boundary.

The woody vegetation had been removed and the seep region had been repaired, seeded, and matted.

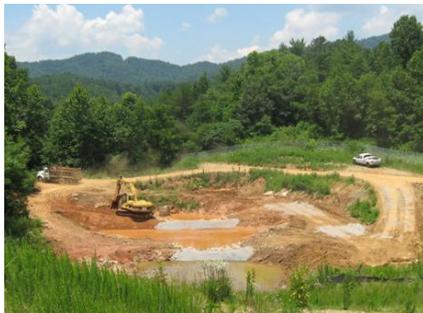
North of leachate lagoon

6. The facility was continuing to work on erosion control/sediment issues noted during the previous inspection including, but not limited to, the repair and maintenance of sediment basins (shown below).
