RE: Construction Quality Assurance Certification
Report – MSW Phase 3
White Oak MSW Landfill Permit # 44-07
Haywood County, North Carolina

**White Oak MSW Landfill
Haywood County, North Carolina
Permit No. 44-07**

**CONSTRUCTION QUALITY ASSURANCE
CERTIFICATION REPORT
MSW PHASE 3**

16.0 PHASE 2 LEACHATE SEWER AND LINER REPAIR

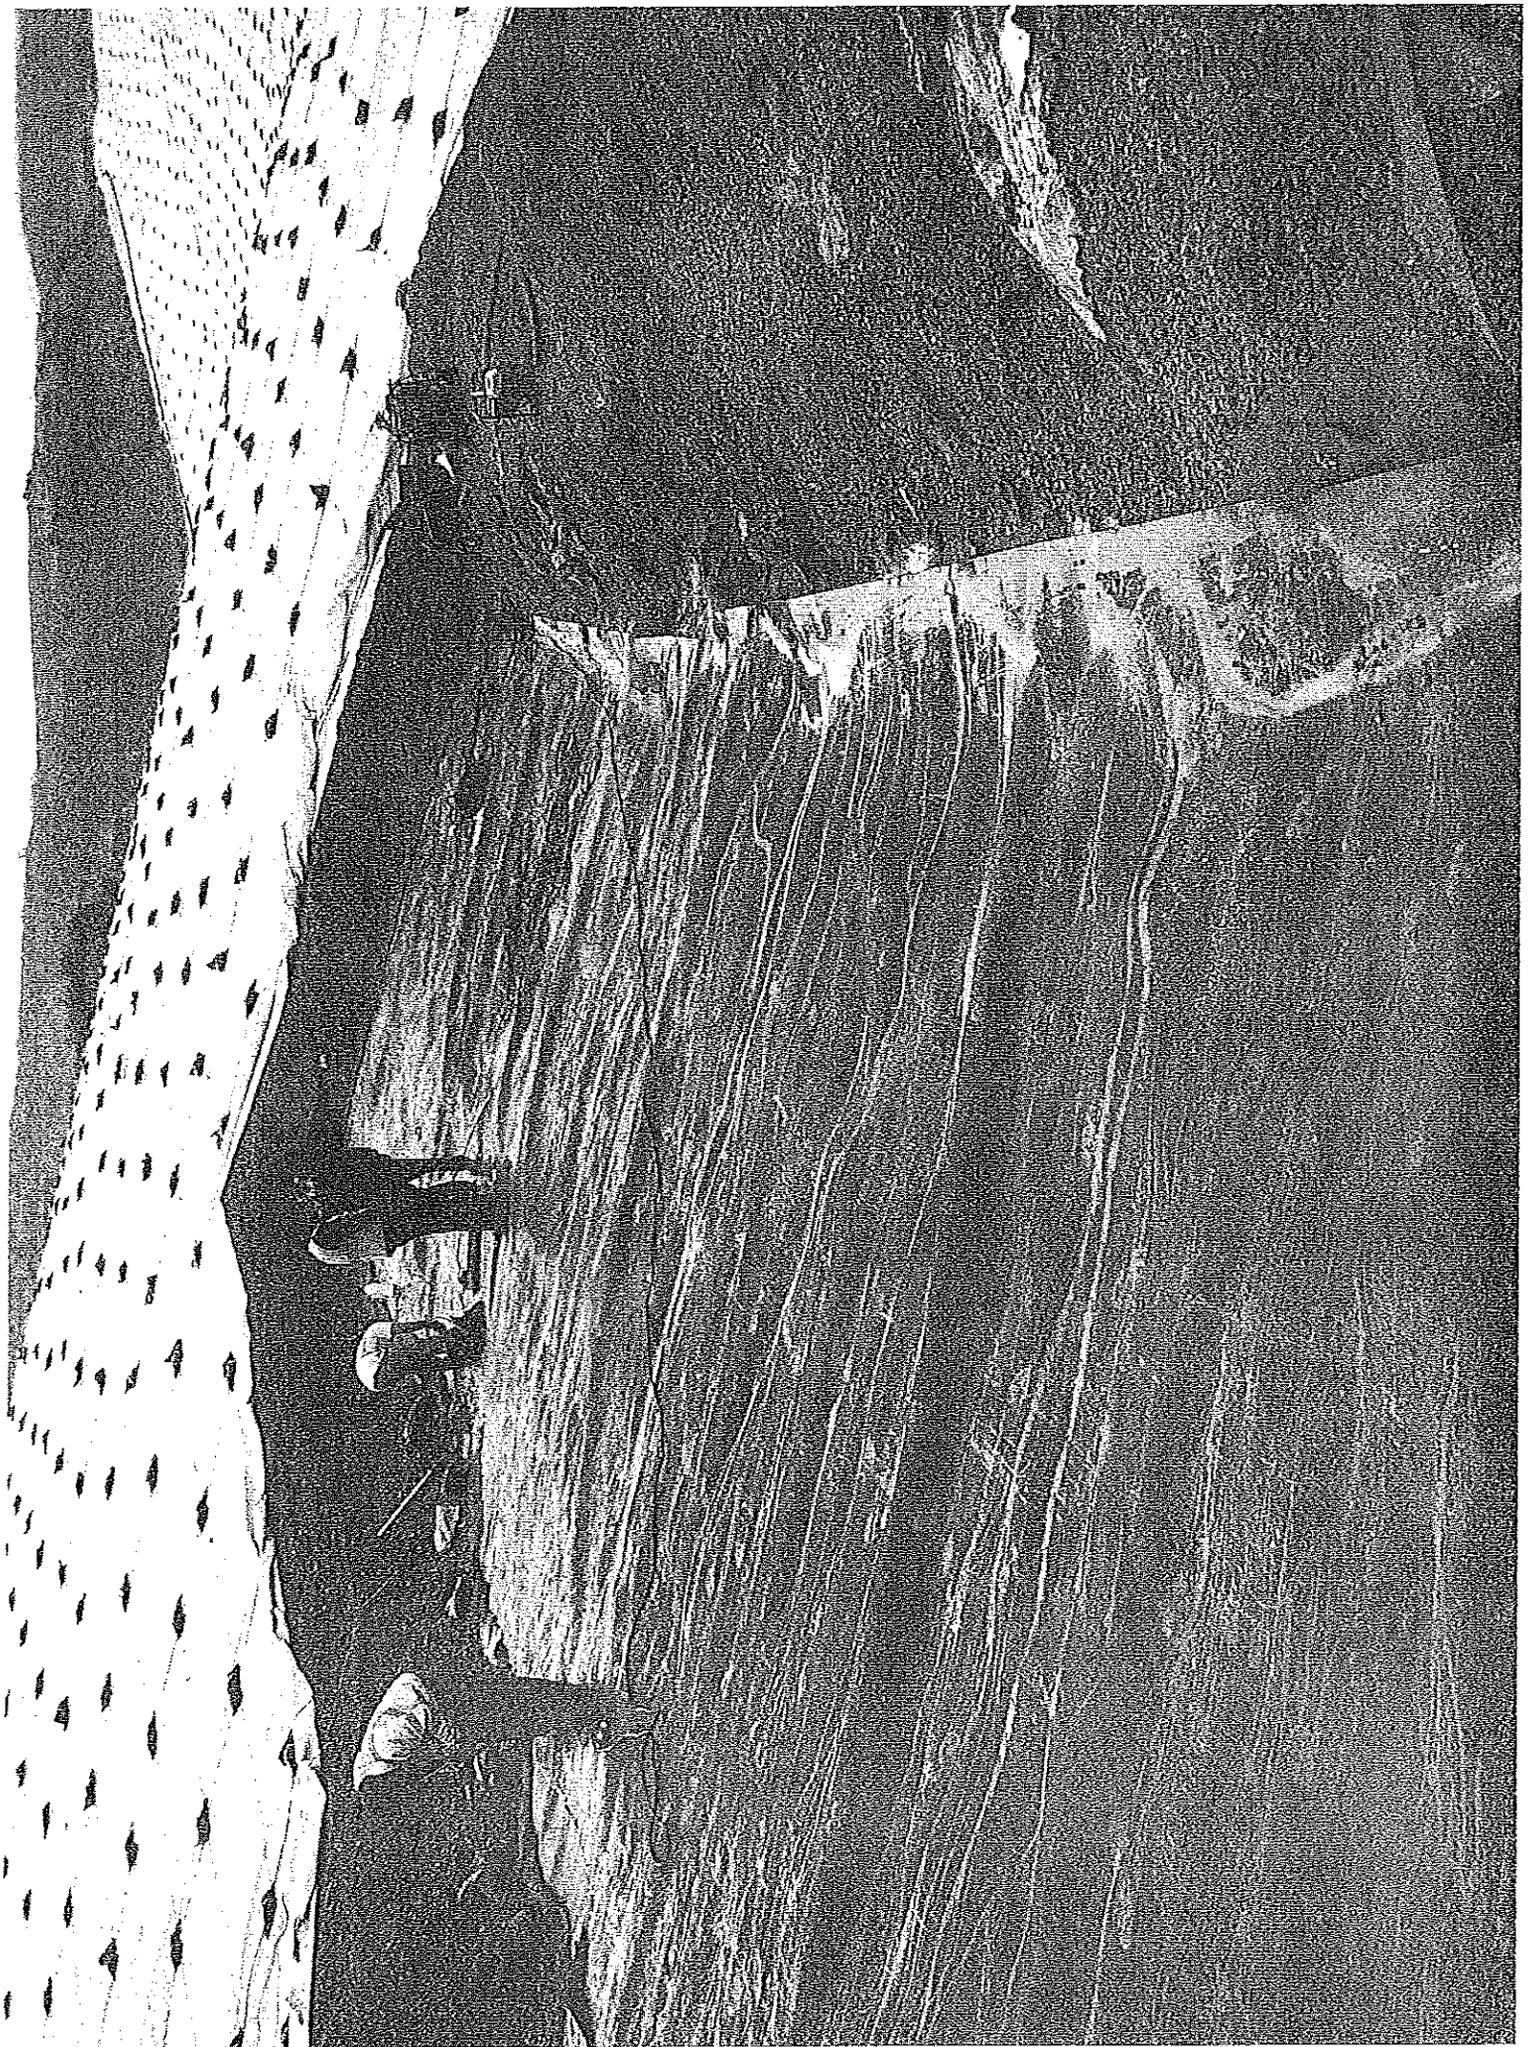
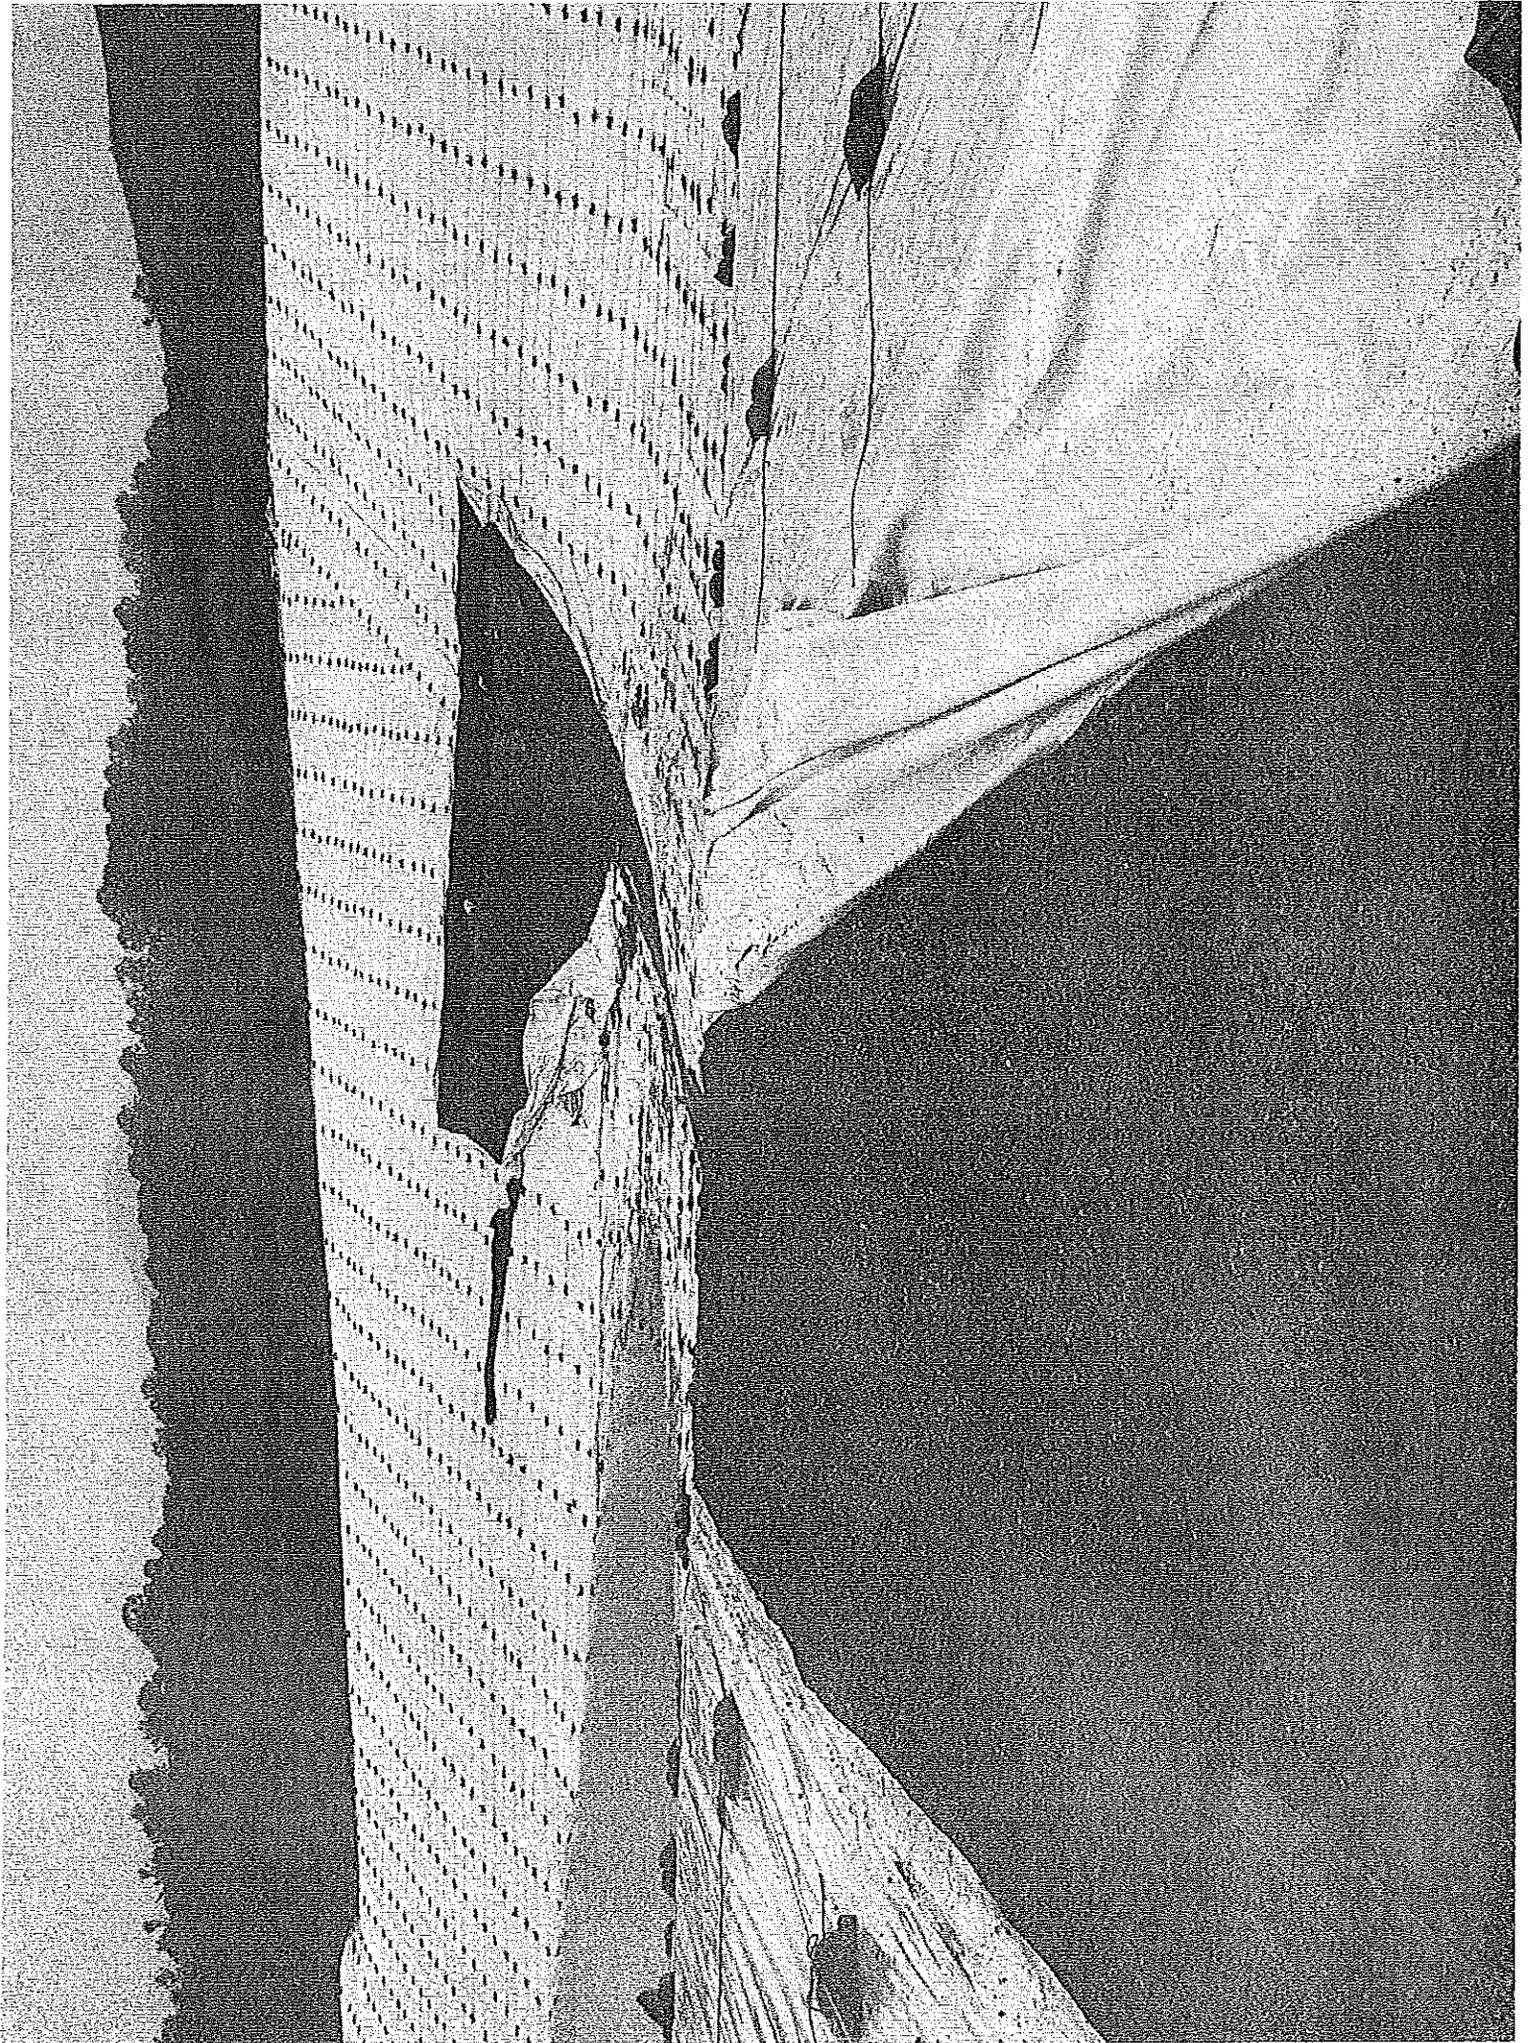
Repair Area Photos

On September 28, 2010 the Contractor mobilized to the site to initiate the repair of the apparent sag in the Phase 2 leachate sewer collection line. In order to access the repair site, the contractor entered the cell area from the western side with the small track backhoe that would be used to remove the stone drainage layer and excavate the soil covering the leachate collection pipe. Prior to entering the site a small strip of the temporary rain cover system was carefully removed in order to allow equipment access with out damaging the rain cover material. The segment of pipe was field located and a portion of the rain cover was removed to expose a work area measuring approximately 7,800 square feet. The two-feet of stone drainage layer was removed

and stockpiled within the work area. The exposed liner materials, comprised of the 16-oz. nonwoven fabric, 60-mil HDPE geomembrane and the geosynthetic clay liner (GCL), were removed and eventually discarded due to damage sustained during the removal process. The pipe segment in question was uncovered with careful attention paid to the location and segregation of the stockpiled soil material so as not to contaminate the surrounding stone drainage layer. The elevations of the exposed pipe segment were checked by field survey and the extent of the proposed repair length adjusted to ensure positive flow before, through and after repaired pipe segment. The elevations of the pipe segment were adjusted under the observation of the Engineer's representative. Once the pipe adjustments were complete, the excavated material was placed and compacted in lifts in much the same order as it was removed. The placement and compaction of the soil material was observed by the Engineer's representative. The CQA Engineer arrived on site on September 30, 2010 and conducted soil density tests on the compacted clay liner portion of the backfilled pipe excavation prior to the placement of the liner system. New GCL, 60-mil textured HDPE geomembrane and nonwoven geotextile were delivered to the site and utilized in the repair. The CQA Engineer observed the placement of the GCL and the 60-mil textured HDPE geomembrane over the area of the repair. The following day the CQA Engineer observed the seaming/welding of the new geomembrane liner system to the existing liner system and the field testing of the seams/welds to ensure compliance with the Contract Documents. Following completion of the geomembrane liner system, the CQA Engineer observed the placement of the nonwoven geotextile fabric and the initial placement of the stone drainage layer on the textile covered repair area. The remaining stone drainage layer was replaced and the equipment removed from the repair area. The rain cover was reinstalled across the repair area and the equipment access route. Appendix IX of the Construction Quality Assurance Certification Report, prepared by Joyce Engineering, Inc. and submitted to McGill Associates for review, is a compilation of the CQA data and submittals associated with the repair of the Phase 2 leachate collection pipe. The Phase 2 leachate sewer collection line (Line LP-4) should function as a drain line for the sump system associated with the Phase 2 Cell area.

A review of the CQA Report revealed that an apparent 10-oz. nonwoven geotextile fabric had been placed as a protective cover over the 60-mil HDPE geomembrane in the repair area. The 10-oz nonwoven fabric utilized in lieu of the 16-oz. nonwoven geotextile fabric specified in the Contract Documents was apparently placed in error. The Contractor was notified of the situation. Discussions were held to determine the best way to remedy the situation without risking damage to the cell's liner system. It was decided that in lieu of removing the stone drainage layer and adding to or replacing the nonwoven geotextile fabric in the repair area, the Contractor would be allowed to provide an engineering certification stating that the installed 10-oz. nonwoven geotextile would provide adequate protection for the geomembrane liner material. The Contractor opted to pursue this remedy. McGill Associates provided the Contractor with minimum design criteria for conducting the evaluation of the 10-oz. nonwoven geotextile's use in lieu of the specified 16-oz nonwoven geotextile fabric. A copy of the design requirements provided by McGill Associates is included in Section 11, Phase 2 Leachate Sewer and Liner Repair, of this report. The Contractor engaged the services of Joyce Engineering, Inc. to evaluate the suitability of the 10-oz. nonwoven geotextile in lieu of the specified 16-oz.

In conclusion, the opinion is the 10-oz. nonwoven geotextile fabric, used as a cushion material for the geomembrane liner as a part of the repair of the Phase 2 leachate collection line, will meet the performance standards for the project relative to the required factor of safety against liner puncture. The factor of safety against puncture is based on the loading criteria for this particular location within the Phase 3 Cell area.

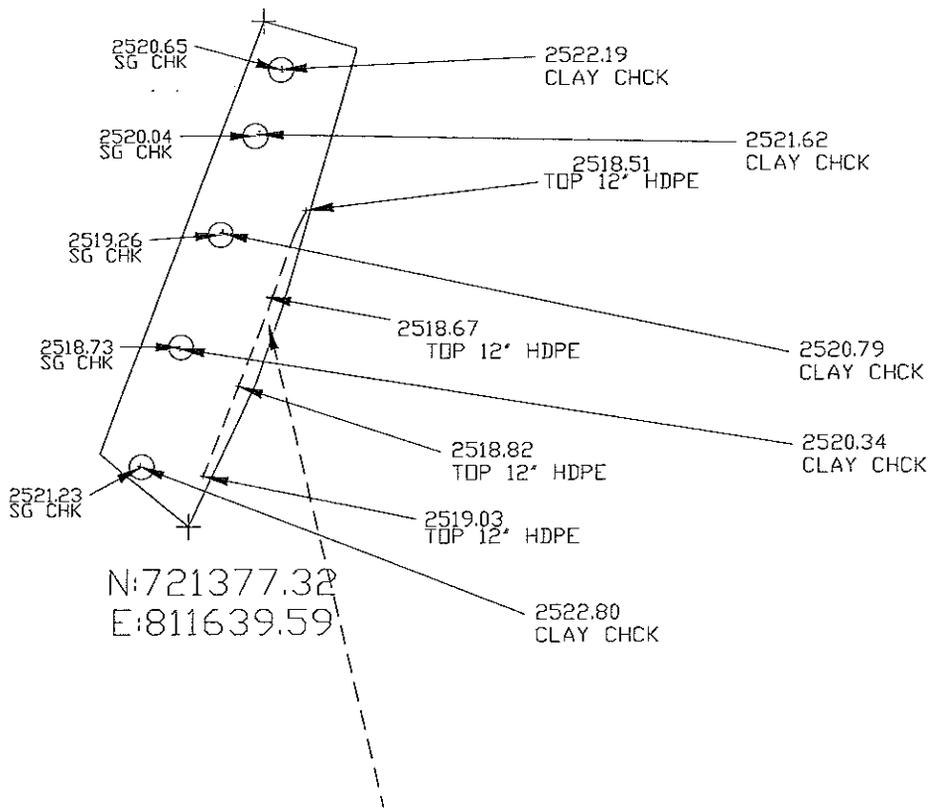
THALLE INC		
<i>DRAWN</i>	<i>DATE</i>	<i>GRAVITY REPAIR</i>
ESM	09/30/10	
<i>APPROVED</i>	<i>DATE</i>	
<i>SCALE</i>	<i>SHEET</i>	<i>PROJECT NO.</i>
NTS	NTS	943 WHITE OAK LANDFILL

DUAL CONTAINED HDPE LEACHATE GRAVITY SEWER
12" SECONDARY, 8" CARRIER PIPE
