**FACILITY COMPLIANCE AUDIT REPORT**  
**Division of Waste Management**  
**Solid Waste Section**

<b>UNIT TYPE:</b>											
Lined MSWLF		LCID		YW		Transfer		Compost		SLAS	<b>COUNTY: HENDERSON</b> <b>PERMIT NO.: 45-01</b> <b>FILE TYPE: COMPLIANCE</b>
Closed MSWLF	<b>X</b>	HHW		White goods		Incin		T&P		FIRM	
Closed CDLF	<b>X</b>	Closed CDLF atop Closed MSWLF	<b>X</b>	Asbestos Disposal Area(s)	<b>X</b>	TVA Industrial Landfill	<b>X</b>	DEMO	<b>X</b>	SDTF

**Date of Audit:** 03/10/2010

Henderson County Solid Waste Landfill

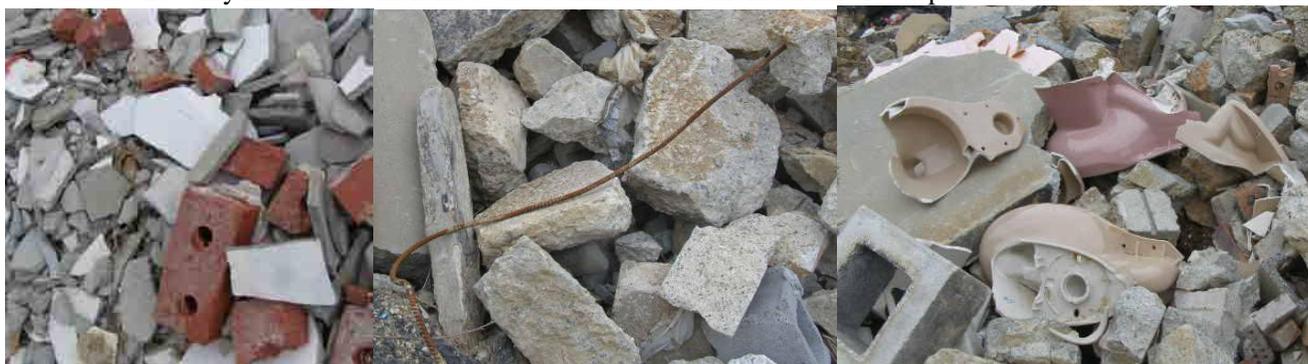
03/10/2010 photos #1: painted block, rebar, porcelain and some plastics were noted.

While most of the material noted at the site conforms with the above-stated definition, **this area is not considered a disposal site for solid waste and thus all non-conforming materials must be sorted and removed from this fill area for proper disposal.**

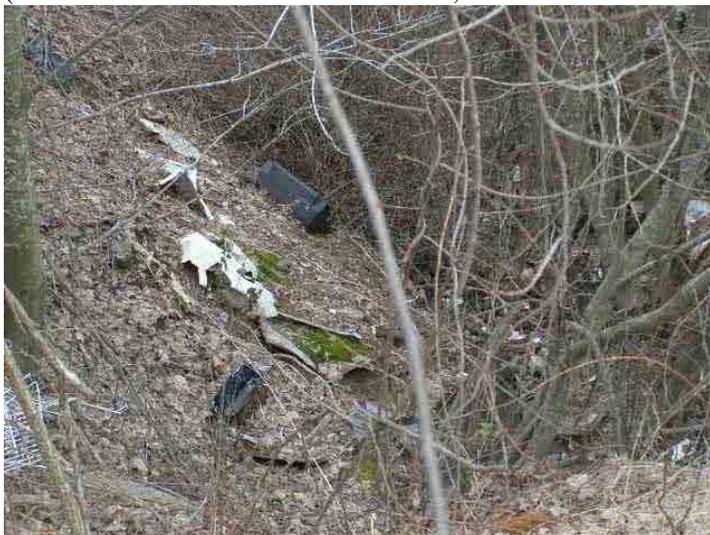
03/10/2010 photo #2

4. Surface water runs between the closed MSWLF and the fill area listed at 1982 Disposal Area (may also be MSWLF), and then passes along the east border of the TVA 1978 fill area. This drainage/creek area appears to have a build up of surface waste (metals and plastics), windblown material, and/or possible uncovered waste (unable to determine fill areas on older, closed fill units as there are no EOW markers in place).

This material should be removed for proper disposal as this activity could be considered the establishment of an illegal open dump site. It is recommended that this clean up be conducted before visibility is lost due to vegetation growth over the spring/summer months.

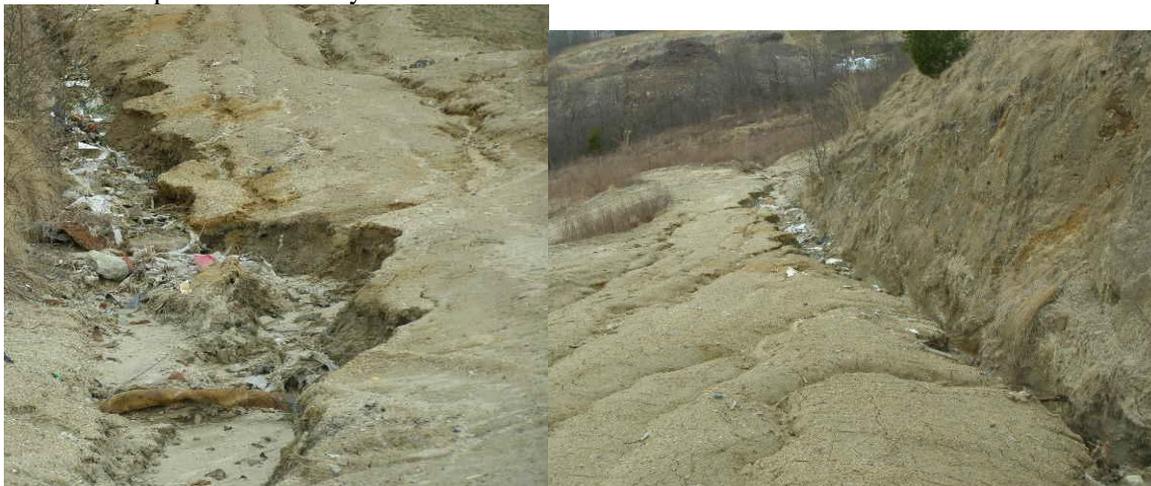
1. The erosion ditch pictured below had exposed waste and appeared to be outside of the existing EOW markers in place at the C&DLF. This may be due to erosion of a previous fill area, or of transport of waste off the C&DLF footprint due to heavy rains/snow.

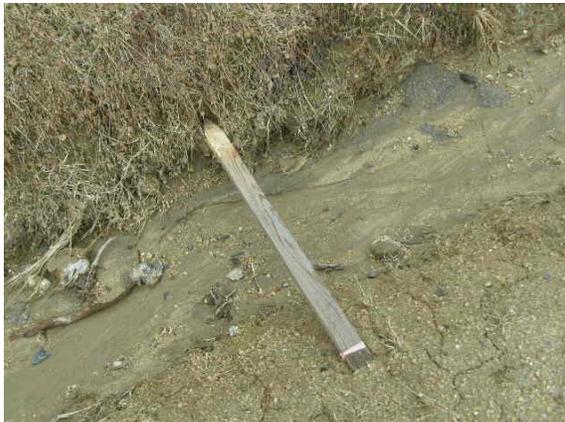
03/10/10 EOW markers

2. EOW markers will need to be re-established for the closed C&DLF. The wooden stakes currently in place are not stable. It is recommended that EOW markers be: visible in line of site from marker to marker, made of materials able withstand the elements, and labeled "EOW" or similar.

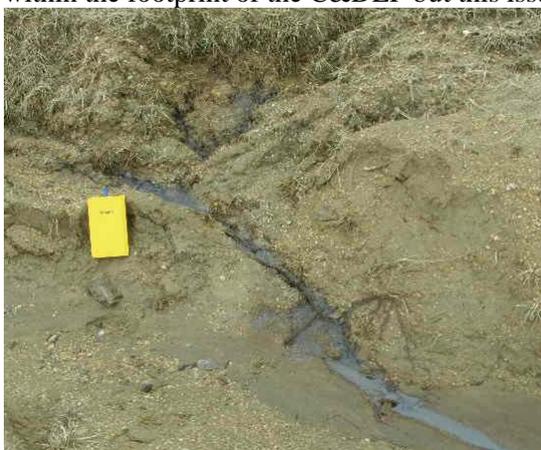
03/10/10

3. Slumping was visible on the southwestern slope of the landfill. Additionally, several leachate seeps were noted. This area requires soil cover and vegetation for erosion control. The leachate seeps appeared to stay within the footprint of the C&DLF but this issue should be investigated by the county to verify.

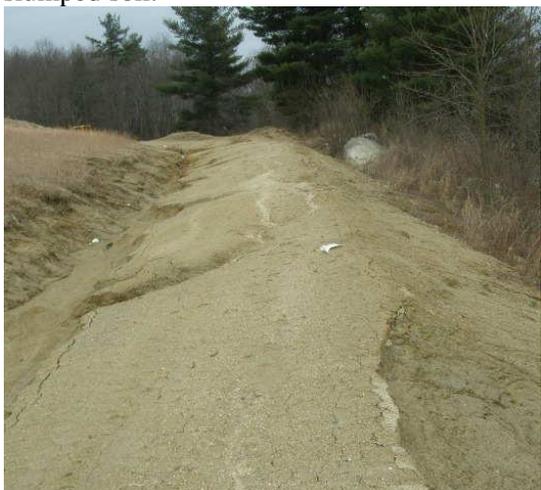
03/10/10

4. The access road on the C&DLF is slumping and eroding and the ground cover appears unstable (visible cracking). The EOW markers are on the outside edge of the access road are being pushed along with the slumped soil.

**Items 1, 2 and 4 need to be addressed as required in the Notice of Violation section within this audit report. The seepage/leachate release issue must be addressed immediately to ensure that leachate does not leave the site.**

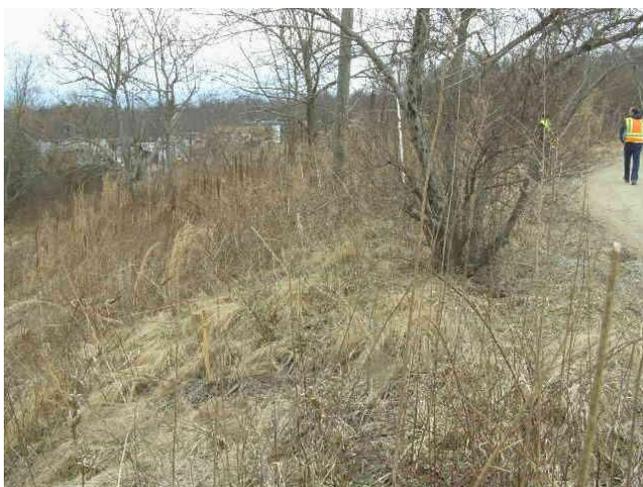
03/10/10 photo #3

1. The closed MSWLF footprint is considerably larger than the current area marked with EOW markers. **Correct the EOW markers as soon as possible.** Due to the planned site construction activities, and with reference to the attached memorandum regarding EOW markers, **a survey of EOW should be conducted for all fill areas.**
2. The access road located on the MSWLF waste fill area (leading up to the white goods, closed C&DLF, and grinding operation areas) currently shows EOW markers to the “outside” or left of the road (see photo below). Per Mr. Sagar and site maps referenced earlier, the EOW is actually 100-300’ past these EOW markers. In this region, significant vegetation has taken root. This area must be accessible, mowed regularly, and must not contain any woody vegetation (trees).

The woody/tree growth is encroaching upon the cap system. As these types of root systems will most likely extend beyond the erosion layer into the impermeable layer of the cap (thus destroying the integrity of the cap system and creating a path for water into the landfill), and as trees both inhibit the proper mowing and necessary maintenance of the cap while impeding on the ability to visually inspect the cap integrity, **this woody shrub/tree growth must be eliminated. Any stumps and root systems of larger trees must be removed and the cap system repaired.**

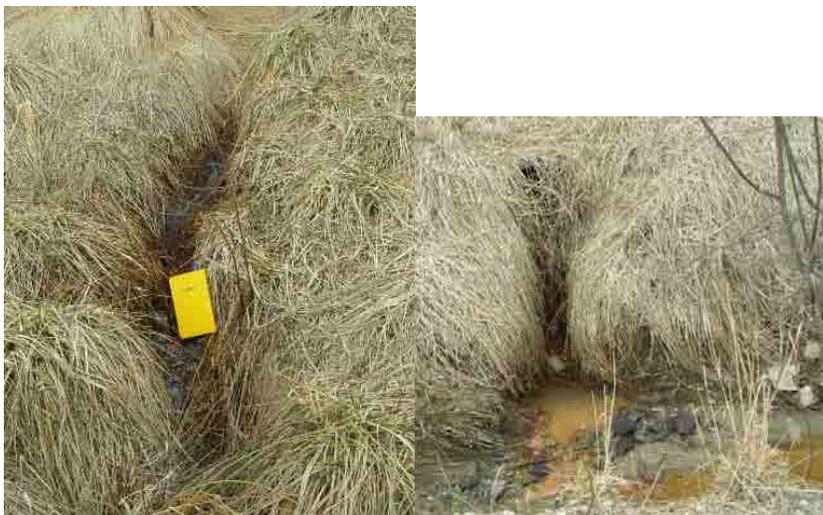
3. The closed MSWLF Post-Closure Conditions (April 11, 2006) in the *Letter of Closure* and the .1600 Rules are the governing regulations for this landfill unit. The list of Approved Documents includes Closure Plans, Post-Closure Use Plan, **Methane Gas Remediation Plan**, and a Ground Water Corrective Action Plan. During the next scheduled site visit, the Section wishes to review these documents, in particular Part C: Methane Gas Remediation Plan – please have this available at the landfill at the time of the site inspection.
4. The closed MSWLF has a drainage ditch running on the “inside” of the access road. This drainage ditch exhibited erosion to the extent that solid waste was exposed and the landfill cap exhibited erosion such that rills had formed and discharge was draining into the drainage ditch.

Rills/discharge from landfill into drainage ditch, photos #4

**Item number 2 and 4 need to be addressed as required in the Notice of Violation section within this audit report. The seepage/leachate release issue must be addressed immediately to ensure that leachate does not leave the site.**

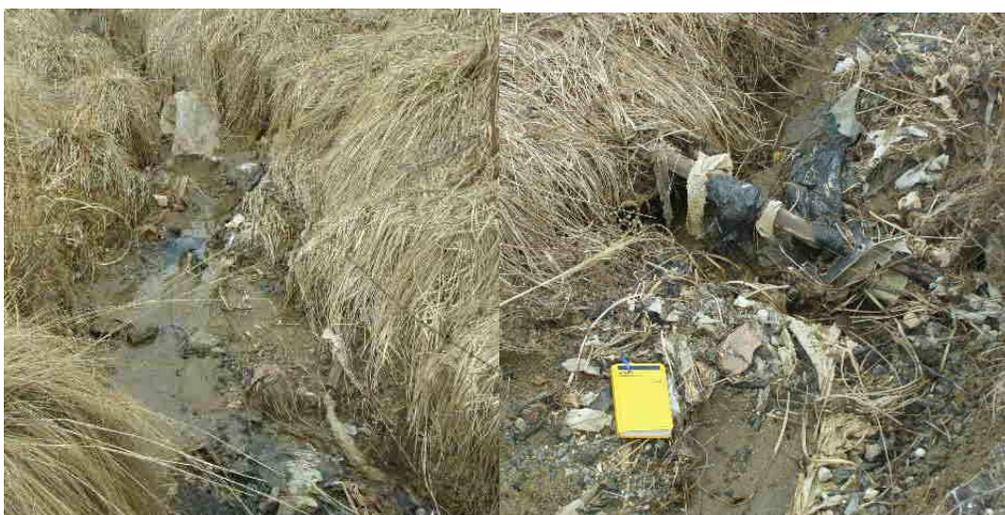
Drainage ditch/waste #5

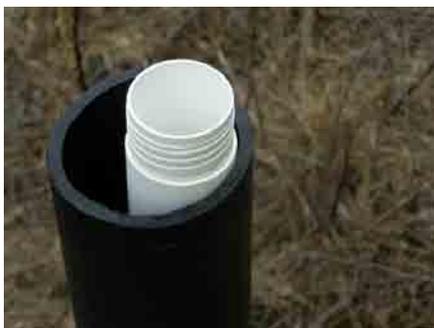
5. The groundwater monitoring data was available and currently under review by the Section hydrogeologist.
6. The landfill gas (LFG) monitoring plan was unavailable at the time of the audit. However, the collected data was available. Henderson County utilizes Enerdyne for maintenance of the gas extraction system and for the collection of LFG monitoring data. While monitoring data was available for review, due to the lack of a Plan it was difficult to determine the following: Number of wells and location of wells, whether the methane data was in % Volume or % LEL, and what the other data points on the spreadsheet represented (structures on/off property?). Additionally, two of the LFG monitoring wells located on the north side of the property (in the region where, historically, methane migration had occurred) **were not capped, locked, or labeled.**

03/10/10 LFG Monitoring well. #6
