**FACILITY COMPLIANCE AUDIT REPORT**  
**Division of Waste Management**  
**Solid Waste Section**

**Date of Audit:** 07/15/10

Les's Mulch Plus  
 2630 Asheville Highway  
 Hendersonville, NC 28792

Comprehensive

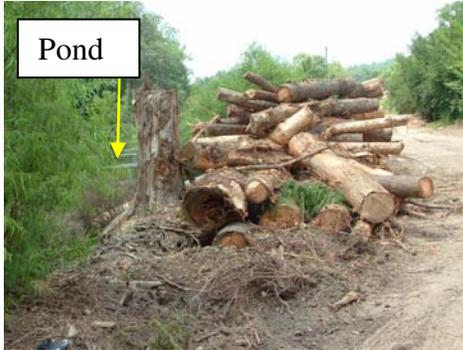
07/15/10

During the July 15, 2010 site inspection the location of waste piles (both processed and unprocessed land clearing debris) violated buffer requirements cited within the Operations Plan (Attachment 2, Document 3 of the approved documents). See Areas of Concerns and Comments #3 below.

During the site inspection, the approximate location of the well (referenced above) was pointed out as being under a pile of staged land clearing (pre-grind) in order to "protect the well." Additionally, chipped product piles were located within approximately 30-feet of the well location. Along the both the on-site stream and the pond locations, land-clearing materials had been staged next to the surface waters (see photo).

**In order to achieve compliance, Les's Mulch Plus must, within 30 days of receipt of this Notice of Violation, mark and maintain the 50-foot buffer requirement between all property lines and the mulching/material storage operations; and must mark and maintain the 100-foot buffer requirement between all on site wells and surface waters and the mulching/material storage operations.**

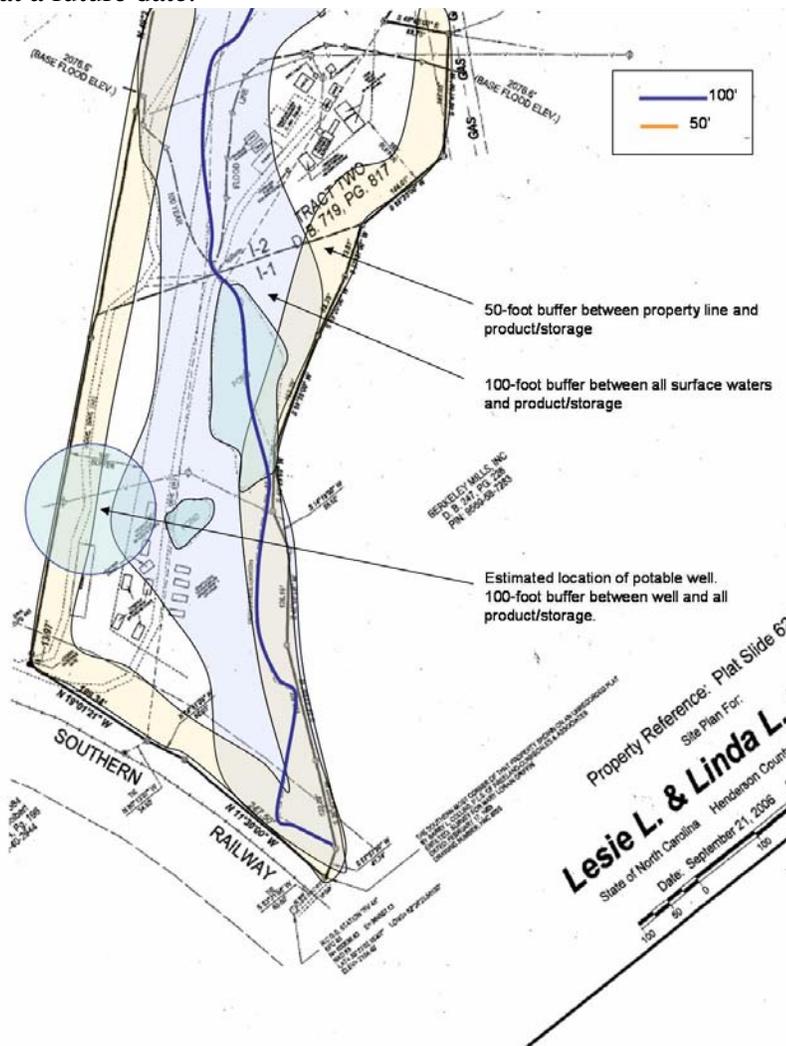
According to the approved site plan (shown below), there is limited available space on site for the storage of materials. This issue may require further discussion with the Section permitting engineer (Larry Frost, 828-296-4704) to determine if a permit modification could resolve this issue for the facility at a future date.
