**FACILITY COMPLIANCE AUDIT REPORT**  
**Division of Waste Management**  
**Solid Waste Section**

**Date of Audit:** August 10, 2010 and August 11, 2010

Iredell County Landfill  
 354 Twin Oaks Road  
 Statesville, North Carolina 28625

Comprehensive Audit

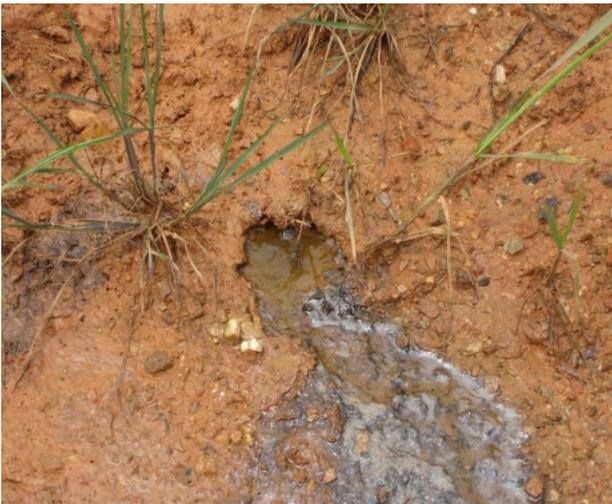
Iredell County is in violation of 15A NCAC 13B .1626(8)(d) in that during the inspection performed on August 10, 2010, a leachate outbreak was observed on the southern portion of Phase 4 near the transition from the inactive Phase 3. Leachate from this outbreak was observed flowing beyond the edge of liner marker. Therefore, leachate was not properly treated prior to discharge.

View of leachate flowing from soil cover. (8/10/10)

21. A leachate outbreak was observed on the south side of Phase 4 adjacent to the transition point from Phase 3 and just north of leachate sump #3. Leachate was observed flowing from below the operational cover at multiple points for distance of approximately 25-feet. Leachate from the outbreak was observed flowing beyond the edge of liner marker located near leachate sump #3 to a slope located above a sediment basin on the south side of the access road leading around the landfill unit. A sediment basin is located below the fill slope south of the leachate outbreak. Mr. Lambert stated that landfill staff was unaware of the leachate outbreak.

1. Monitor to assure leachate is contained on site or properly treated prior to discharge in accordance with 15A NCAC 13B .1626(8)(d).

2. To assess the impact of the leachate release outside the waste cell, Iredell County shall acquire the services of a N.C. licensed geologist with experience in assessment and remediation of ground water contamination and submit a phased assessment plan to the Division. The professional geologist shall consult with the Solid Waste Section Hydrogeologist about the site prior to developing the plan. The Section will review the submitted plan, approve, or request more information or amendments before implementation. The plan shall be implemented as approved. Within 30 days, submit this plan to:

3. Within 30 days, submit a revised leachate management plan to detail procedures to identify and repair any future leachate seeps and to prevent a leachate release beyond the liner system. Submit the revised plan to:

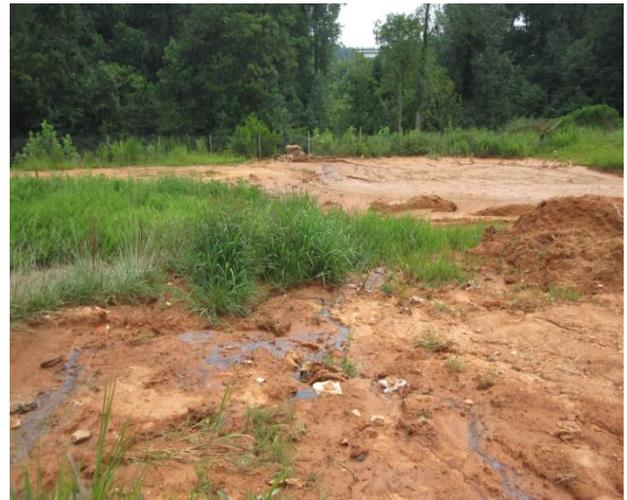
View of leachate leading from waste area beyond edge of liner. (8/10/10)

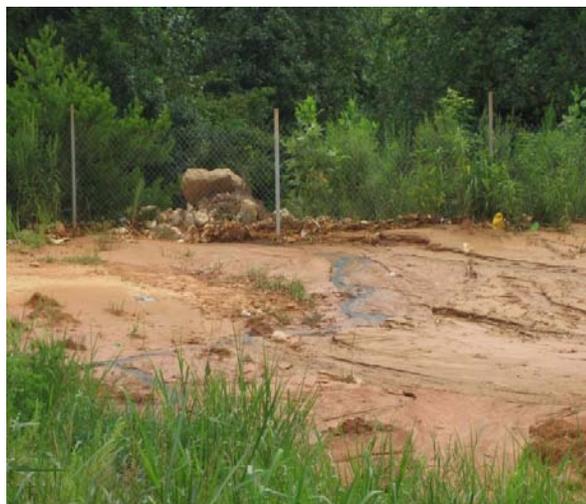
Close-up view of leachate flowing toward slope beyond edge of liner. (8/10/10)

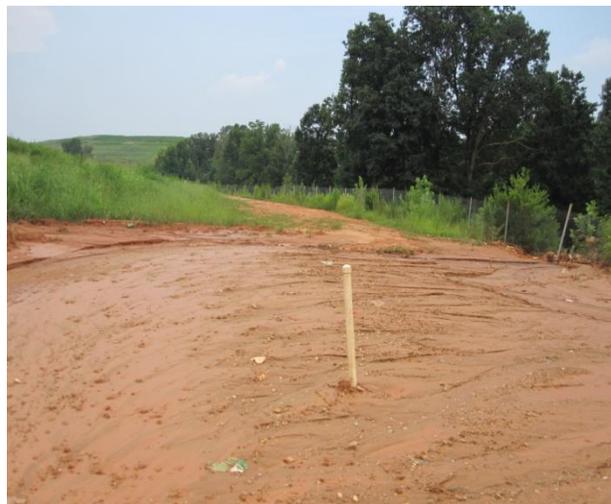
Edge of liner marker in foreground with leachate flowing beyond in background. (8/10/10)

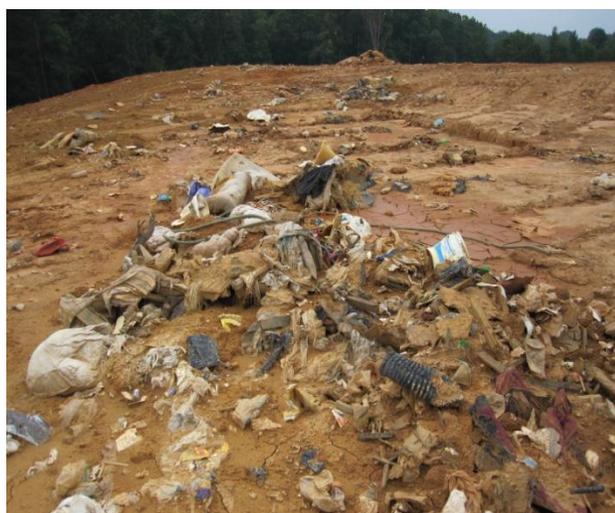
Operational cover was inadequate on inactive areas south of the working face of the MSWLF unit during both inspections performed on August 10, 2010 and August 11, 2010.

View of exposed waste at top of southern slope. (8/10/10)

20. Operational cover was inadequate on inactive areas south of the working face. A significant amount of waste was visible above the soil. Severely eroded slopes were observed on the southern slopes of the landfill exposing waste. Mr. Lambert stated that waste had not been placed in the southern portion of the landfill for approximately one month.

To achieve compliance, Iredell County must cover all inactive areas with a minimum of six inches of earthen material within 5 days of this audit report with Notice of Violation(s).

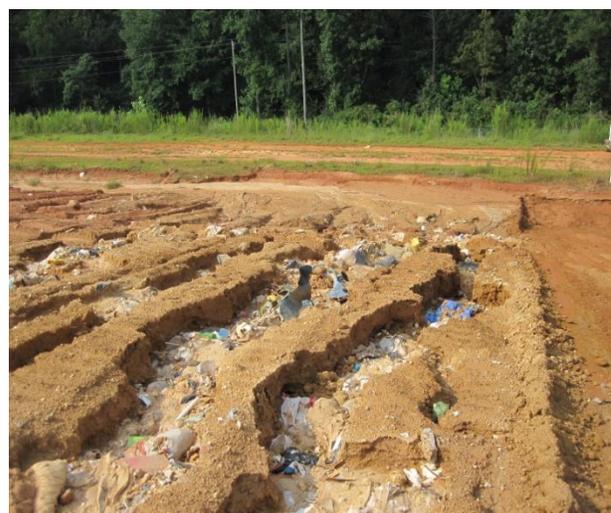
View of gullies with exposed waste on south slopes. (8/11/10)

26. Observed the location of the severe leachate outbreak adjacent to the transition point from Phase 3. The area had been re-graded with additional soil as observed the previous day. No leachate was observed.
27. Work had commenced to place soil on the severely eroded gullies with exposed waste located on the southern slopes of the landfill. Soil was being placed at the top of the slope to be pushed over waste. Some gullies had been covered, but additional work was needed to cover remaining exposed waste.
