FACILITY COMPLIANCE AUDIT REPORT
Division of Waste Management
Solid Waste Section

Date of Audit: 8 March 2011

Jones County Landfill
 Landfill Rd (NC SR#1343)
 Trenton, NC

Closed: Unlined MSW Landfill

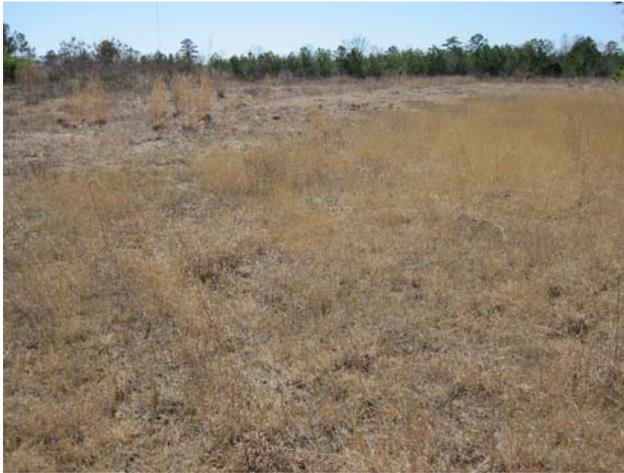
- 7) A coppice-type cover has been established throughout the landfill. Overall, the cover crop has been well established and no areas of erosion were noted during this audit.

Landfill cover-well established coppice-type cover crop

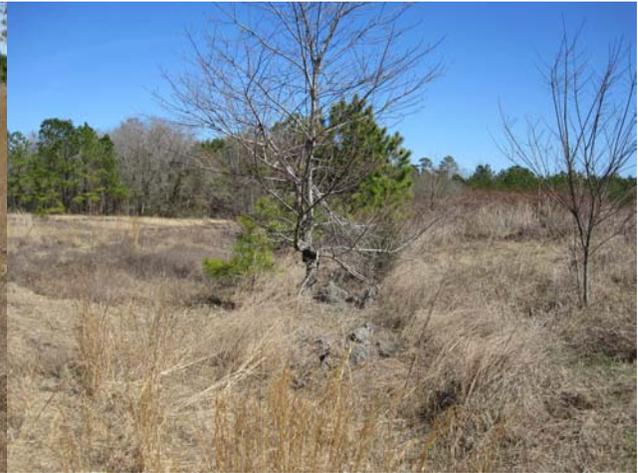
- 8) This facility has not been mowed in some time and a large amount of brush and woody vegetation including several mature trees has been allowed to grow in the cap. Several of the trees have died, which increases the possibility of surface water infiltration through the landfill cap system. *Within thirty days of receipt of this report, please remove all trees, woody growth, and brush from the landfill and all landfill sideslopes. Also, a regular maintenance/mowing schedule should to be initiated for the proper maintenance of the landfill cap system.

Trees and brush needing removal from the facility

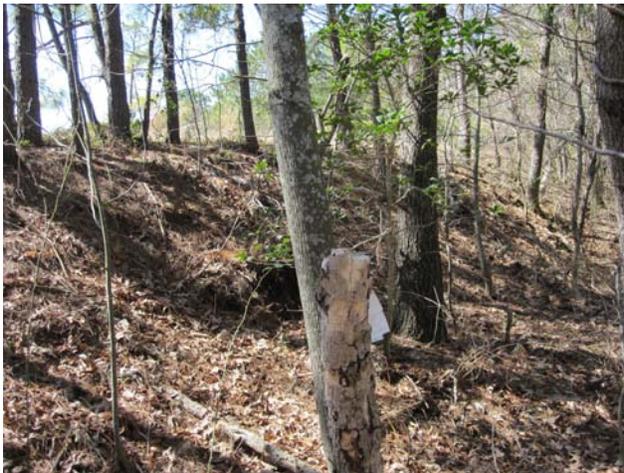
Trees needing removal from northeast sideslope

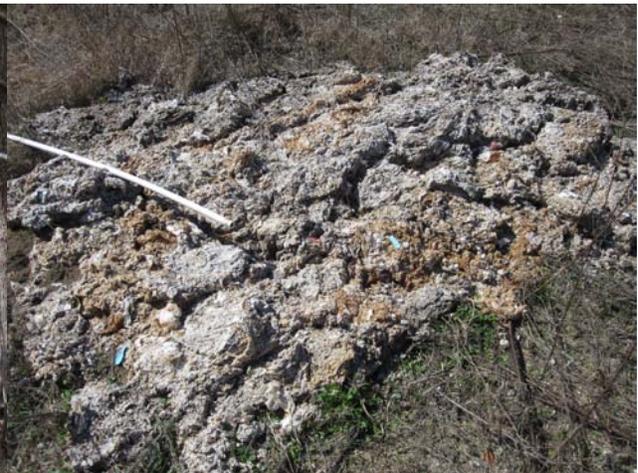
- 11) A load of unpermitted waste, which appears to be grease trap type waste and mixed MSW refuse, has recently been dumped in an area to the southwest, and adjacent to, the concrete/brick pile. *Within thirty days of receipt of this notice, please collect and dispose of this waste at a facility permitted to receive such wastes. It is also recommended that measures be put in place to increase site security to prevent future unauthorized access and possible illegal dumping.

Waste illegally disposed near concrete pile

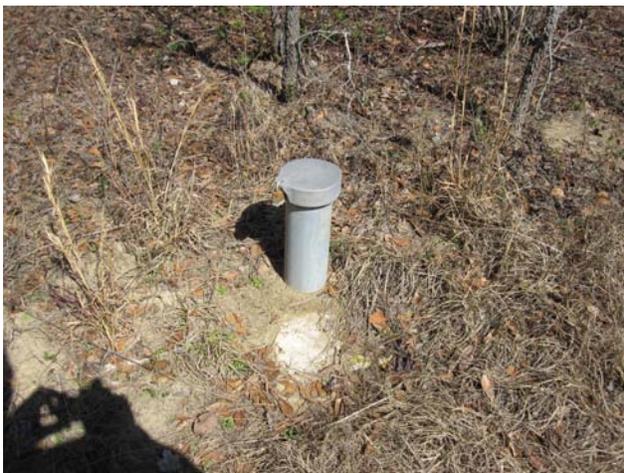
- 1) This facility is a closed MSW Landfill.
- 2) The site is secured by a locked gate at the facility entrance.
- 3) The facility access road is of all weather construction and is being well maintained at this time.
- 4) The facility monitoring wells were reviewed during this audit. All of the wells are easily accessible and secured by locks. The well numbers are stamped into the well covers. *To reduce the possibility of damage to the monitoring wells by facility maintenance equipment, the installation of high visibility markers and/or protective bollards adjacent to each well is recommended.

Groundwater monitoring well, accessible, locked, and labeled

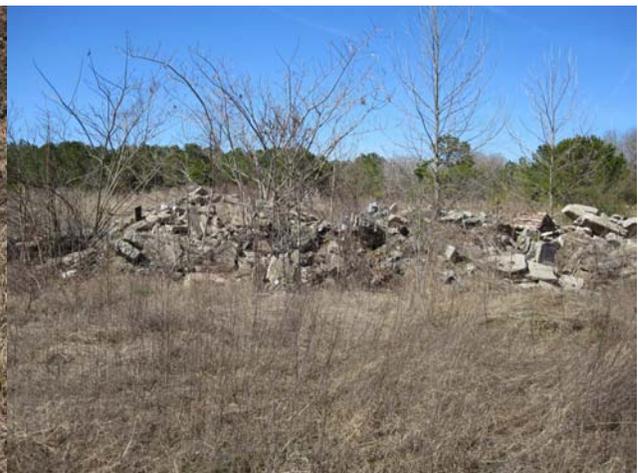
- 10) A large amount of concrete and bricks has been placed to the south of, and adjacent to, the landfill access road. A small amount of yard waste and C&D material has been mixed with portions of this recyclable material *A recycling/re-use plan needs to be initiated for this material. Please ensure that all non-recyclable waste is removed from the pile and disposed at a facility permitted to receive such wastes.

Concrete/brick pile staged for recycling
