**CONSTRUCTION CERTIFICATION REPORT  
FOR  
LINER SYSTEM REPAIR - PHASE II**

**LINCOLN COUNTY LANDFILL  
PERMIT NO. 55-03  
CROUSE, NORTH CAROLINA  
S&ME Project No. 1356-11-030**

**Reference: CONSTRUCTION CERTIFICATION REPORT  
LINER SYSTEM REPAIR, PHASE II**  
Lincoln County Landfill, Permit No. 55-03  
Crouse, North Carolina  
S&ME Project No. 1356-11-030

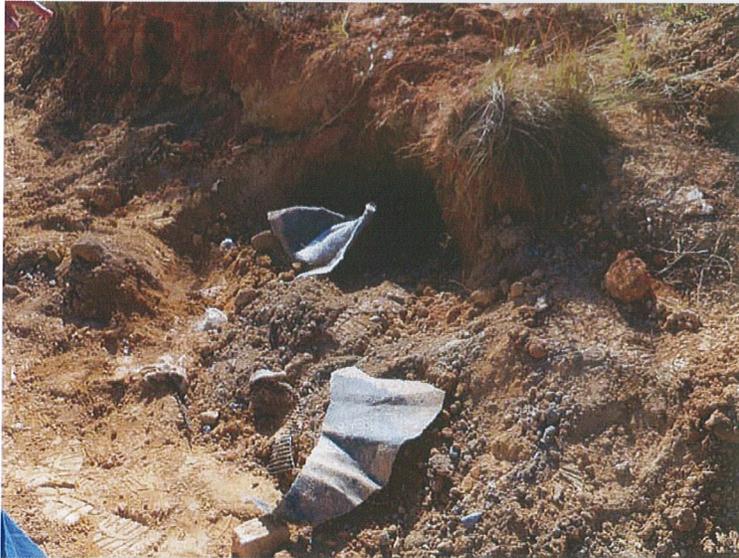
Photograph 1

<b>Date:</b> 10-04-11	
<b>Photographer:</b> William Harrison	
<b>Location / Orientation</b>	Inside Phase II – ~5 Feet Northeast of Damaged Area – Facing Southwest
<b>Remarks</b>	Liner System Damage

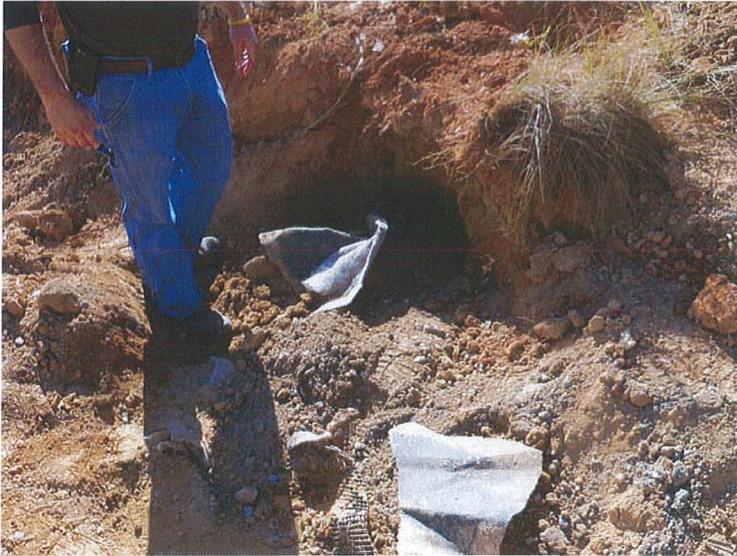
Photograph 2

<b>Date:</b> 10-04-11	
<b>Photographer:</b> William Harrison	
<b>Location / Orientation</b>	Inside Phase II – ~5 Feet Northeast of Damaged Area – Facing Southwest
<b>Remarks</b>	Liner System Damage

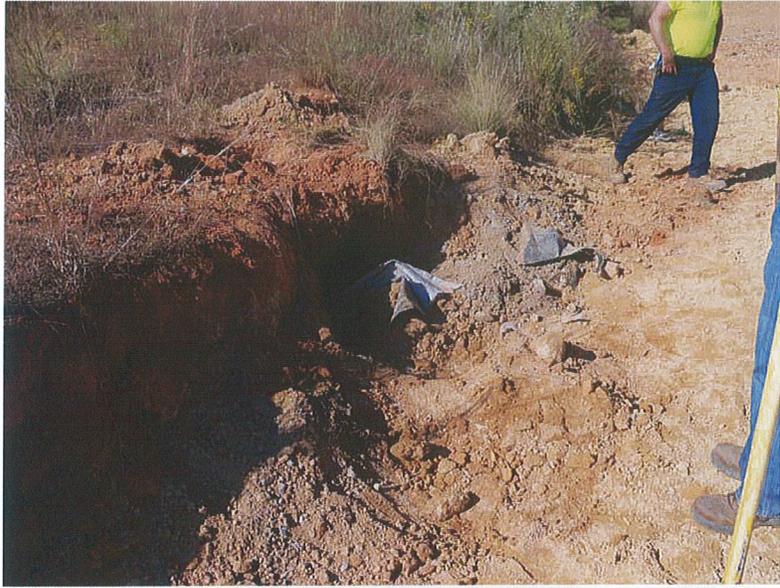
Photograph 3

<b>Date:</b> 10-04-11
		<b>Photographer:</b> Will Harrison
<b>Location / Orientation</b>	Inside Phase II – ~10 Feet South of Damaged Area - Facing North	
<b>Remarks</b>	Liner System Damage

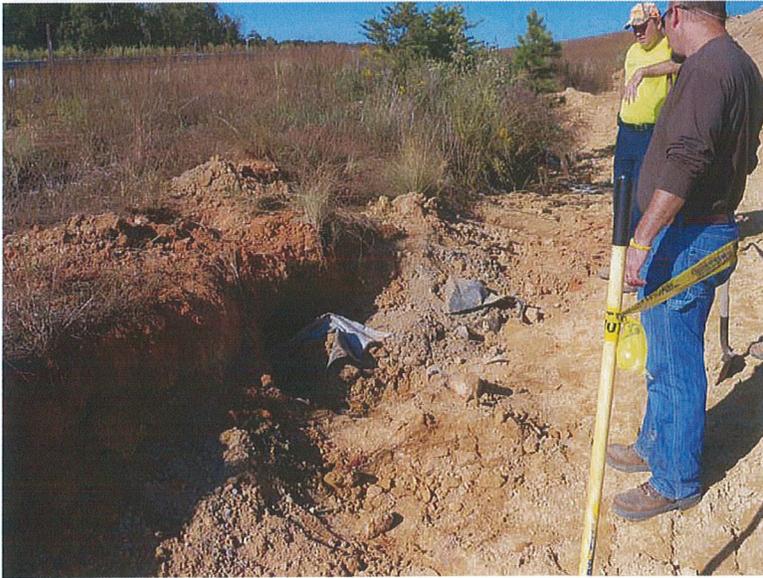
Photograph 4

<b>Date:</b> 10-04-11
		<b>Photographer:</b> Will Harrison
<b>Location / Orientation</b>	Inside Phase II – ~10 Feet South of Damaged Area - Facing North	
<b>Remarks</b>	Liner System Damage

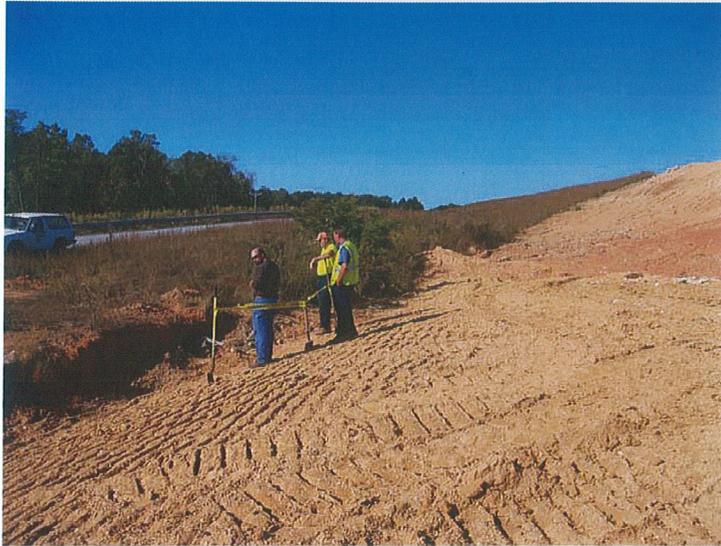
Photograph 5

Date: 10-04-11	
Photographer: Will Harrison	
<b>Location / Orientation</b>	Inside Phase II – ~50 Feet South of Damaged Area - Facing North
<b>Remarks</b>	Liner System Damage and Operations Soil Cover

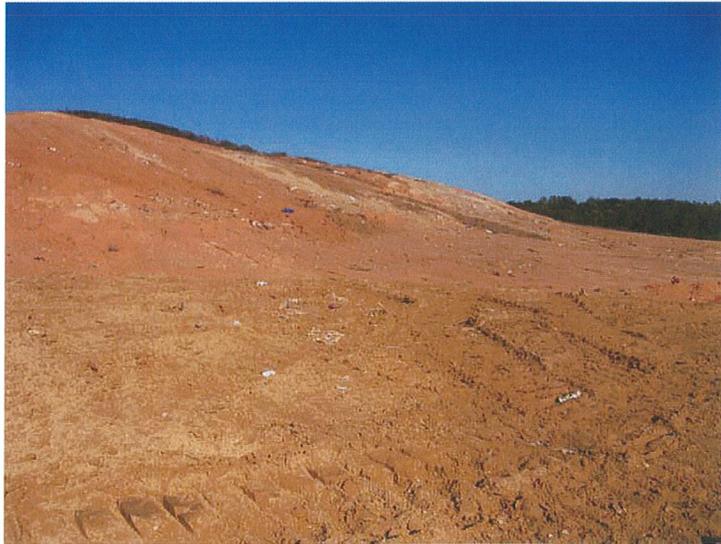
Photograph 6

Date: 10-04-11	
Photographer: Will Harrison	
<b>Location / Orientation</b>	Inside Phase II – ~50 Feet North of Damaged Area – Facing Northeast
<b>Remarks</b>	Operations Soil Cover

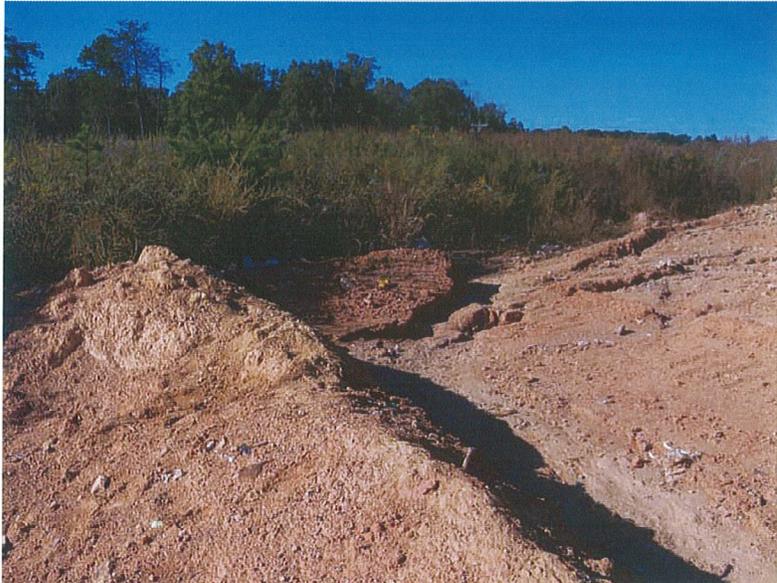
Photograph 7

Date: 10-04-11	
Photographer: Will Harrison	
<b>Location / Orientation</b>	Inside Phase II – ~50 Feet North of Damaged Area – Facing Northwest
<b>Remarks</b>	Operations Soil Cover Bermed Up North (Upstream) of Damage

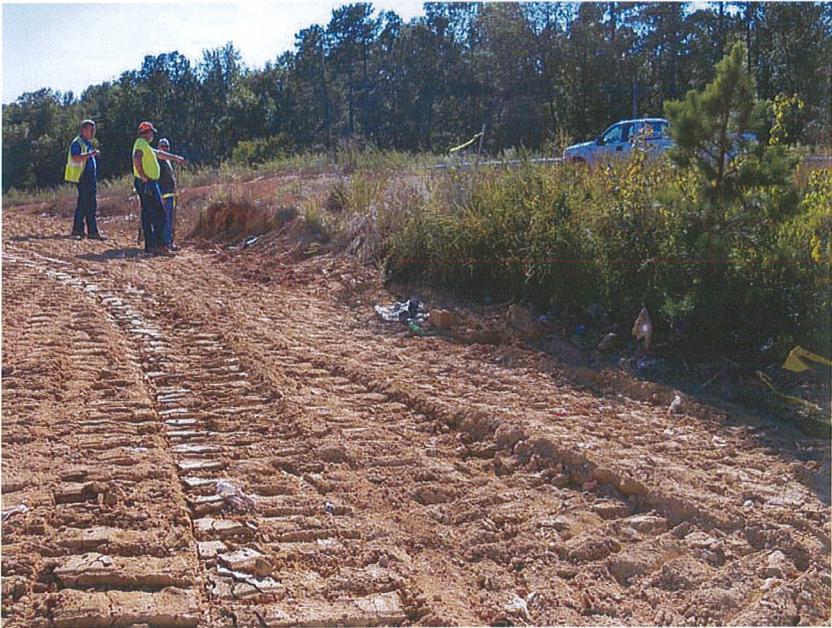
Photograph 8

Date: 7-08-10	
Photographer: William Harrison	
<b>Location / Orientation</b>	Inside Phase II – ~50 North of Damaged Area – Facing Southwest
<b>Remarks</b>	Liner System Damage and Perimeter Berm

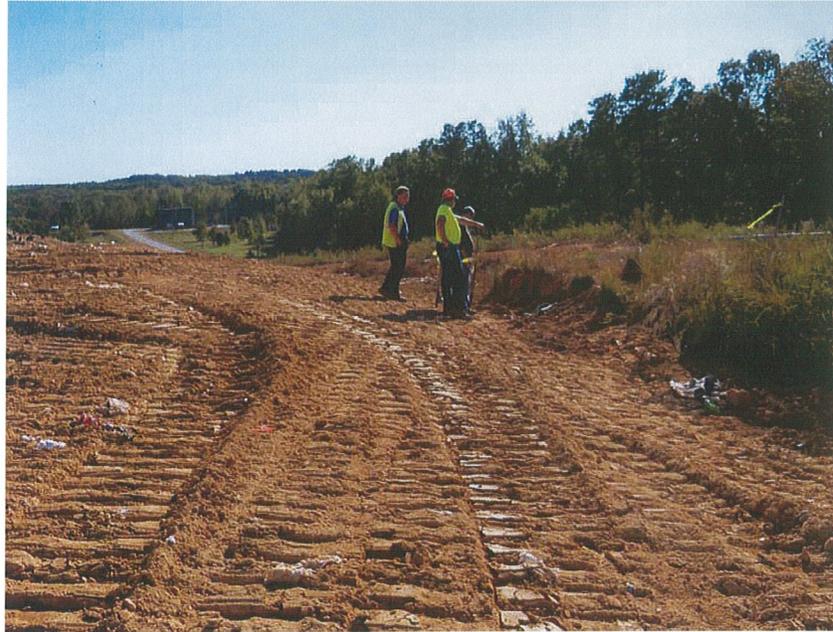
Photograph 9

<b>Location / Orientation</b>	Inside Phase II – ~50 North of Damaged Area – Facing South
<b>Remarks</b>	Liner System Damage and Perimeter Berm

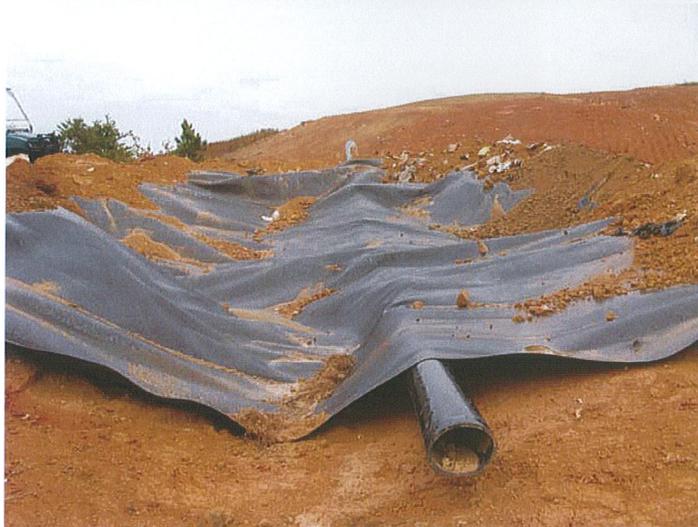
**Photograph 10**

<b>Location / Orientation</b>	Temporary cover of liner system damage
<b>Remarks</b>	Used scrap geomembrane to cover damaged area (located under center of temporary cover). Pipe was placed under cover to deter water from ponding on the cover.

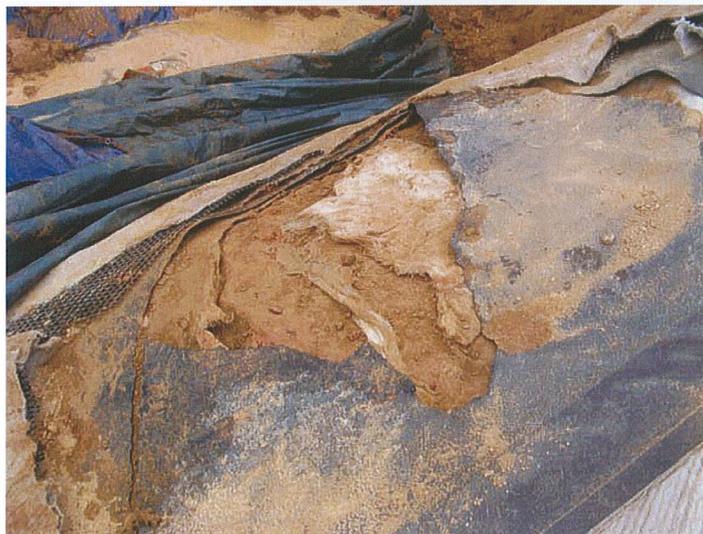
**Photograph 11**

<b>Location / Orientation</b>	Looking down on area of exposed liner system damage.
<b>Remarks</b>	Damaged drainage layer, liner, and GCL

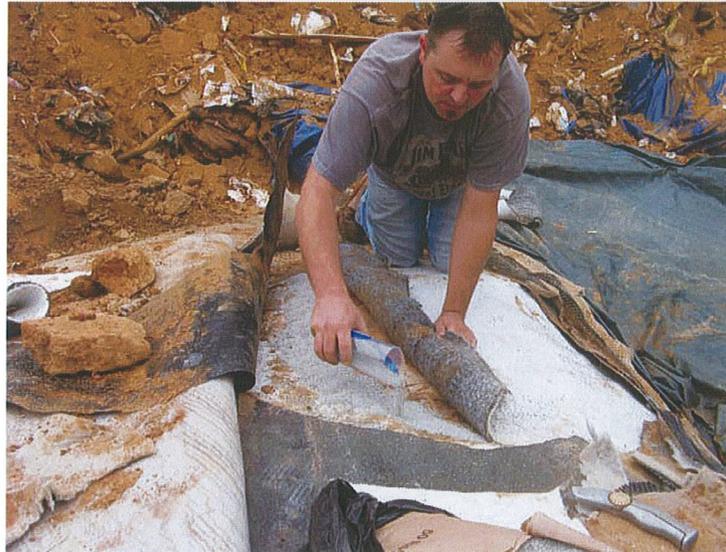
**Photograph 12**

GCL patch

Bentonite ring placed under GCL patch

The damaged GCL layer was repaired as documented in the S&ME Field Report and Photos 10 through 13 dated October 12, 2011 included in Attachment 3. The existing isolated damaged GCL section was removed. A new GCL section was placed in the repair area. Bentonite was sprinkled around and under the new GCL section where it overlapped the existing GCL. Repair of the GCL was performed in general accordance with the project specifications.

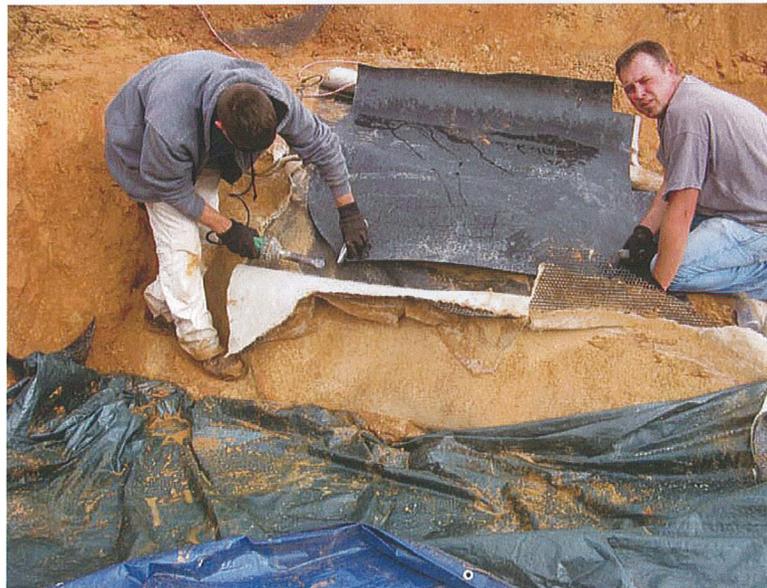
**Photograph 13**

Heat-tacking liner patch over GCL patch

Smooth textured, 60 mil liner

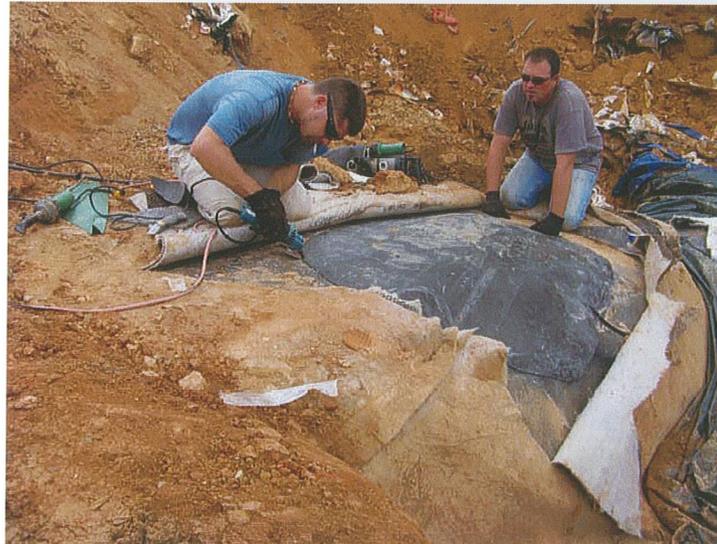
**Photograph 14**

<b>Location / Orientation</b>	Grinding/cleaning liner patch seam
<b>Remarks</b>	none

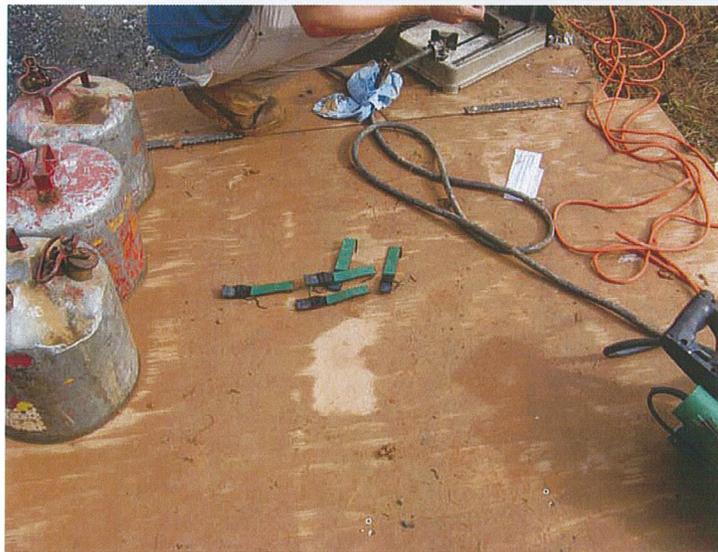
**Photograph 15**

<b>Location / Orientation</b>	1-inch liner weld test strips
<b>Remarks</b>	5 strips for peel, and 5 strips (not shown) for shear

1020 – CQA of extrusion weld method. Temperature of extrusion gun was 175° F and 240° F. Pulled 5, 1-inch test strips for peel tests and 5, 1-inch test strips for shear tests using a tensiometer (Machine #1). Peel results were 82, 97, 104, 116, and 91 which pass the required value of 78 for 60 mil liner peel. Shear results were 127, 141, 148, 128, and 125 which pass the required value of 120 for 60 mil liner shear.

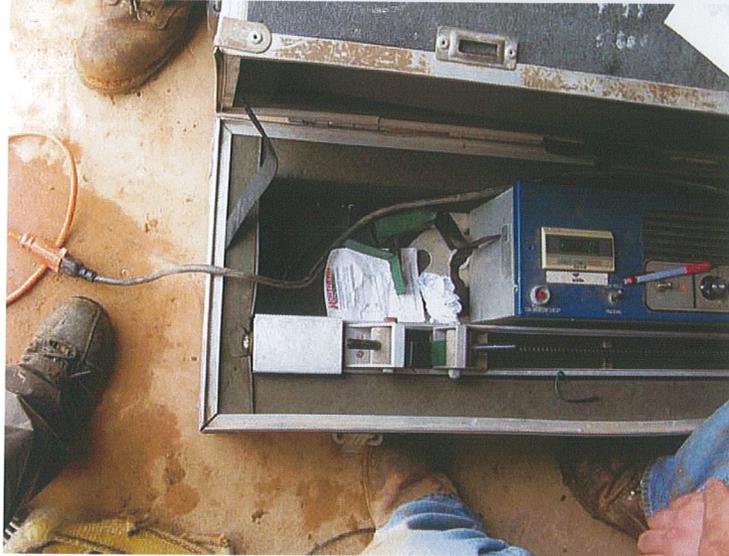
**Photograph 16**

Tensiometer pulling a liner weld test strip (Machine #1)

Example of peel test

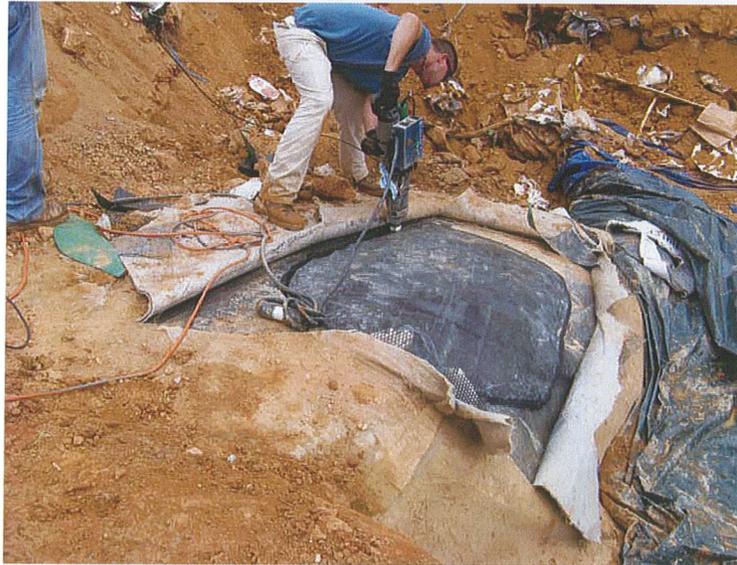
**Photograph 17**

Extrusion Weld

Temp of gun = 175° F and 240° F

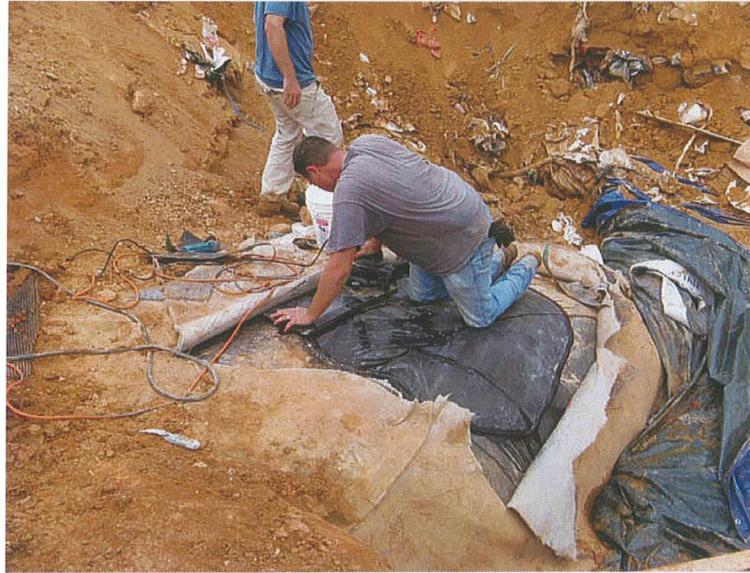
**Photograph 18**

**Location / Orientation** Soap and vacuum test of weld seal

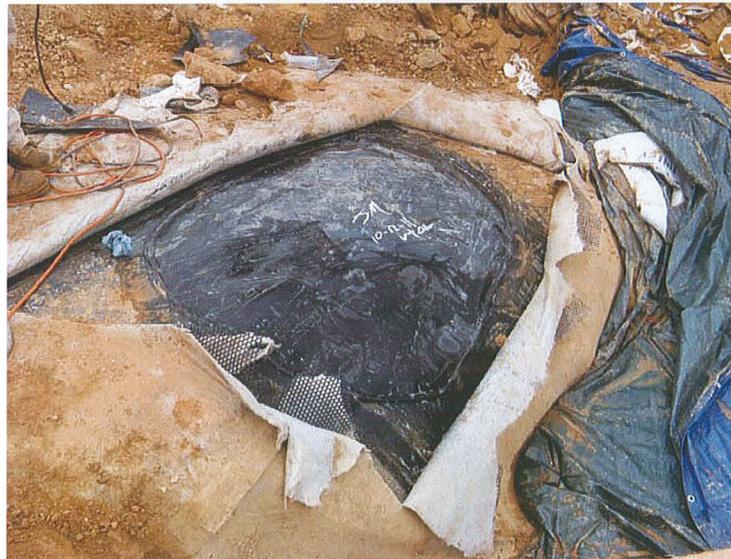
**Photograph 19**

**Location / Orientation** Completed liner patch

**Remarks** Marked with technician's initials "JM" and date "10-12-11"

The damaged geomembrane was repaired as documented in the S&ME Field Report and Photos 14 through 19 dated October 12, 2011 provided in Attachment 3. The damaged geomembrane section was removed. The geomembrane repair section was placed over the damaged area and heat-tacked to the existing geomembrane. The edges of the new geomembrane and the underlying existing geomembrane were then ground to remove oxidation. Following trial seam welding and testing, the existing and new geomembrane were welded together by extrusion welding. The extrusion welded seam was then tested with a vacuum box, and no leaks were observed.

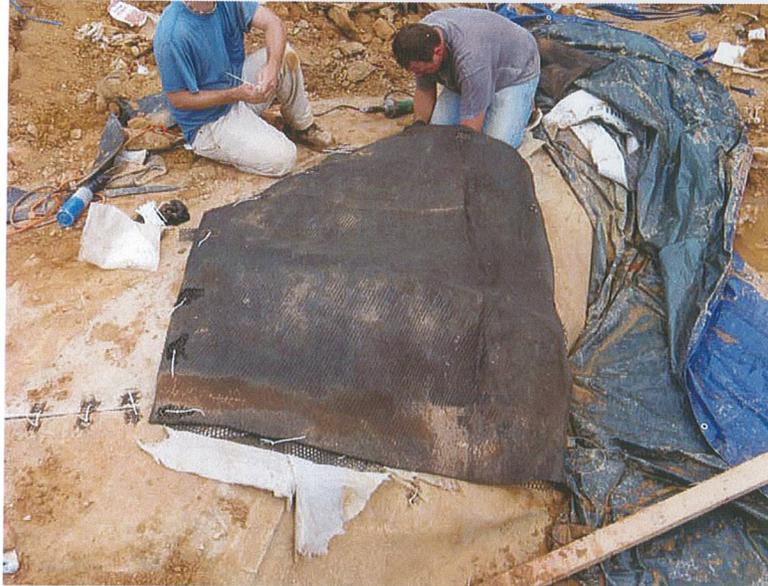
**Photograph 20**

**Location / Orientation** Drainage layer repair

**Remarks** Zip-ties every 6-inches

The damaged geocomposite layer was repaired as documented in the S&ME Field Report and Photos 20 and 21 dated October 12, 2011 provided in Attachment 3. The damaged section of the existing geocomposite was removed. A new geocomposite section was placed over the damaged area such that it overlapped the existing geocomposite by approximately six inches. The geocomposites were then zip tied together every six inches along the overlapped sections. A nonwoven geotextile filter fabric was then placed over the repair patch and heat tacked to the existing geocomposite.

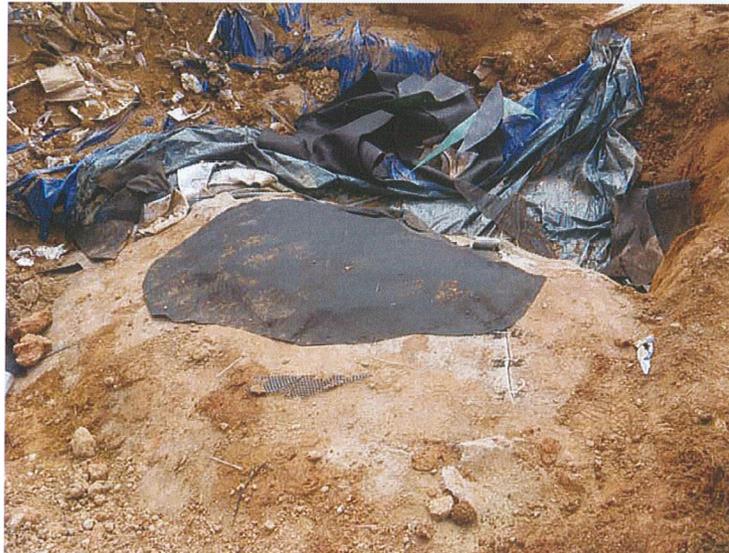
**Photograph 21**

**Location / Orientation** Completed patch of liner system

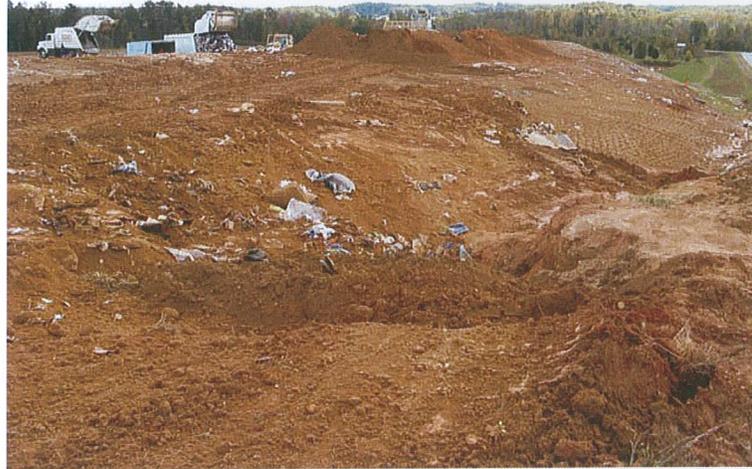
**Photograph 22**

<b>Location / Orientation</b>	Soil cover placed over liner system patch
<b>Remarks</b>	Approximately 4 feet thick; placed by Lincoln County personnel

After geosynthetic repair work was completed, approximately four feet of protective cover soil was placed over the repair area as documented in the S&ME Field Report and Photo 22 dated October 12, 2011 provided in Attachment 3.
