FACILITY COMPLIANCE AUDIT REPORT

Division of Waste Management Solid Waste Section

McDowell County Transfer Station
 2849 NC Hwy 226 South
 Marion, NC 28752

Follow-up Audit.

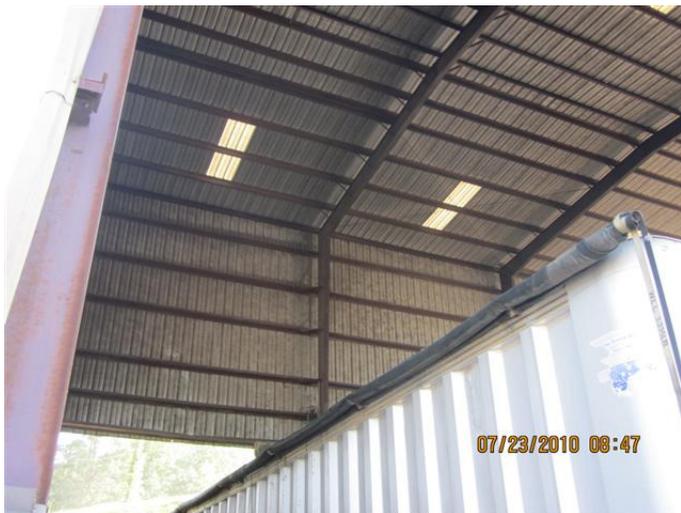
1. Violation of 15A NCAC 13B .0201(h) by failing to maintain the McDowell County Transfer Station in a sanitary condition.

1. Looking up from the entrance of the receiving bay at the east wall and the roof of the transfer station. (Transfer trailer in the right foreground.)

McDowell County corrected this violation by washing down the interior walls, tipping floor and receiving bay of the transfer station. (See photos #1 and #2 below.)

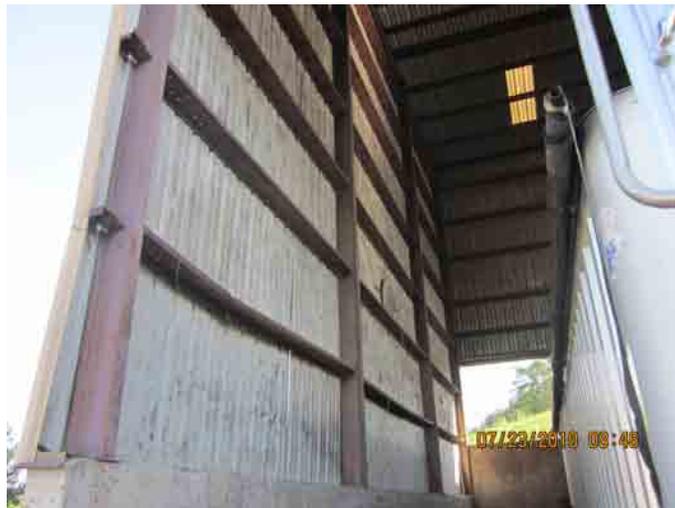
2. Looking up from the entrance of the receiving bay at the back wall and the roof of the transfer station. (Transfer trailer on the right.)

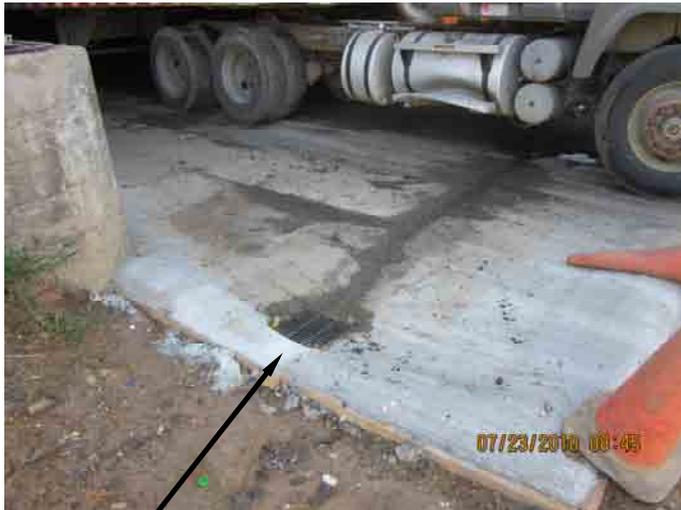
2. Violation of 15A NCAC 13B .0402(3) by failing to either, contain on-site or properly treat, all water that comes into contact with solid waste prior to discharge from the site.”

3. New drain at the entrance to the receiving bay.

McDowell County corrected this violation by extending the floor of the receiving bay & installing a new drain, at the entrance to the receiving bay, to capture leachate. (See photos #3 and #4 below.)

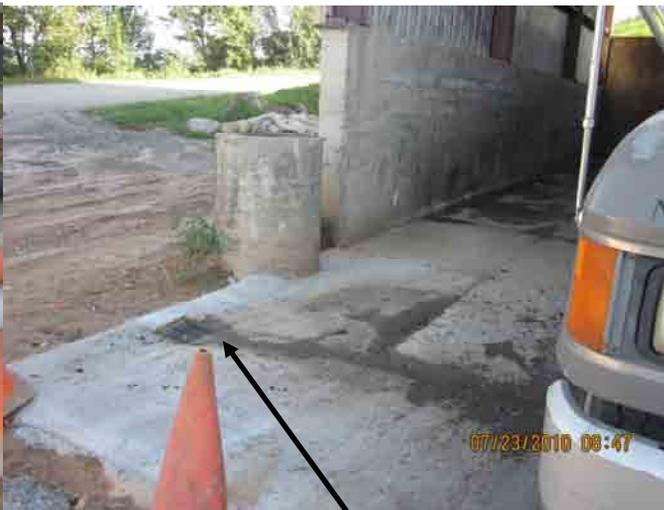
4. Reverse angle of the new drain at the entrance to the receiving bay.

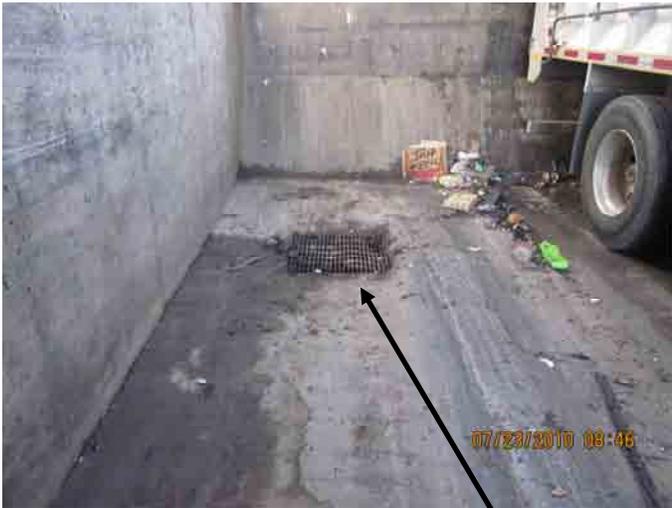
5. There is a water supply holding tank on site is used to supply wash-down water for the transfer station.
6. In addition to the new drain at the entrance to the receiving bay, there is a larger floor drain at the head of the receiving bay. (See photo #5 below.)

5. Looking into the receiving bay, from the entrance, at the second floor drain NE corner of the receiving bay.

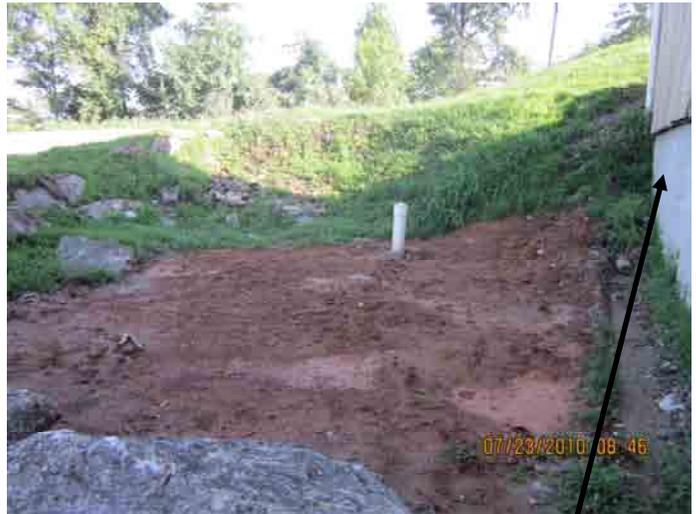
6. Looking east at the area of the 2,000- gallon leachate underground storage tank on the north side of the transfer station. (The transfer station is to the right.)

7. Leachate and wash down water from the transfer station is captured by two floor drains and directed to one 2,000-gallon underground storage tank (UST) that is located immediately north of transfer station.
8. The contents of the leachate UST are pumped out as needed and taken to the Marion wastewater treatment plant for treatment and disposal.
9. The service area for the transfer station is limited to McDowell County.
10. All wastes are taken to the Foothills MSW Landfill in Lenoir.
11. The wastes are hauled by HILCO Transport, Inc., out of Greensboro, NC.
