FACILITY COMPLIANCE AUDIT REPORT

Division of Waste Management Solid Waste Section

Date of Audit: January 15, 2010.

International Automotive Components (IAC) / Formerly Collins & Aikman Products Co.
 1506 E. Main St.
 Old Fort, N.C. 28762

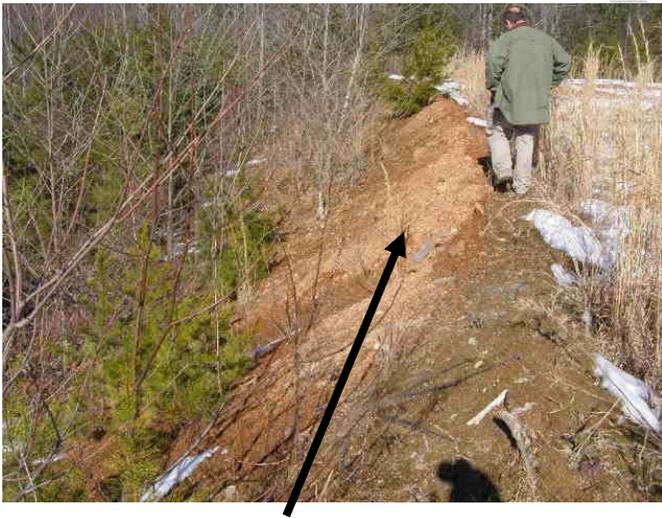
- Violations of 15A NCAC 13B .0505(4)(a): The top of the berm on the western edge of the landfill was breached in two places - in the central part of the berm and at the extreme SW corner. The breach in the central portion of the berm has been repaired. The breach in the SW corner has occurred again. (See photos #1 and #2 below.)

1. Looking (S) along top of berm on (W) edge of landfill at repaired area of wall.

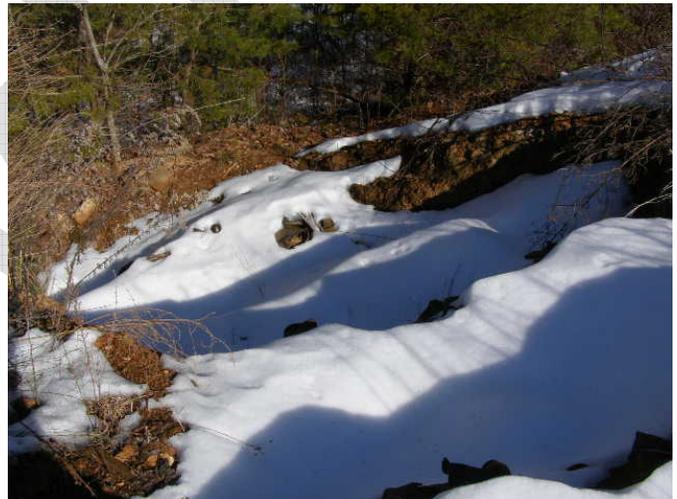
International Automotive Components is in violation of 15A NCAC 13B .0505(4)(a) by failing to maintain the berm at the north west corner of the landfill which has been breached in one place. (See photo #2 below.)

2. Looking from the top of the berm at the (SW) corner of the landfill at breach in the berm.

To correct this violation and be in compliance with 15A NCAC 13B .0505(4)(a), within 30 days from receipt of this notice, fill, compact and stabilized the breach in the berm at the north west corner of the landfill.

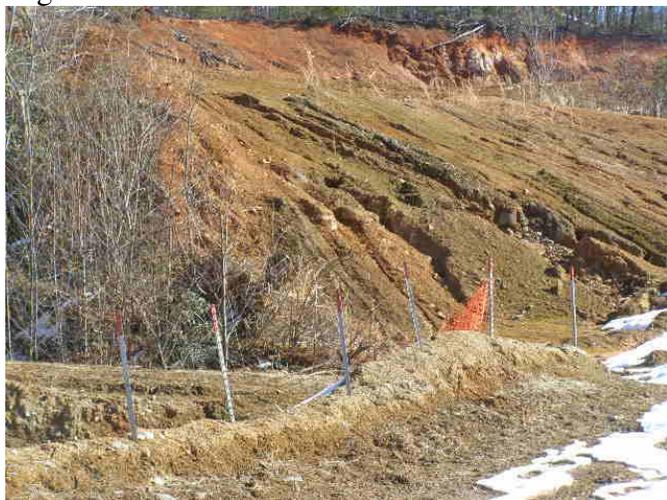
International Automotive Components is in violation of 15A NCAC 13B .0505(4)(b) by failing to prevent excessive on-site erosion by failing to stabilized the site with vegetation. (See photo #3 below.)

3. Looking (E) over the top of the “new” sediment basin at eroded slope leading to the barrow area.

To correct these violations and be in compliance with 15A NCAC 13B .0505(4)(a), within 30 days from receipt of this notice, stabilized the landfill with native grasses or other erosion control devices (e.g., Erosion control blankets or mats.)

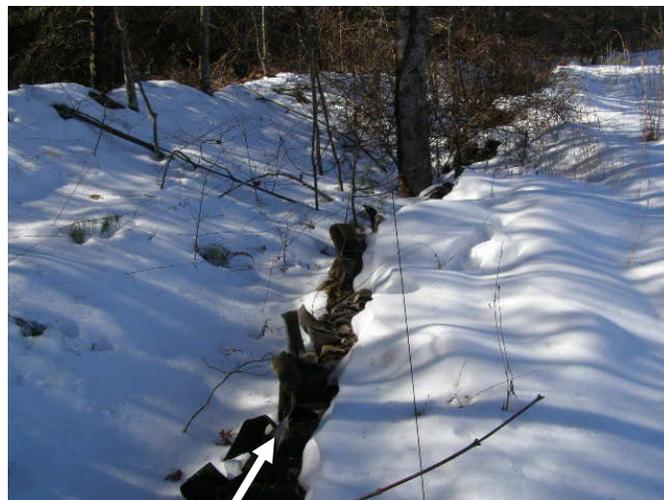
International Automotive Components is in violation of 15A NCAC 13B .0505(3)(b) by failing to prevent provide and maintain one foot of intermediate cover over waste. (See photo #4 below.)

4. Looking (W) along the southern limits of the landfill at exposed waste.

To correct these violations and be in compliance with 15A NCAC 13B .0505(4)(a), within 30 days from receipt of this notice, ensure that all waste has at least one foot of intermediate cover.

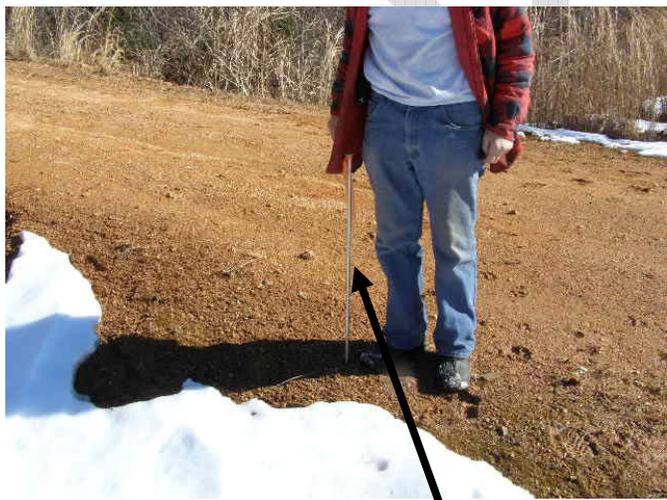
1. A search of the NC Secretary of State’s corporation’s web page confirms that International Automotive Components (IAC) is now registered to do business in NC.
2. The permit that expired on 9/19/07 was issued to the Collins and Aikman Products Company. This permit is not transferable. (See *Item (6) of Part I: Industrial Landfill Facility General Conditions* of the December 19, 2002 Permit.) Please complete the permitting process in accordance with 15A NCAC 13B .0200.
3. The limits of waste have been staked with 3 to 4-foot steel rods that are flagged with surveyor’s tape. Jack Davis (IAC Plant Engineer – retired) placed the stakes approximately 100 to 150-feet apart. (See photo #5 below.)

5. Waste limits marker: 4-foot steel rod topped with florescent surveyor’s tape.

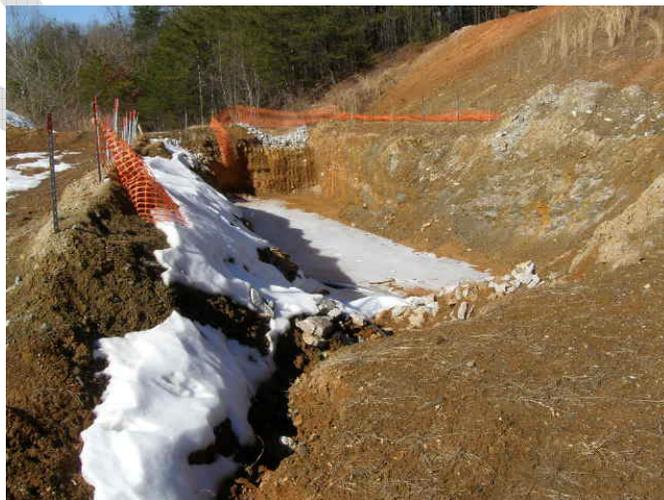
6. Looking (W) into the “new” sediment basin.

4. A “new” sediment basin was put in place at the head of the access road to in an effort to control on-site erosion. (See photo #6 above.)
5. Heavy rains this past year have badly eroded the access road. New sediment traps at the top of the access road were installed. (See photos #7 and #8 below.) The road needs to be repaired.
6. Due recent snow and ice storms, the access road was blocked in multiple places by downed trees. (See photo #9 below.)

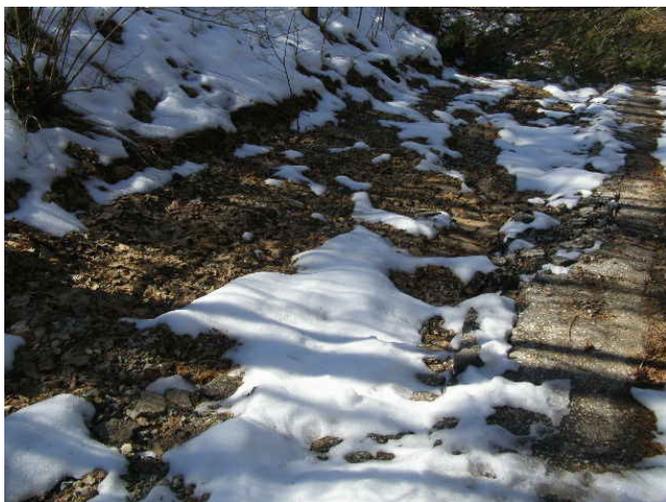
7. Looking (W), near the top, at the eroded access road.

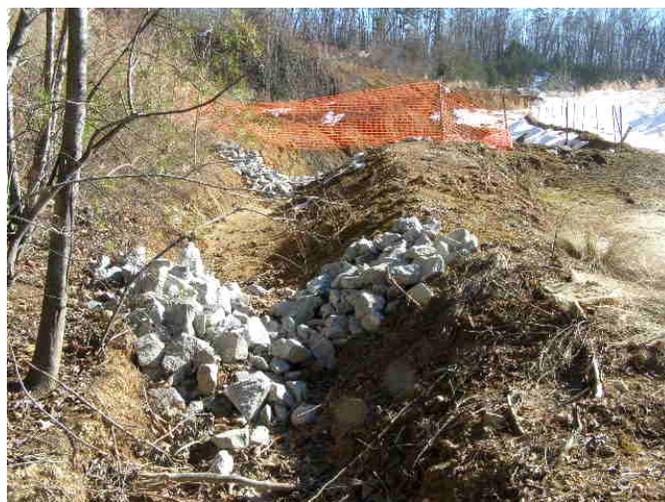
8. Looking (E), from the top of the access road at the new sediment traps. (The “new” sediment basin is in the background, behind the orange construction fence.)

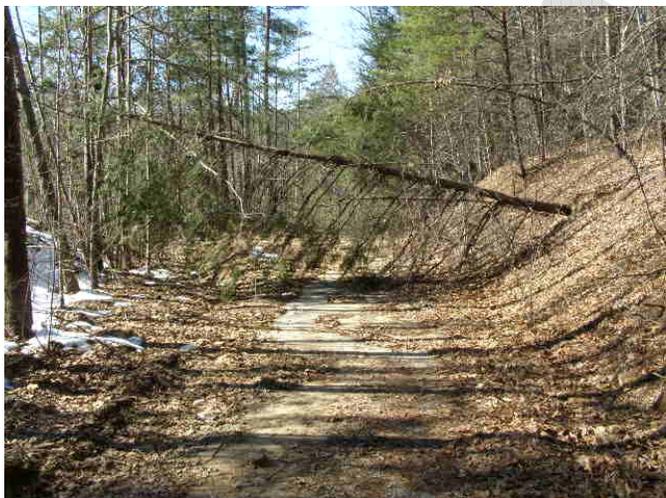
9. Looking (W) at one of many trees blocking the access road.
