FACILITY COMPLIANCE AUDIT REPORT
Division of Waste Management
Solid Waste Section

Date of Audit: November 18, 2010

Macon County Construction and Demolition Landfill (Highlands)
 1080 Rich Gap Road
 Highlands, NC 28741

Comprehensive audit of Closed C & D Landfill

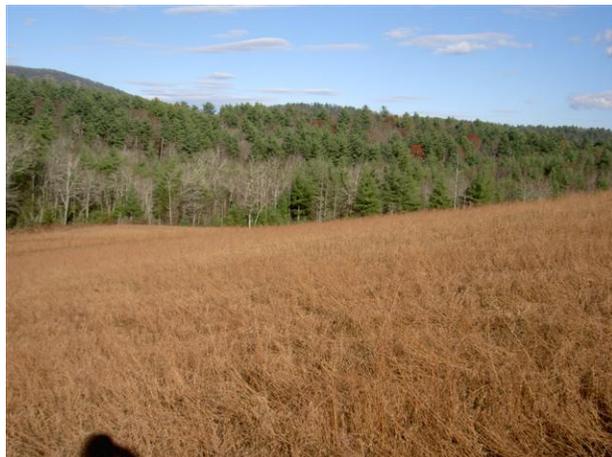
1. All photographs were taken by Troy Harrison on November 18, 2010.
2. The landfill ceased receiving waste on June 30, 2008. The final Closure and Post-Closure Plan was submitted on June 30, 2008 and received on July 1, 2008. The final cap was certified as constructed according to the closure plans and specifications of 15A NCAC 13B .0505 by Mr. Jeff Bishop, P.E., Senior Project Manager, McGill Associates. This was required by 15A NCAC 13B .0505 and .0531(c)(1).
3. The cap of the landfill was observed. Vegetation has begun to grow on the cap. No leachate breakouts or seeps were observed. No ponding of water was observed on top of the cap.

Cap of Landfill looking West

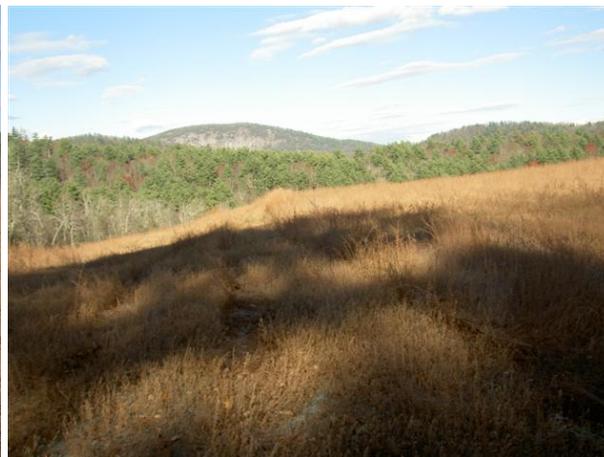
Cap of landfill looking Northwest

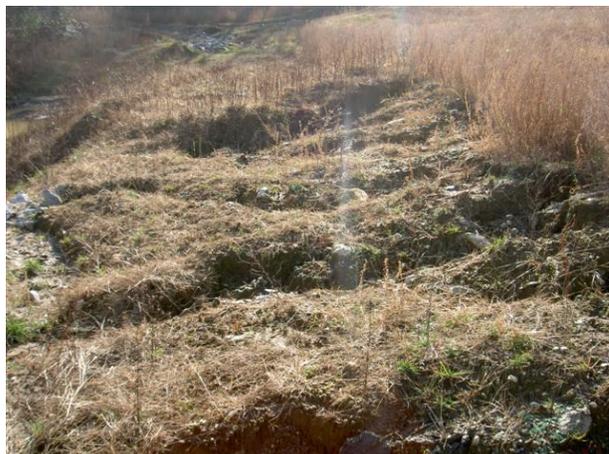
4. There were two areas that will need attention to maintain the integrity of the cap.
 - a. **There was erosion observed on the southern slope near the sediment basins. The erosion was not severe enough to expose waste. This will need to be repaired immediately.**

Southern slope of landfill looking East showing erosion

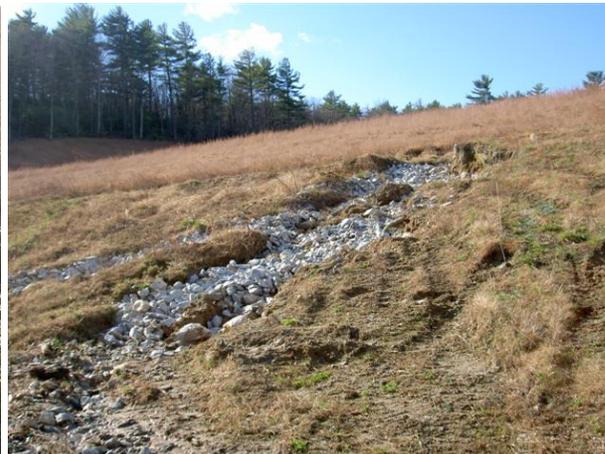
Southern slope of landfill looking Northeast showing erosion & partial repairs

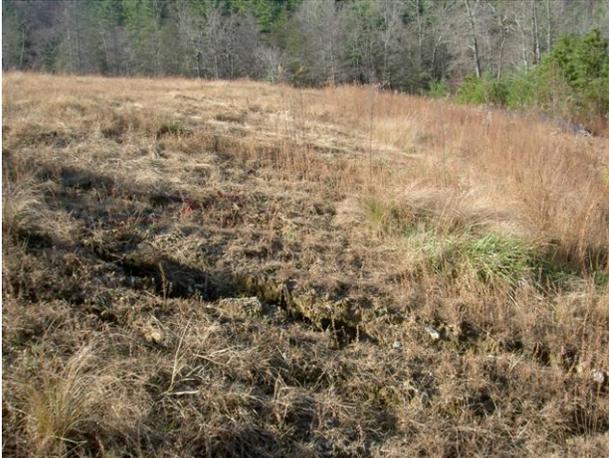
- b. **The Western (lower) slope of the landfill had moderate erosion. The edges of the cap had not been mowed. These areas need to be mowed to prevent encroachment of woody vegetation onto the landfill.**

Western slope looking north showing erosion

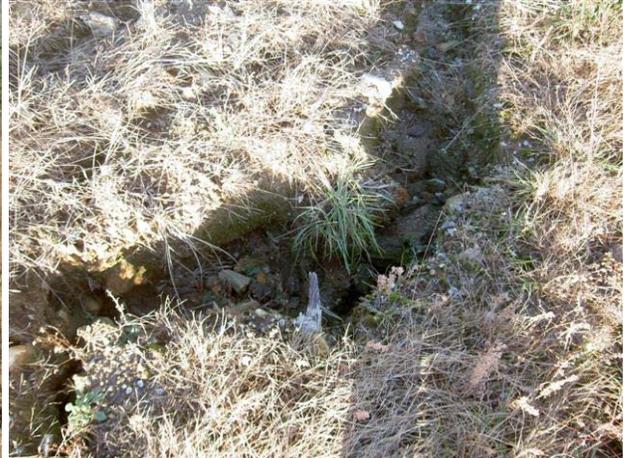
Close-up of erosion on Western Slope.

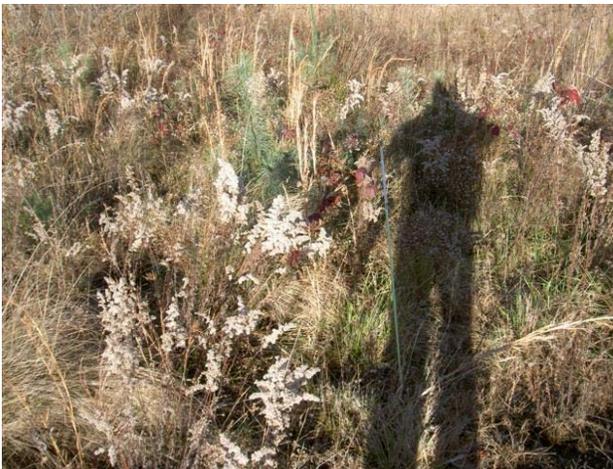
Close-up of Edge of Waste Marker on Western Slope

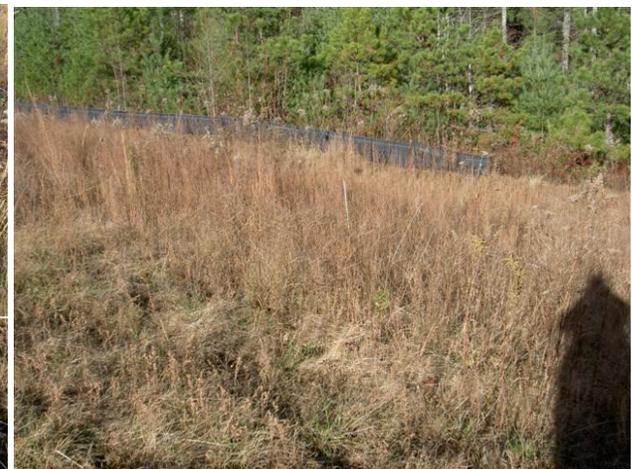
Edge of Waste marker on Western Slope
