FACILITY COMPLIANCE AUDIT REPORT
Division of Waste Management
Solid Waste Section

Date of Audit: March 16, 2011

B & B Concrete Products, Inc.
 1687 Georgia Highway
 Franklin, N. C. 28734

Comprehensive Audit of Type III Compost Facility

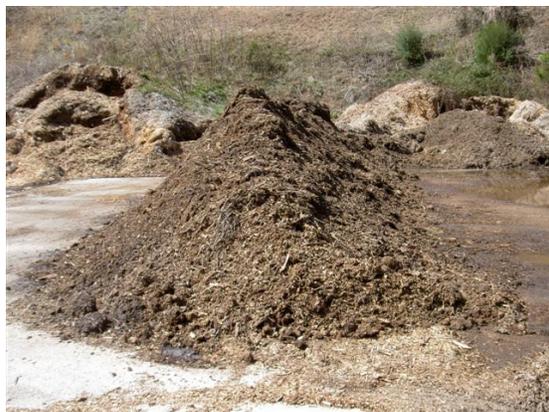
3. The only materials included in the compost pile are wood chips, brush from a grinding operation and grease from restaurants. The normal composition is 20 yards of grease and 40 yards of chips/brush.

Compost pile

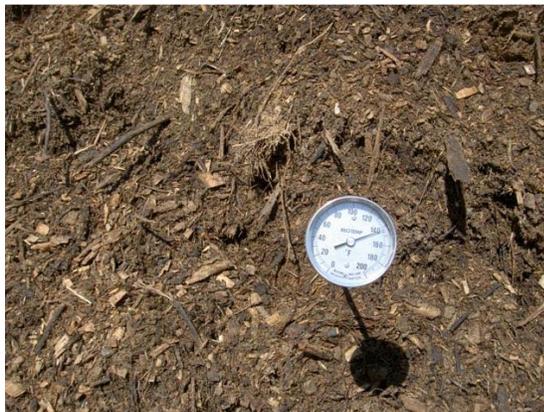
Temperature taken during audit

7. The site is not open to the public. Access is by a single private road that is staffed during work hours.
8. There were two piles of compost. The pile had an internal temperature of around 140°F. Turning of the piles may be required to prevent excessive temperatures.
9. Temperature and other records are kept in the office and were found to be in good order.

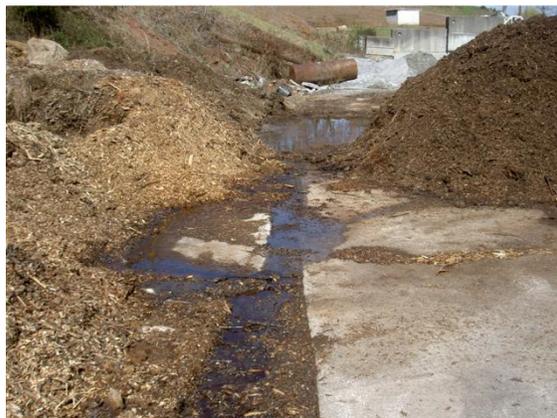
4. Little odor was observed at the pile. No flies or other vectors were observed.
5. The site is not located in a 100 year flood plain and no wells were observed within 100' of site.
6. The compost is located on top of a concrete pad and leachate normally drains to one side into a drain which empties into a septic tank. The company also operates a septic tank pumping service. There had been heavy rain earlier in the week and leachate was observed on the concrete pad. **The drainage ditch was clogged however, leachate was not observed leaving the concrete. The drainage needs to be cleared immediately to prevent leachate from leaving the site.**

Clogged leachate drain

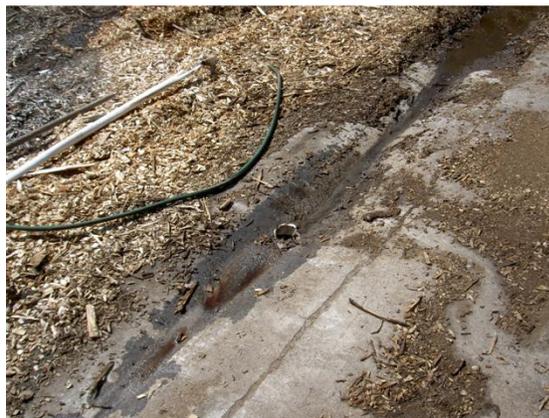
Drain to Septic Tank
