FACILITY COMPLIANCE AUDIT REPORT
Division of Waste Management
Solid Waste Section

MADISON COUNTY SOLID WASTE FACILITY
 271 Craig Rudisill Road
 Marshall, NC 28753

COMPREHENSIVE AUDIT

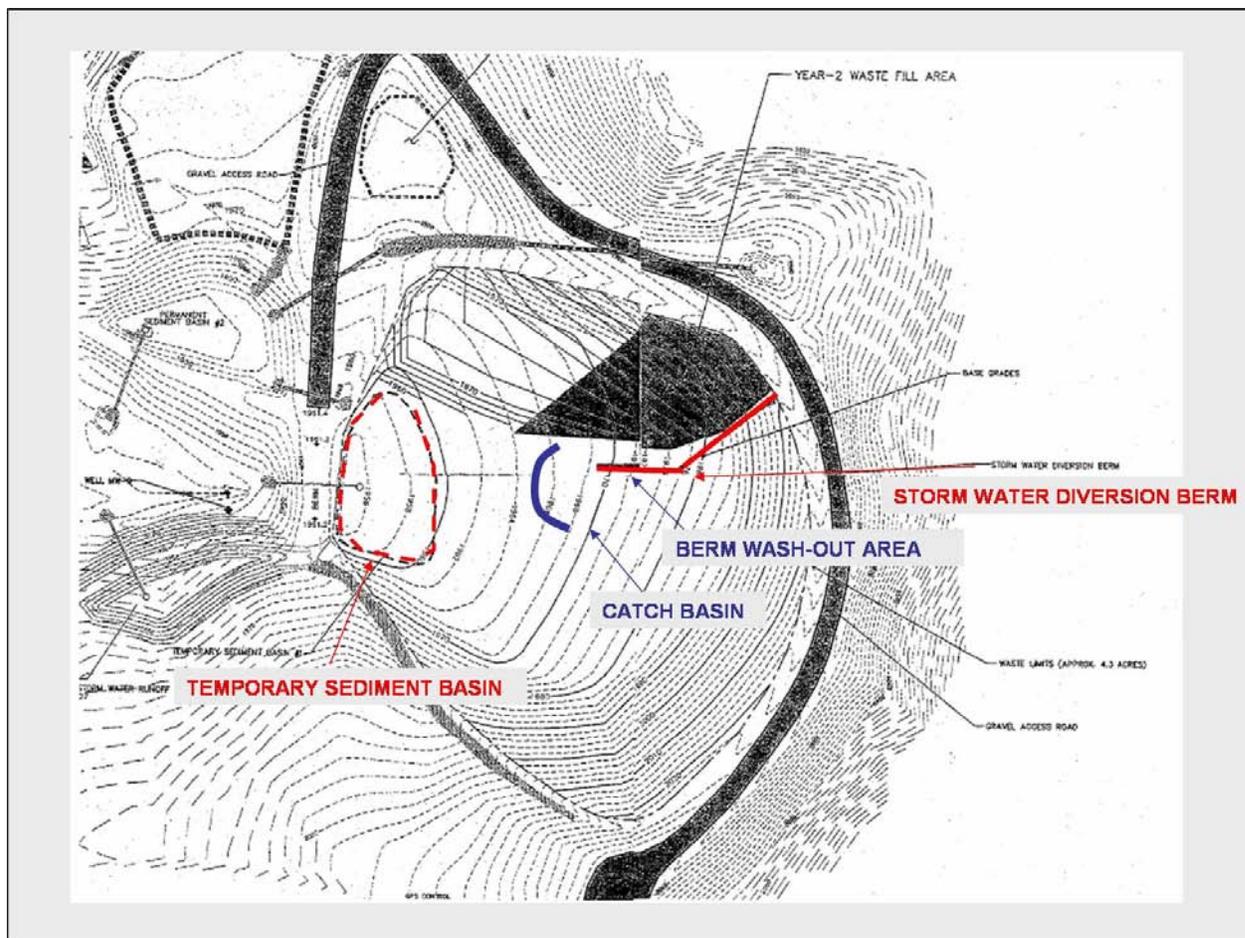
- The Operations Plan for the C&DLF Unit 2 (October 2006) and associated fill pattern figures located in the Permit to Operate (PTO) submittal indicate that the fill sequence at the landfill matches the "Year 2 Waste Fill Area" from Sheet FILL-2. Note that this figure and fill sequence is an approved document (*CQA Report and Operations Plan, C&DLF Unit 2, Madison County, NC*, prepared by McGill Associates October 12, 2006) per the approved permit. Note that the storm water diversion berm must be maintained at all times and that the temporary sediment basin must be protected from any leachate leaving the C&D disposal area.

- As indicated in the figure in item #5, the required storm water diversion berm had an area of wash-out during the site inspection of 03/25/10. During the 09/17/10 inspection, the berm appeared to be intact. As the temporary sediment basin discharges outside the permitted waste fill area of Unit 2, the facility must ensure stormwater contacting C&D waste (leachate) and leachate seeps from the active fill area do not reach the sediment basin. During the 09/17/10 inspection, leachate seeps were visible at the working face. This condition was discussed with the operator (L. Wright).

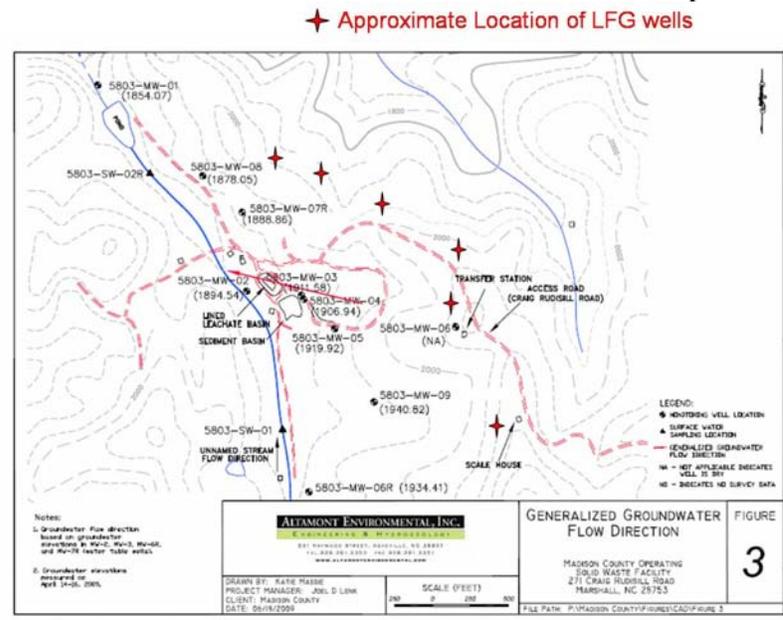
5. Landfill Gas Monitoring records were reviewed. Calibration is done at the facility and once-a-year by Altamont Environmental. LFG wells (six) were inspected (locked, no labels). An approved Landfill Gas Monitoring Plan was unavailable at the time of the audit, as well as a site map indicating LFG wells.

A random check of the LFG well nearest to MW-6 revealed the lack of a pvc cap on the well. **Please check all wells for proper caps** – this issue will be reviewed during a follow-up audit to the facility – **and have a copy of the approved LFG plan present for review.**
