FACILITY COMPLIANCE AUDIT REPORT
Division of Waste Management
Solid Waste Section

Date of Audit: 3/18/10 & 3/30/10

City of Albemarle MSW Landfill Facility
 40592-B Stony Gap Road
 Albemarle, North Carolina

Complaint Investigation/Operational Audit

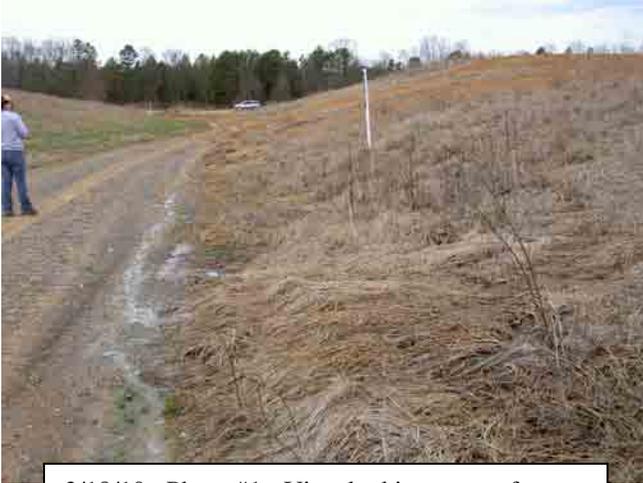
The City of Albemarle Landfill is in violation of 15A NCAC 13B .0542(l)(4) and 15A NCAC 13B .0505(7)(c) in that on March 18, 2010, several leachate outbreaks were observed on the southern side of the Construction and Demolition Landfill unit operating over a closed, unlined municipal solid waste landfill. The leachate from the outbreaks was

observed to have flowed onto and across the access road (photos #1, 2, 3, 5). From the access road, the leachate flowed to the west into two drainage ditches (photos #4, 5 and 6), through two culverts under the haul road (photos #4 and 5) and into two ditches that lead to the sediment basin (photos #6, 7 and 8). The sediment basin discharges from an outlet located on the downstream side of the basin (photo #10). On March 30, 2010, a follow-up inspection was conducted. All but one of the leachate outbreaks previously observed on March 18, 2010, had been repaired. The leachate from this area was still outside the disposal unit along the access road but did not cross the access road. Jan Borgman was made aware of the existing leachate outbreak that was not repaired.

3/18/10: Photo #1 - View looking west, of easternmost leachate outbreak on the southern side of the CDLF over the closed MSWLF, flowing west toward vehicle.

1. Properly determine the edge of waste and install permanent markers around all disposal units, including the closed, unlined municipal solid waste landfill;
2. Assure leachate is contained within the boundary of the disposal unit or properly treated prior to discharge; and
3. Assess the impact of the leachate release outside of the landfill area. Please contact Ervin Lane, Compliance Hydrogeologist with the SWS, at (919) 508-8516 or Ervin.Lane@ncdenr.gov regarding the assessment. Within 30 days of receipt of this audit report, submit the results of the assessment to Mr. Lane at:

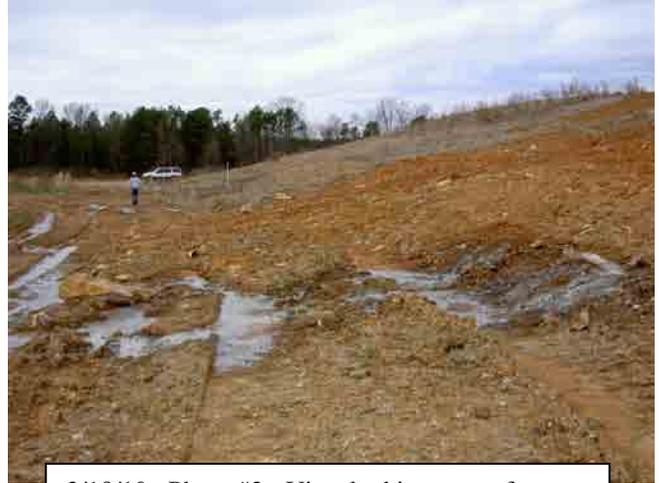
3/18/10: Photo #2 - View looking west of leachate outbreak on the southern side of the CDLF over the closed MSWLF.

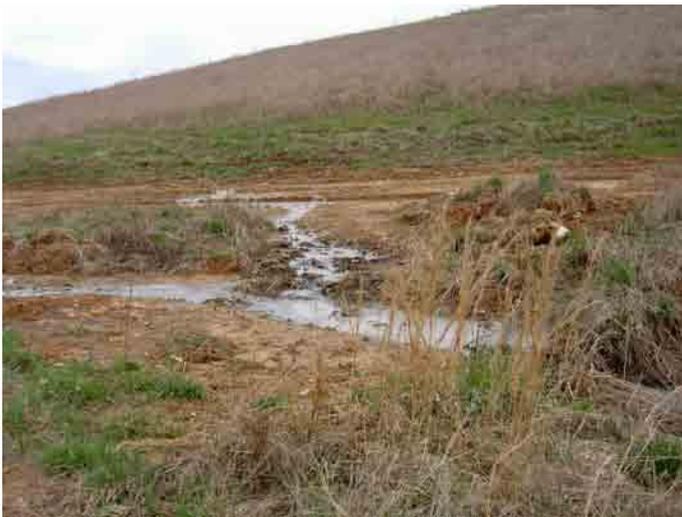
3/18/10: Photo #3 - View of leachate flowing from CDLF over the closed MSWLF and across access road to the second drainage ditch.

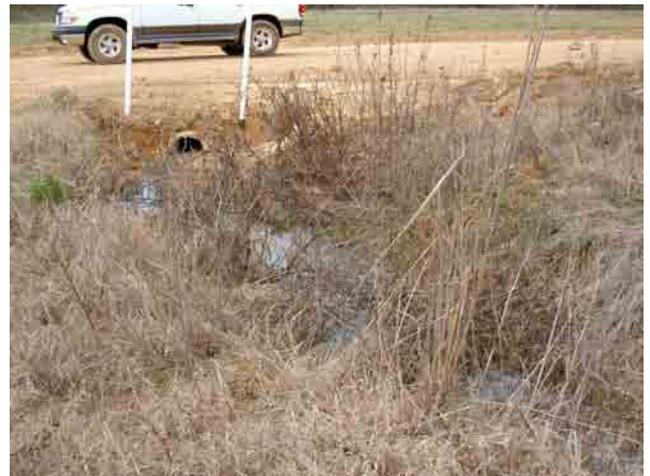
3/18/10: Photo #4 - View of leachate in the first drainage ditch flowing towards vehicle.

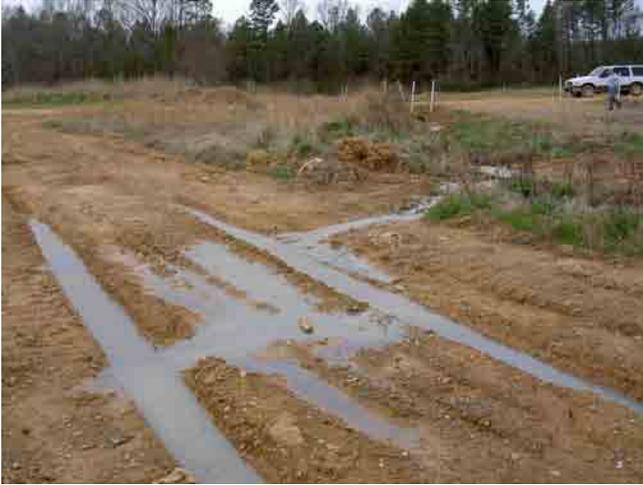
3/18/10: Photo #5 - View of leachate in access road entering second drainage ditch.

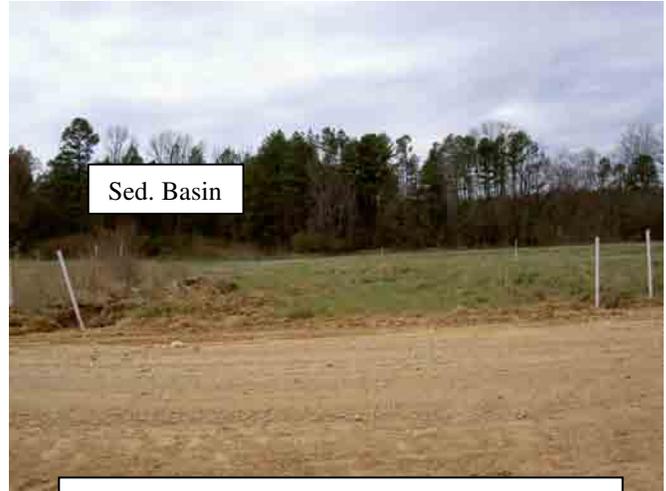
3/18/10: Photo #6 - View of first (right) and second (left) drainage ditches leading to the sediment basin located in the background.

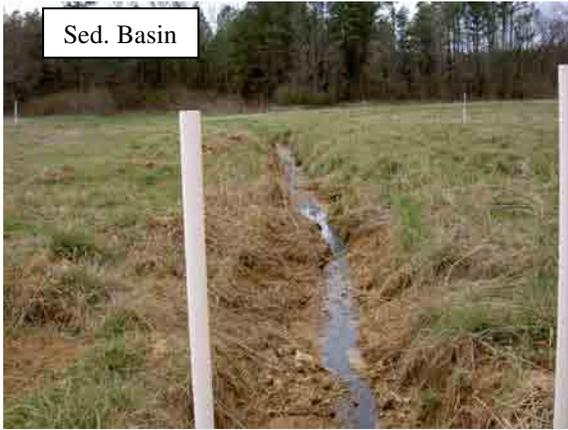
3/18/10: Photo #7 - View of second drainage ditch leading to the sediment basin located in the background.

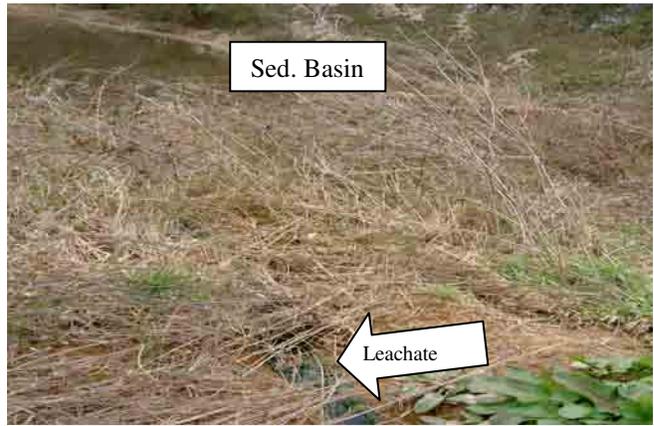
3/18/10: Photo #8 - View of leachate entering the sediment basin.

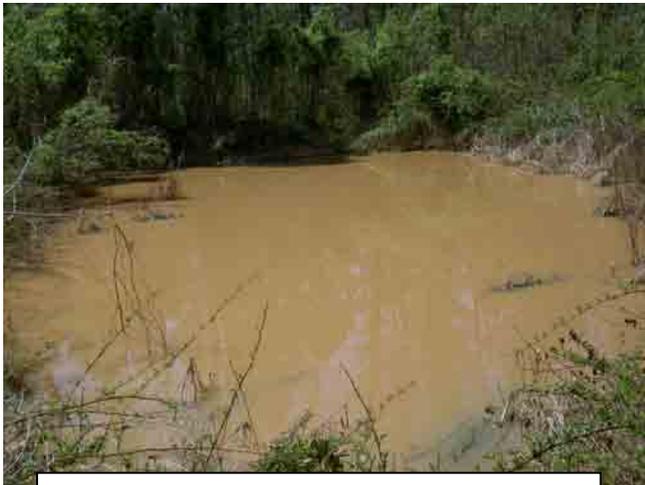
3/30/10: Photo #9 - View of the sediment basin.

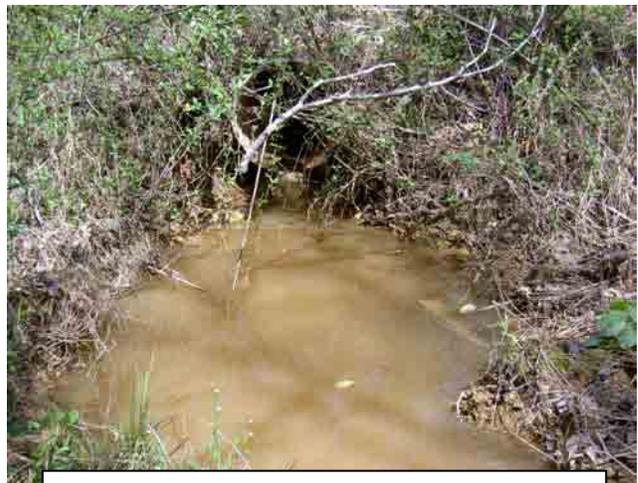
3/30/10: Photo #10 - View of the outlet on the downstream side of the sediment basin.

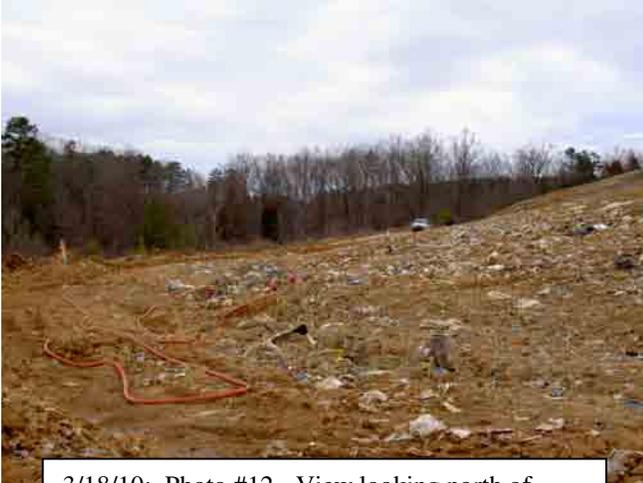
The City of Albemarle Landfill is in violation of 15A NCAC 13B .1626(2)(c) in that on March 18 and March 30, 2010, waste was observed with inadequate soil cover in the area where the trench was excavated on the south/southwest side slope on Phase 1 of the MSWLF (photos #12, 13 and 16).

3/18/10: Photo #12 - View looking north of inadequate cover on the south/southwestern side slope of Phase 1 of the MSWLF.

1. Provide the Section a demonstration that the liner was not penetrated in the excavation on the northwest side slope of Phase 1;
2. Fill all excavated areas; and
3. Cover all exposed waste with at least 6 inches of soil.

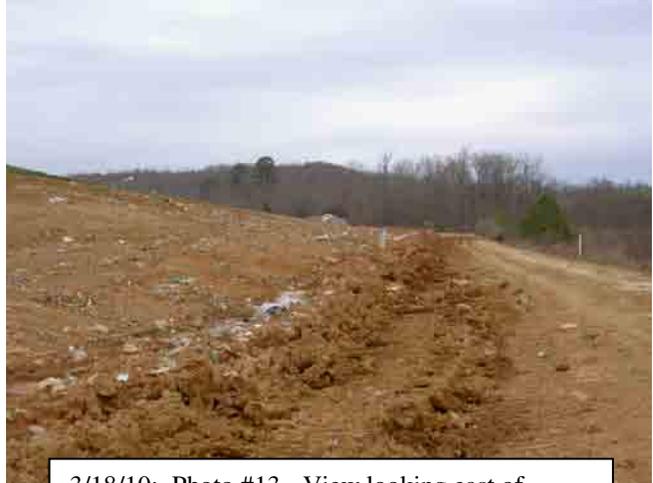
3/18/10: Photo #13 - View looking east of inadequate cover on the southern side slope of Phase 1 of the MSWLF.

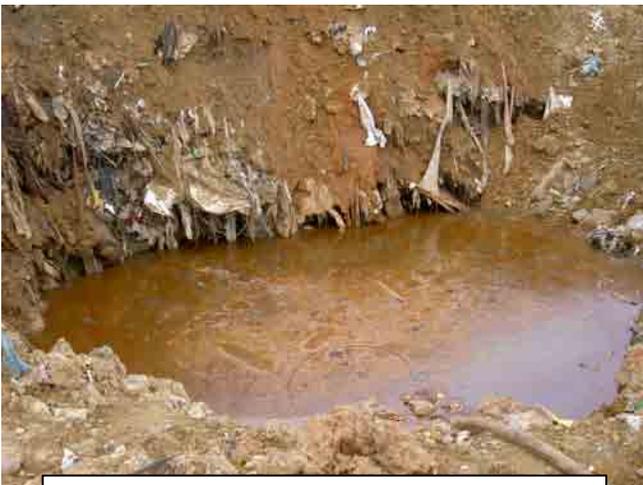
On March 18, 2010, in response to the complaint, Teresa Bradford conducted a facility audit and observed an excavated area containing leachate on the northwest side slope of Phase 1 of the MSWLF (photo #14). The excavated area was filled with leachate and the condition of the liner could not be determined. According to Nina Underwood, the excavation of the waste was performed in order to repair a leachate outbreak. Teresa Bradford observed a hose that ran from the excavated area into a trench that was excavated for the purposes of correcting leachate outbreaks. According to Darren Preslar, the excavated area on the northwest side of Phase 1 was left open to monitor the leachate level. During the inspection on March 30, 2010, the leachate in the excavated area was observed to have been pumped out (photo #15). Also on March 18, 2010, Teresa Bradford observed another area of uncovered waste adjacent to an excavated area near the sump located on the southern side of Phase 1 (photo #16). According to Darren Preslar, the excavated area was left open to monitor the level of leachate during the pumping of impounded leachate from Phase 2 to Phase 1 leachate collection system.

3/18/10: Photo #14 - View of leachate in the excavated area on the northwest side of Phase 1.

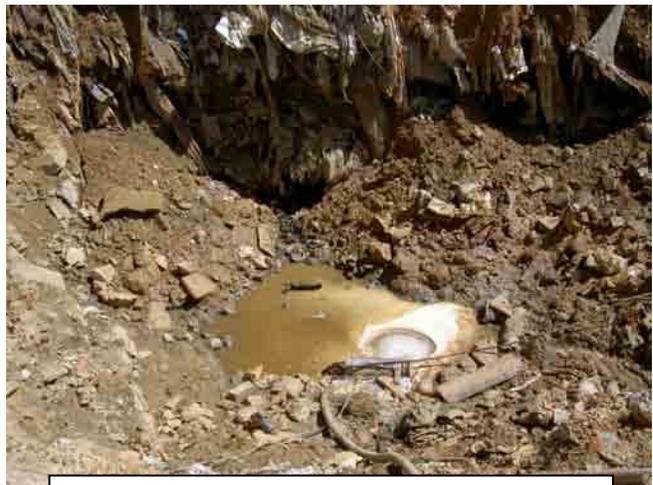
3/30/10: Photo #15 - View of the excavated area on the northwest side of Phase 1. Note: Leachate has been pumped from area into the trench.

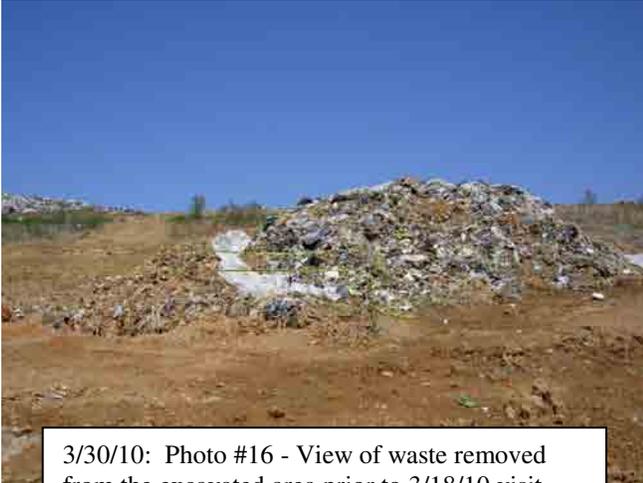
During the follow-up inspection on March 30, 2010, facility personnel had started adding additional soil cover and borrow material to reinforce the soil berm at the toe of the slope on the southern side of Phase 1 (photo #17). Uncovered waste that was removed from the excavated area near the Phase 1 sump located on the southern side slope that was observed on March 18, 2010, was observed to be still uncovered on March 30, 2010 (photo #16). Facility personnel had applied a plastic tarp over the waste that had been excavated from the Phase 1 sump area. The tarp had blown off and had not been reapplied.

3/30/10: Photo #16 - View of waste removed from the excavated area prior to 3/18/10 visit, located near the sump on the southern side slope of Phase 1.

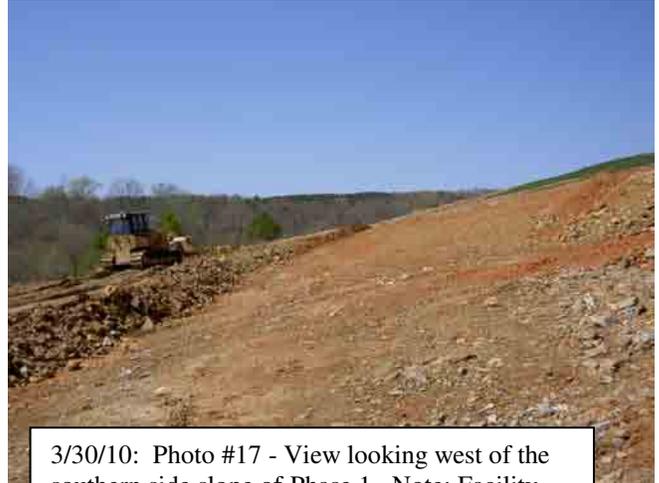
3/30/10: Photo #17 - View looking west of the southern side slope of Phase 1. Note: Facility applying additional soil cover and reinforcing the soil berm.
