**FACILITY COMPLIANCE AUDIT REPORT**  
**Division of Waste Management**  
**Solid Waste Section**

Domtar Paper Company Landfill  
 Ken Trowbridge Road  
 Plymouth, North Carolina

Active; Permit to Operate Landfill 3 Phases 1A, 1B, and 2; Permit to Construct Landfill III Phases 3 and 4 issued 10 November 2010; Revised 17 May 2011. Permit to Operate expires 22 May 2013. A complete permit review request including updated facility, operations, and waste screening plans is due on or before 22 November 2012. This application must comply with the rules and regulations in effect at the time of the application.

Partial audit without records review to review corrective actions taken in response to FCAR 94-01, 041411

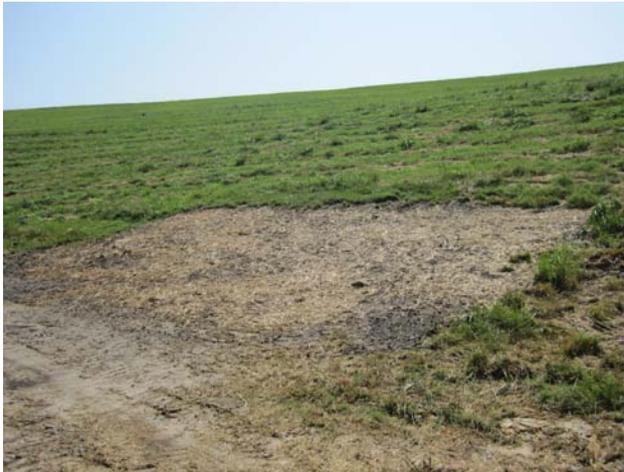
- 8) The wet area that was noted at the toe of the bottom lift on the western sideslope in the previous audit has been repaired. The area was excavated and packed to prevent further seepage. The excavated area was then covered, graded, seeded, and mulched to establish a groundcover suitable to prevent erosion of the landfill cap system.  
\*Please continue to monitor this area to ensure the effectiveness of the repair.

Repaired area noted as seeping in FCAR 94-01, 041411

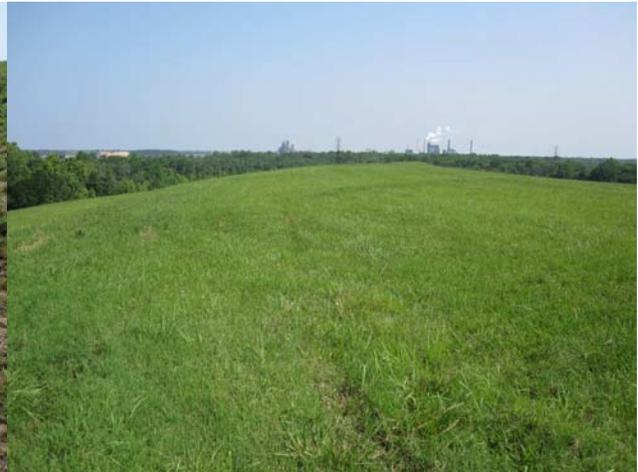
- 4) Landfill Units I and II have been closed and covered and have a well established cover crop of native warm season grasses.
- 5) The cover crop in Unit I is mowed as needed throughout the growing season; this element has recently been mowed.

Top lift of closed unit with well established cover crop

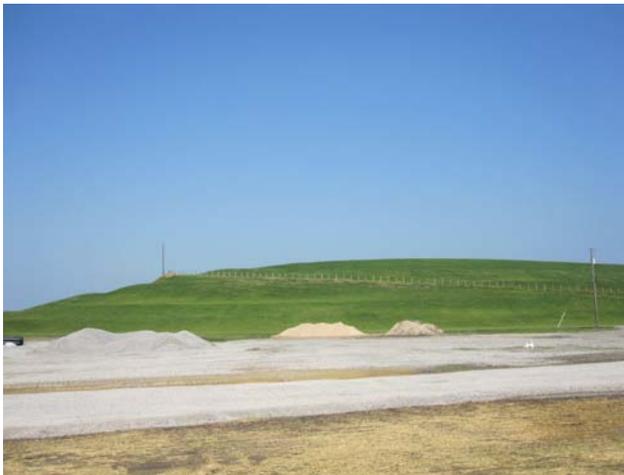
- 6) Highly visible, permanent edge of waste markers have been installed and are being maintained as required.
- 7) No areas of erosion were noted in the cap system of Landfill Unit 1.

Well maintained sideslope in closed Unit I

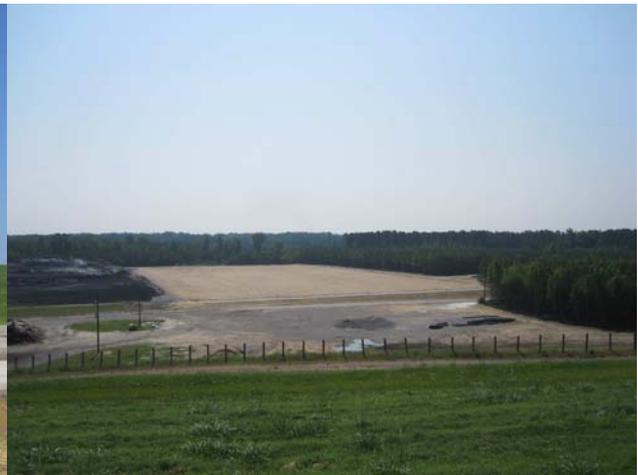
- 10) This landfill is currently operating in Unit III cells 1b and 2. Unit II Cell 1 has been closed and covered.
- 11) Construction of Landfill Unit III Cells 3 and 4 has been completed.

Completed Unit III Cells 3 and 4

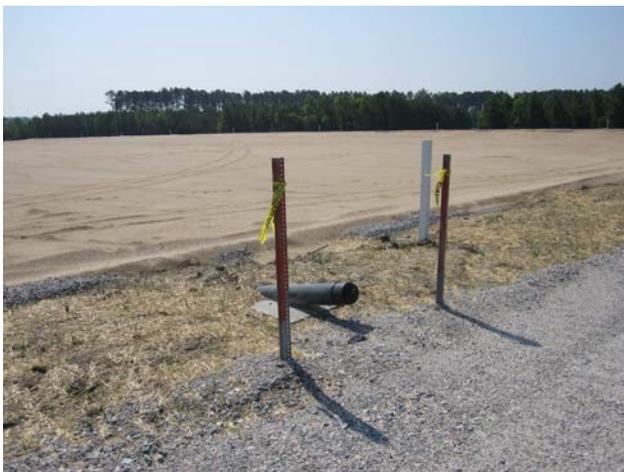
- 12) The leachate collection system cleanouts are being well maintained and are visible and accessible. The leachate collection system is scoped and cleaned annually.

- 19) No windblown debris was observed leaving the facility.
- 20) Leachate is collected and treated on-site.
- 21) Highly visible edge of liner markers have been installed and are being maintained as required.

Leachate line cleanout and edge of liner marker (white post) in new cell

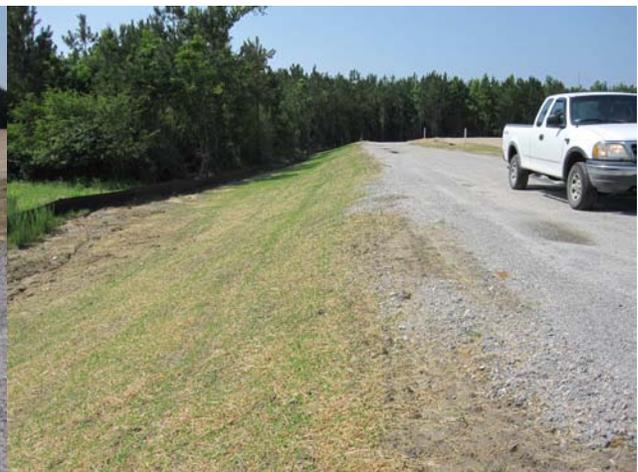
Sideslope of Unit III Cells 3 and 4 graded, seeded and mulched
