FACILITY COMPLIANCE AUDIT REPORT
Division of Waste Management
Solid Waste Section

Date of Audit: 16 March 2010

Washington County MSW Landfill
 718 Landfill Rd
 Mackeys, NC 27970

Comprehensive

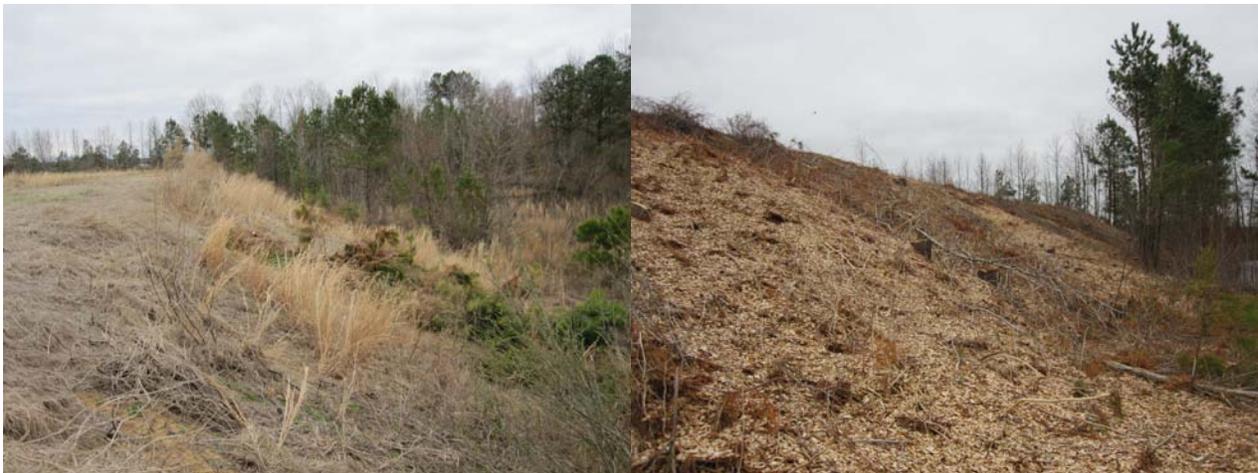
- 8) The trees that were observed growing on several of the sideslopes of the landfill during the previous audit have been removed.
- 9) Edge of waste markers have been installed along the toe of the landfill sideslopes.

Sideslopes-trees and brush removed

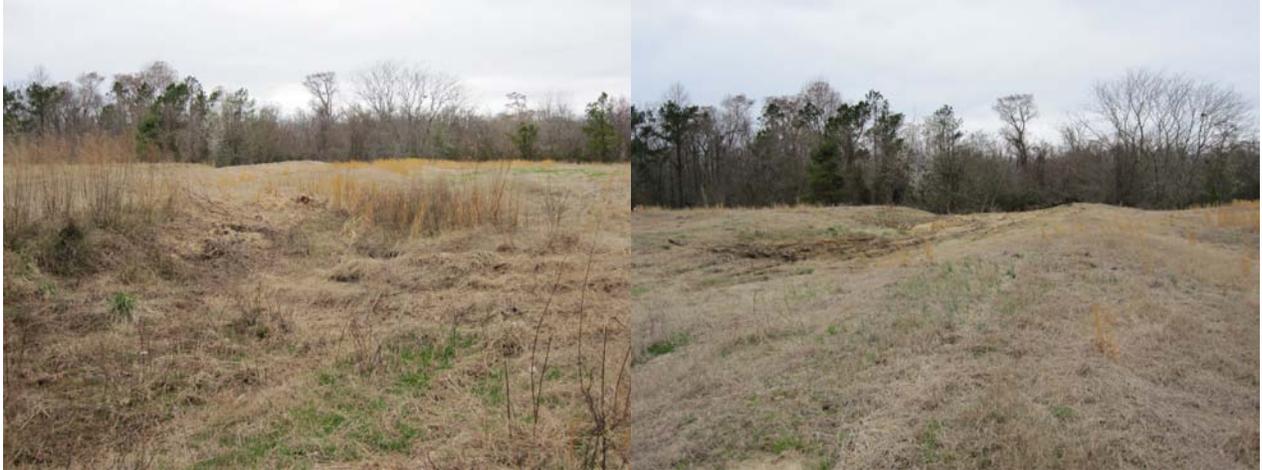
Surface of landfill-trees and brush removed

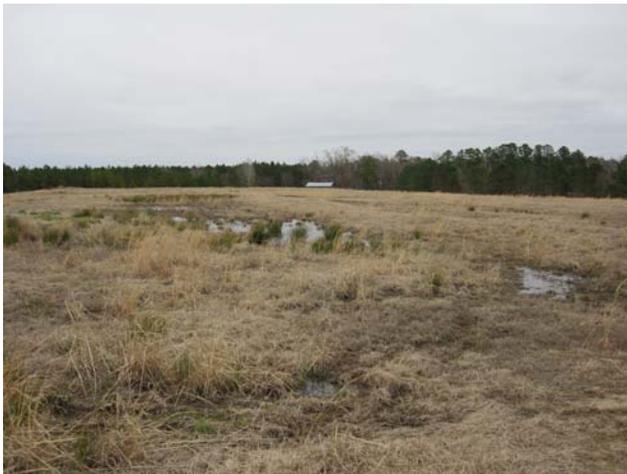
Surface of landfill-areas of settlement needing repair

- 7) Several areas of settlement across the surface of the landfill were noted as retaining water. *Please fill and grade these areas to ensure positive drainage of surface waters from the landfill and to ensure the integrity of the cap system.
