**FACILITY COMPLIANCE AUDIT REPORT**  
**Division of Waste Management**  
**Solid Waste Section**

**Date of Audit:** 11 February 2011

Washington County MSW Landfill  
 718 Landfill Rd  
 Mackeys, NC 27970

94-02, 021111

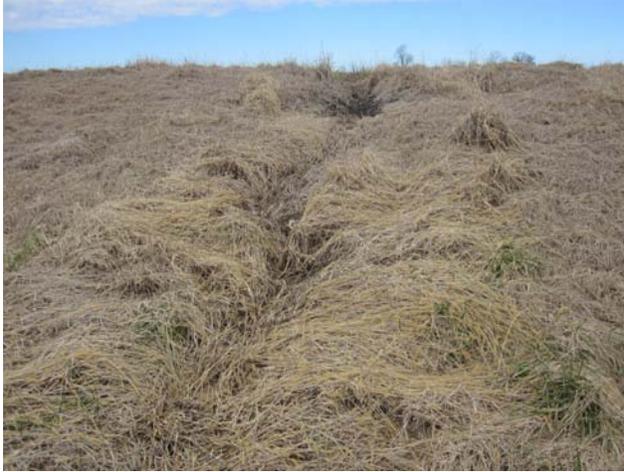
- 8) Overall, vegetative cover is well established over the entire closed landfill and no bare areas were noted during this audit.
- 9) There were two areas of erosion noted on the southern sideslope. The first, approximately one third down the sideslope from the southeast corner, and the second, just past the newly constructed firing range berm. \*To protect the integrity of your landfill cap system, please fill, grade, seed, and mulch these areas to establish a groundcover suitable to prevent erosion and to promote positive, controlled drainage of all surface waters from the landfill.

Eroded area on the southern sideslope in need of repair

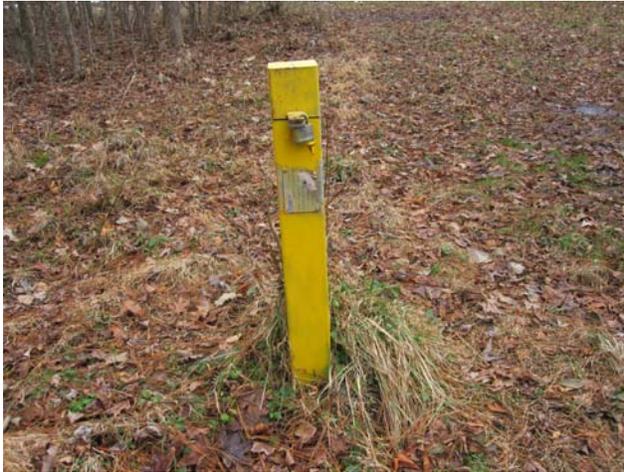
- 11) The groundwater monitoring wells were observed during this audit. All wells were readily accessible, painted with high visibility paint, properly labeled, and secured with functional locks.

Monitoring well; labeled, accessible, highly visible, secured

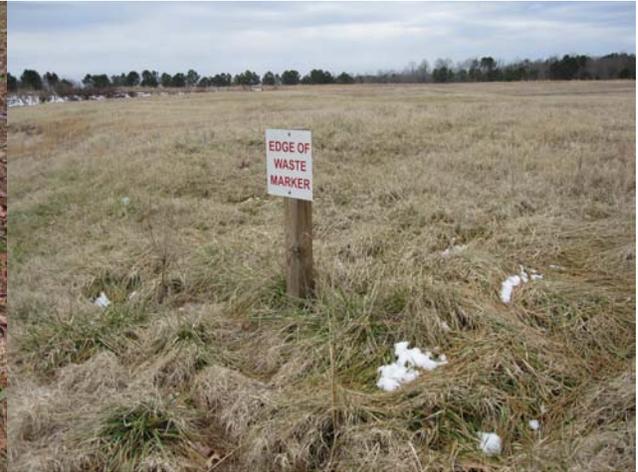
- 13) Edge of waste markers have been installed and are being maintained along the toe of the landfill sideslopes.
- 14) Most of the inert debris stored on-site has been re-used in the construction of the shooting range berm. The remaining material has been pushed up into one compact pile. \*Please process and reuse the remaining material or dispose of it in the active C&D landfill unit.

Edge of waste marker installed and maintained

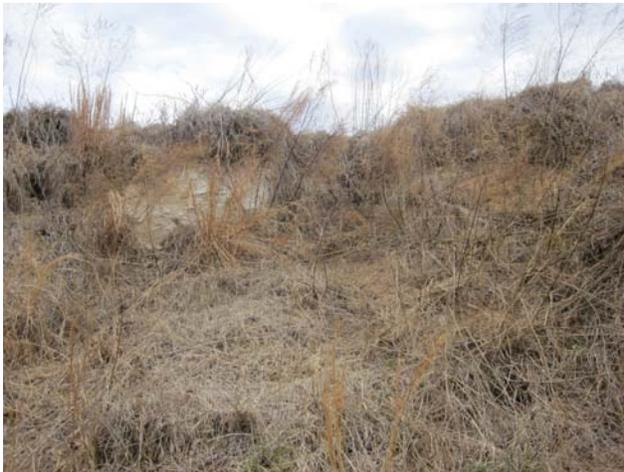
- 10) A third area of erosion was noted on the western sideslope approximately forty yards from the southwest corner of the landfill. \*To protect the integrity of your landfill cap system, please fill, grade, seed, and mulch this area to establish a groundcover suitable to prevent erosion and to promote positive, controlled drainage of all surface waters from the landfill.

Eroded area on western sideslope

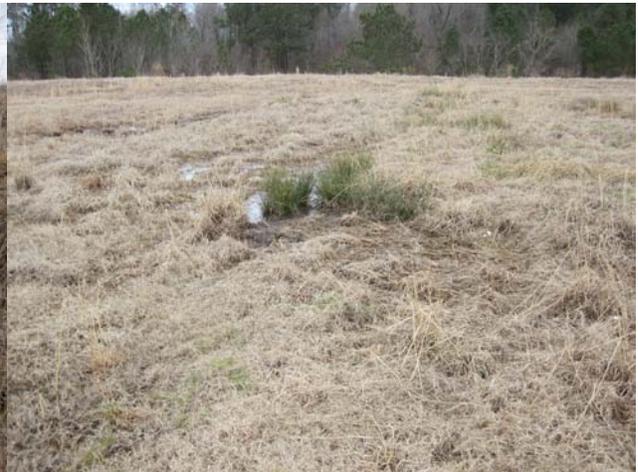
- 12) Several areas of settlement across the surface of the landfill were noted as retaining water. \*Please fill and grade these areas to ensure positive drainage of surface waters from the landfill and to ensure the integrity of the cap system.

Area of settlement, ponding water on landfill surface
