FACILITY COMPLIANCE AUDIT REPORT
Division of Waste Management
Solid Waste Section

Date of Audit: 10 June 2011

Washington County MSW Landfill
 718 Landfill Rd
 Mackeys, NC 27970

94-02, 061011
Page 2 of 3

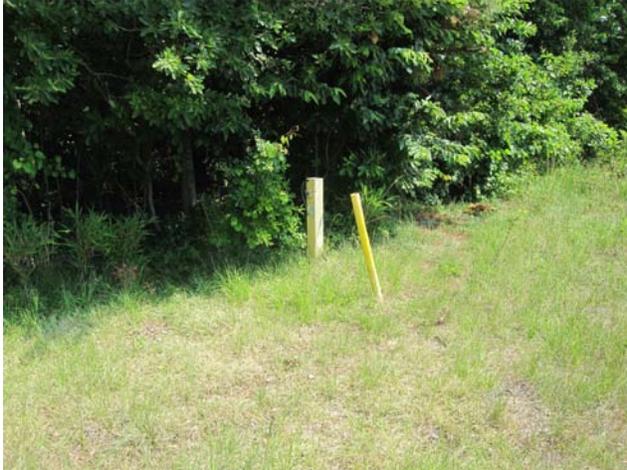
- 10) The groundwater monitoring wells were observed during this audit. All wells were readily accessible, painted with high visibility paint, properly labeled, and secured with functional locks.

Monitoring well; labeled, accessible, highly visible, secured

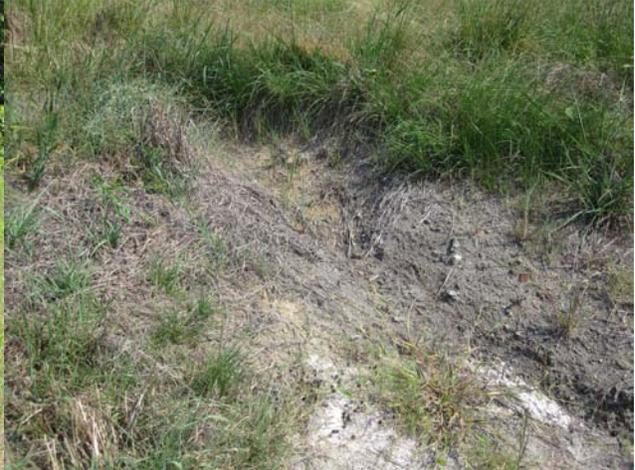
- 8) There were two areas of erosion noted on the southern sideslope. The first is approximately one third of the way down the sideslope from the southeast corner, and the second is just past the firing range berm. *To protect the integrity of your landfill cap system, please fill, grade, seed, and mulch these areas to establish a groundcover suitable to prevent erosion and to promote positive, controlled drainage of all surface waters from the landfill.

Eroded area on the southern sideslope in need of repair

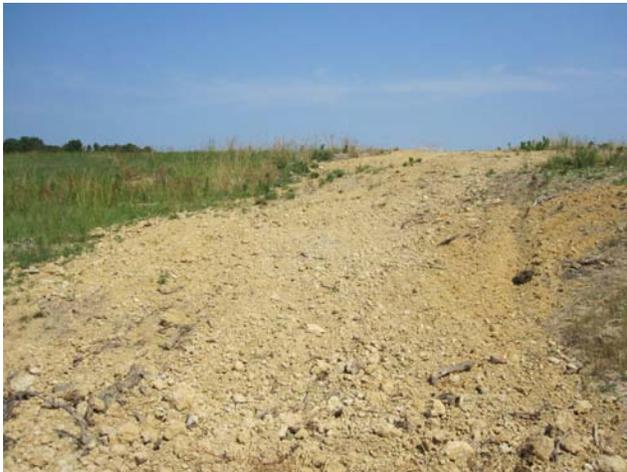
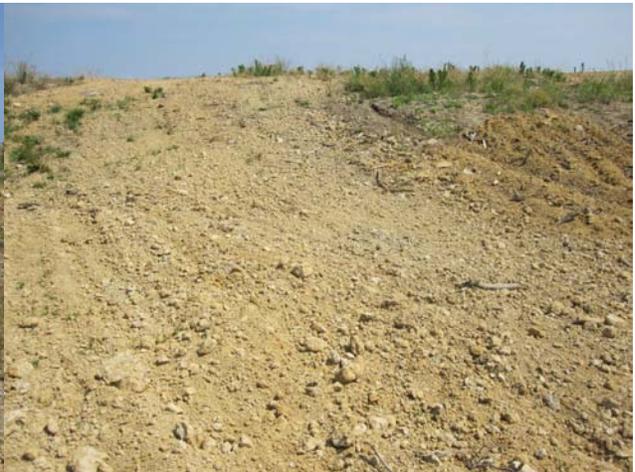
Repaired areas needing seeding and mulching

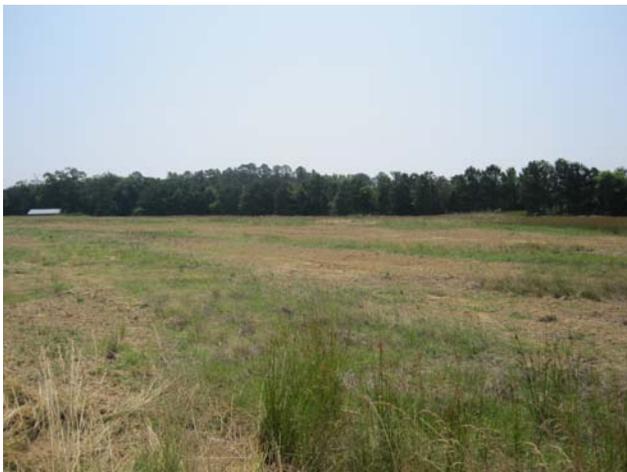
- 11) Work has begun to repair the areas of settlement noted across the surface of the landfill. *Please continue filling and grading these areas to ensure positive drainage of surface waters from the landfill and to ensure the integrity of the cap system.

Repaired settlement needing seeding and mulching

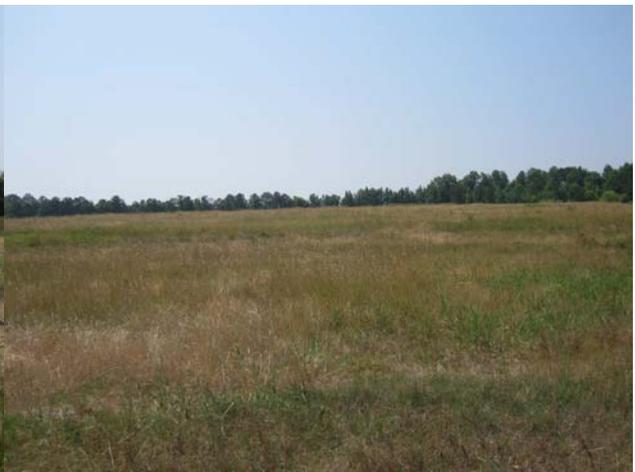
- 6) This facility is mowed quarterly. The most recent mowing event was conducted in May of 2011.
- 7) Overall, this landfill has a well established vegetative cover of native warm season grasses.

Well established cover crop of native warm season grasses
