**FACILITY COMPLIANCE AUDIT REPORT**  
**Division of Waste Management**  
**Solid Waste Section**

**Date of Audit:** 8 December 2009

Washington County C&D Landfill  
 718 Landfill Rd  
 Mackeys, NC 27970

Comprehensive

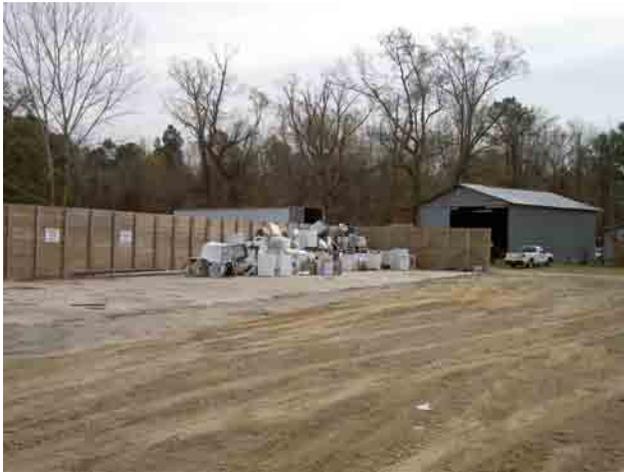
- 23) All scrap tires are being placed directly into a covered trailer for removal by direct haul.
- 24) The white goods/metal recycling area is being well managed:

- All metal containing materials collected for recycling are deposited on-site on the concrete pad and are maintained in an orderly fashion until collected by the metal salvage contractor.

White goods/metal recycling area

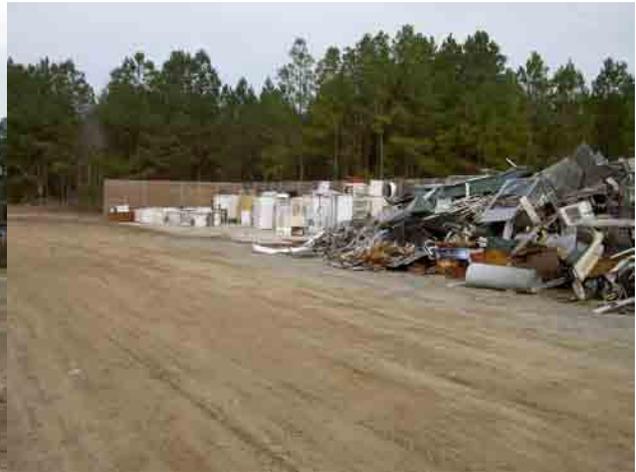
- All Freon containing white goods are placed and maintained in an upright condition and are kept separate from non-Freon containing white goods.
- 25) Digital photographs were taken during this facility audit. See photographs below.

Freon containing goods kept separate for proper management

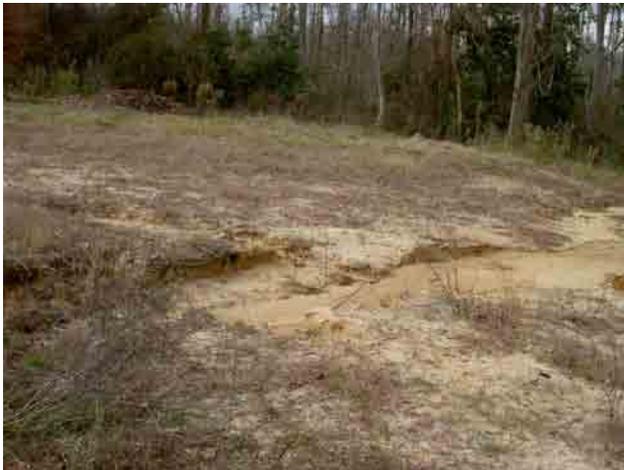
- 22) An area of erosion was noted behind the yard waste management unit. \*Corrective measures need to be taken to prevent further erosion and any sediment from leaving the site.

Erosion behind yard waste unit needing repair

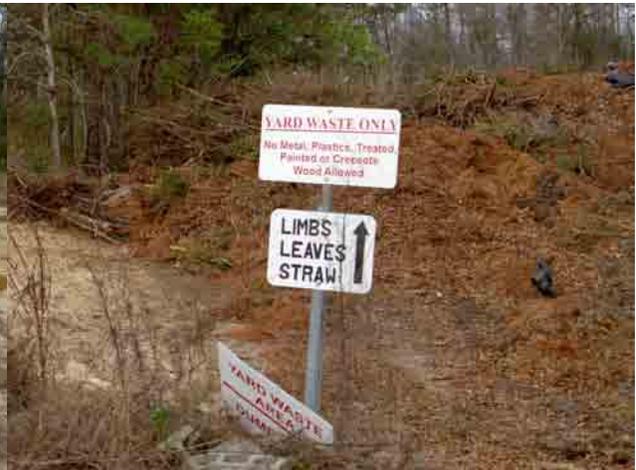
- 20) Permanent Edge of Waste Markers have been installed.
- 21) All yard waste and land-clearing debris is managed in the yard waste area. All such wastes are ground on-site and removed for use as boiler fuel.

Yard waste management unit

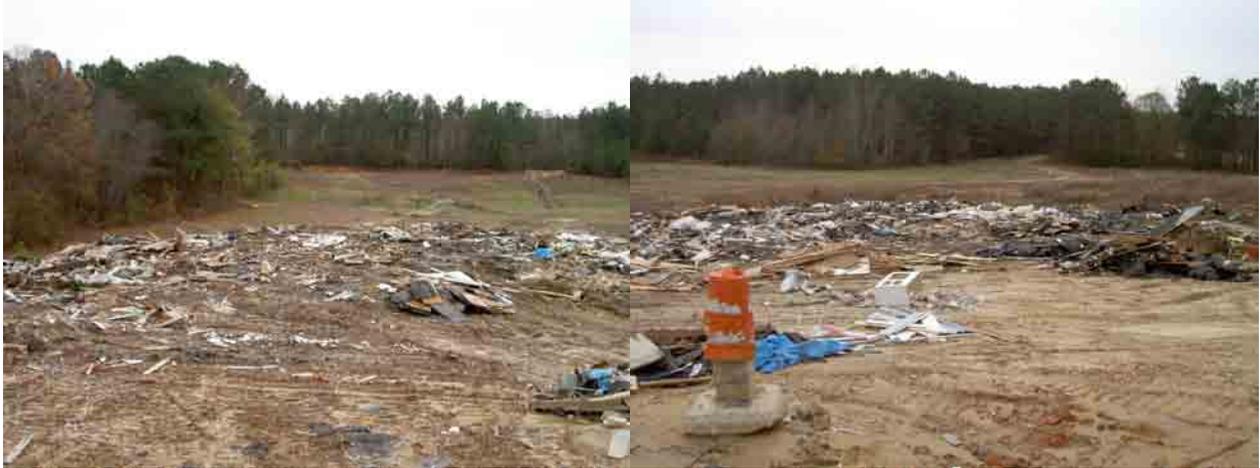
- 16) The facility was noted as having approximately ½ acre of exposed waste. \*Care should be taken to ensure that all waste is covered with a minimum of six inches of soil at least once per week or when the active disposal area reaches ½ acre in size.

Working face; needs cover when reaching ½ acre in size

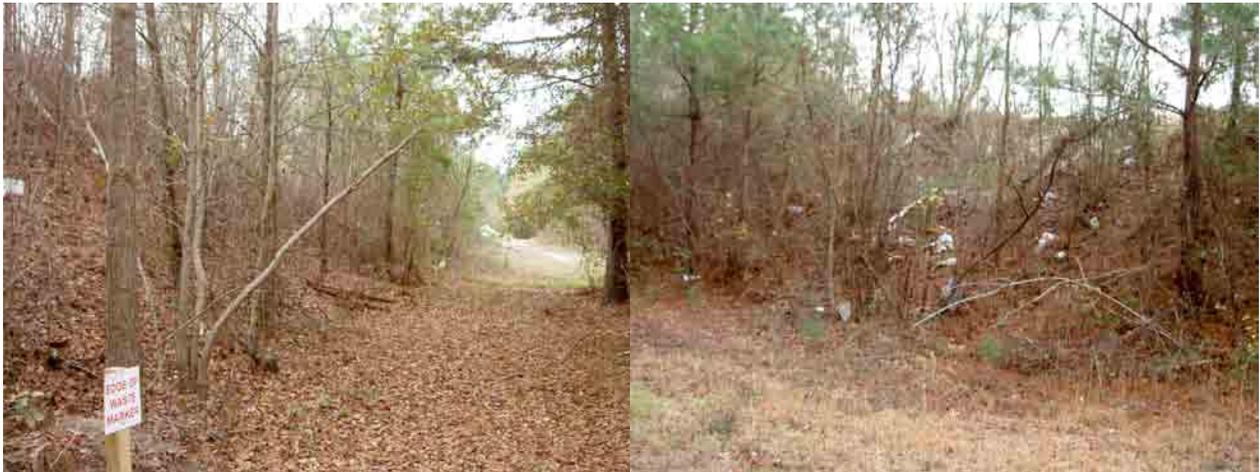
- 14) Trees and other woody vegetation were noted growing in the landfill sideslopes. \*The landfill sideslopes need to be cleared of all woody vegetation that has been allowed to grow in the cap. For proper maintenance of the facility cap, a regular maintenance schedule which includes mowing the facility on at least an annual basis needs to be established.

- 17) No unpermitted waste streams were noted in the landfill during this audit.
- 18) Wind blown debris was noted on the landfill sideslopes. \*Please ensure that all wind blown debris is collected and returned to the working face at the end of each workday.

Permanent Edge of Waste Marker

Trees and other woody growth and wind blown debris on sideslope

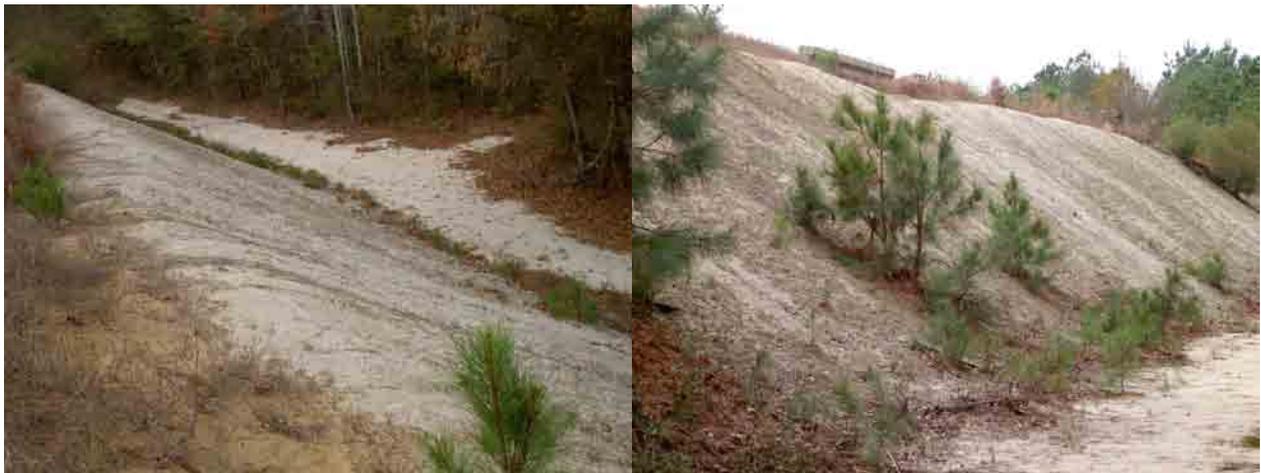
- 15) Several areas were noted on the facility sideslopes as lacking sufficient vegetative cover to effectively prevent erosion of the landfill cap system. One of these areas has already experienced significant erosion. \*Please fill and grade the eroded area and begin mulching/seeding operations to ensure the establishment of proper vegetative cover to prevent future erosion damage to your landfill cap system.

Bare areas on sideslope needing vegetative cover for effective erosion control

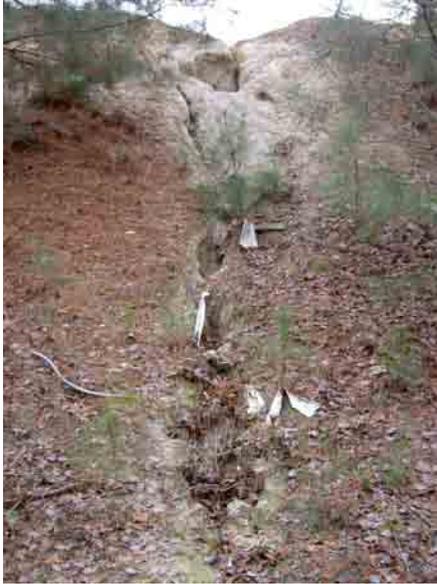
Erosion of cap system on sideslope

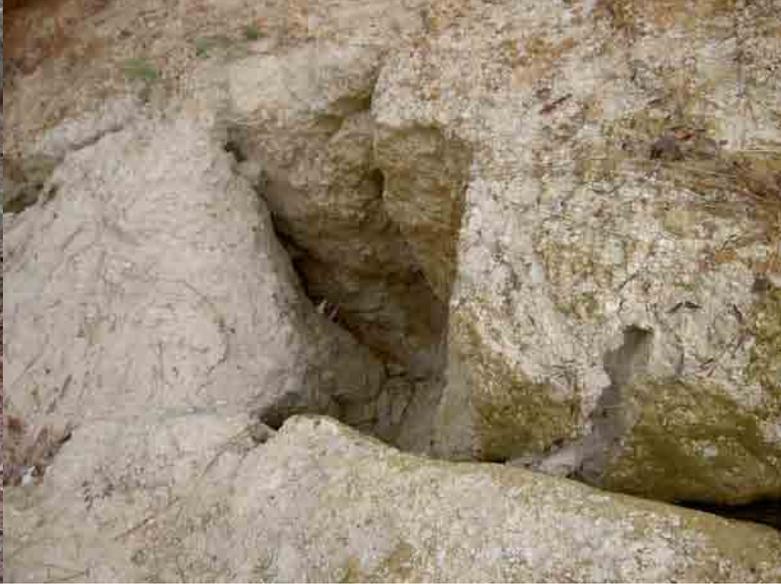
Close up of eroded area at the top of the sideslope

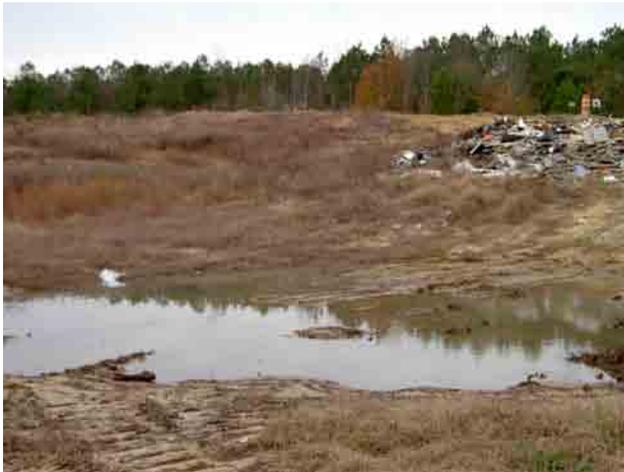
- 19) An area of standing water was noted at the toe of the landfill working face. \*Please fill and grade this area to promote positive drainage of all surface waters away from the toe of the slope and to prevent future ponding.

Ponding water at toe of slope

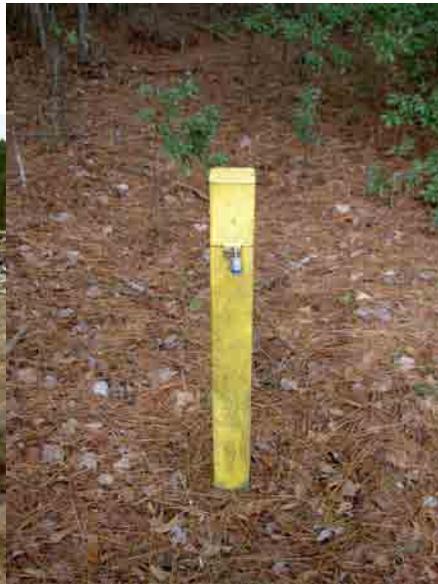
- 12) The landfill cover log is being maintained at the scalehouse and was presented for review during this audit.
- 13) The facility groundwater monitoring wells were observed during this audit. All wells were readily accessible, painted with high visibility paint, properly labeled, and secured with functional locks.

GW monitoring well highly visible and locked
