FACILITY COMPLIANCE AUDIT REPORT
Division of Waste Management
Solid Waste Section

UNIT TYPE: Structural Fill/CCB

Date of Audit: December 22, 2009

Lake Norman Airport – Lot #1
 Located on Yeager Rd off SR1494

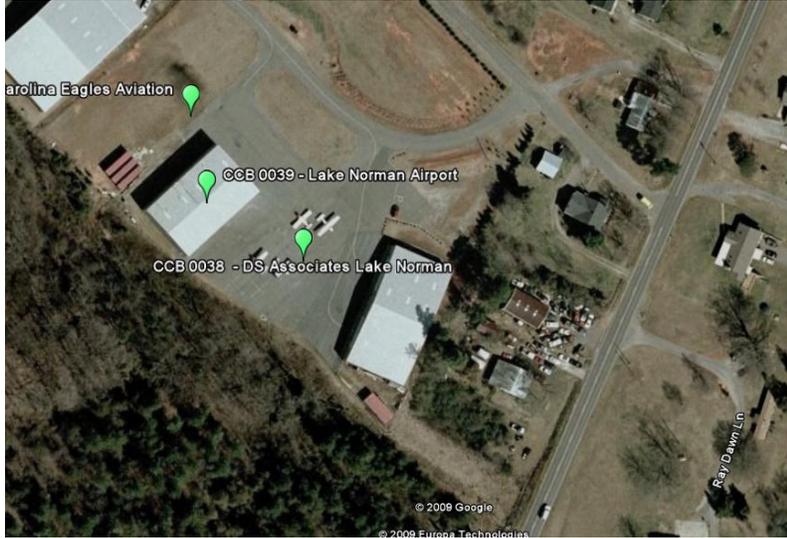
Google Earth 12/17/09

3. Current Use: Area is currently paved and used as a staging/parking area for airplanes.
4. Waste Limit Siting Requirements:
