FACILITY COMPLIANCE AUDIT REPORT
Division of Waste Management
Solid Waste Section

UNIT TYPE: Structural Fill/CCB

Date of Audit: December 22, 2009

Lake Norman Airport – Lot 2
 117 Yeager Road, Mooresville, NC

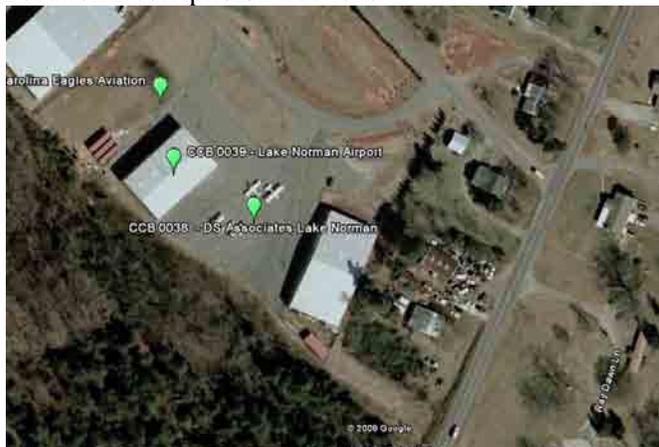
Google Earth 12/17/09

3. Current Use: Site is stabilized with a plane hangar and asphalt.
4. Waste Limit Siting Requirements:
