FACILITY COMPLIANCE AUDIT REPORT

Division of Waste Management Solid Waste Section

Basnight Building Supply
 Corner of River Rd and Hwy 301
 Weldon, North Carolina 27890

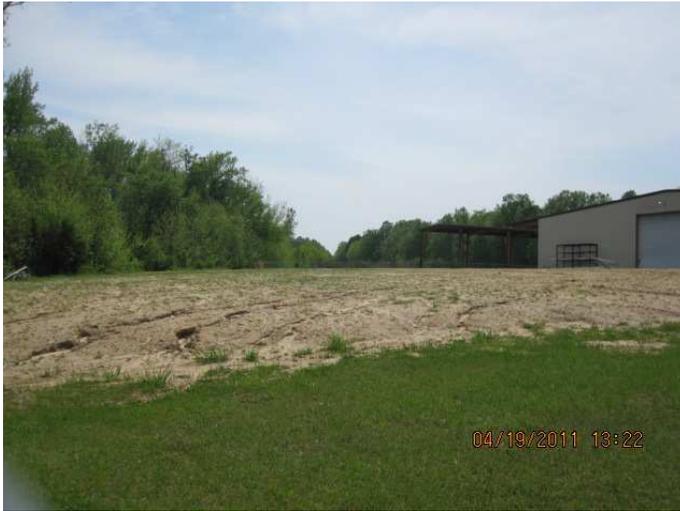
The back of the property showing cover showing slight erosion

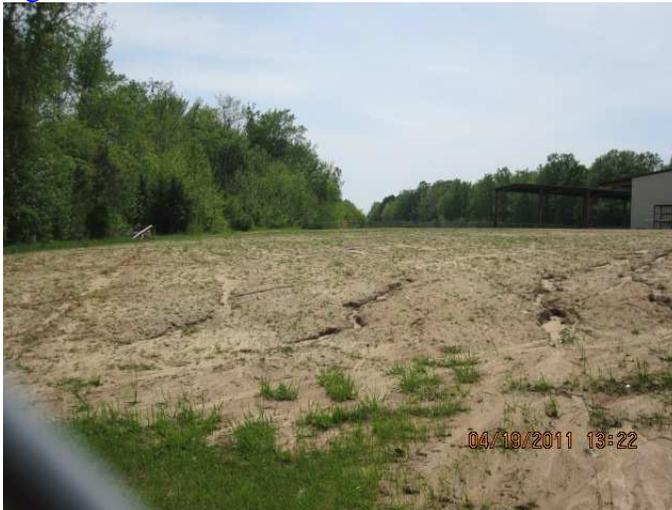
The back of the property showing cover and slight erosion

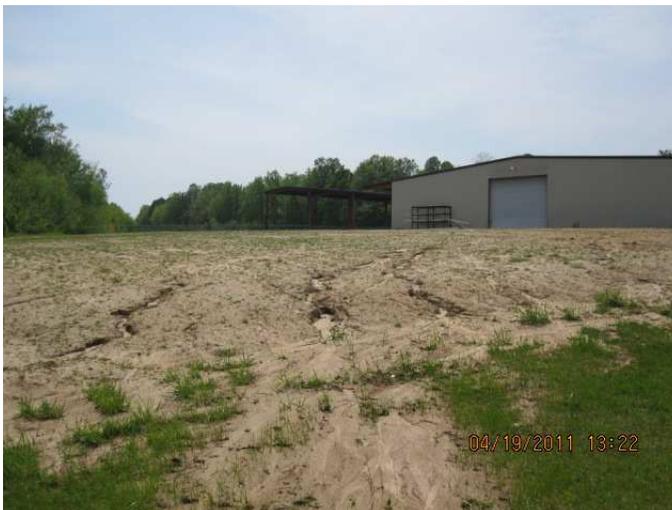
The back of the property showing cover and slight erosion

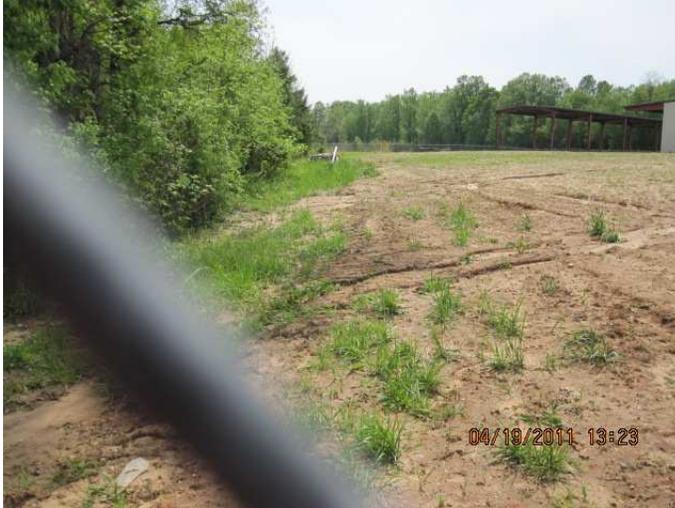
Back of the property showing cover and slight

erosion

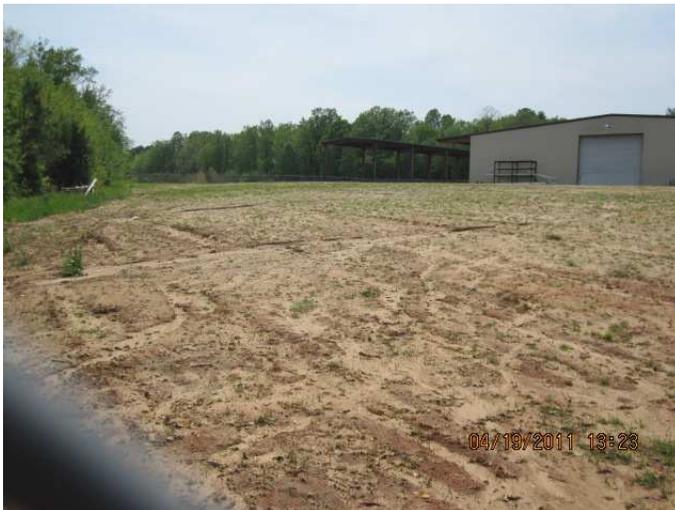
Back of the property showing cover and slight

erosion

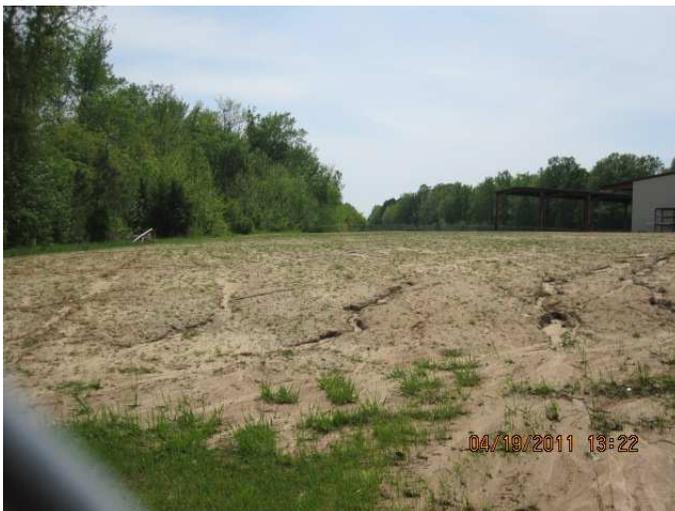
Back of the property showing cover and slight

erosion
