FACILITY COMPLIANCE AUDIT REPORT
Division of Waste Management
Solid Waste Section

Date of Audit: 27 July 2011

Wayne's Construction LCID
 Morehead City, NC 28557

N0077, 072711

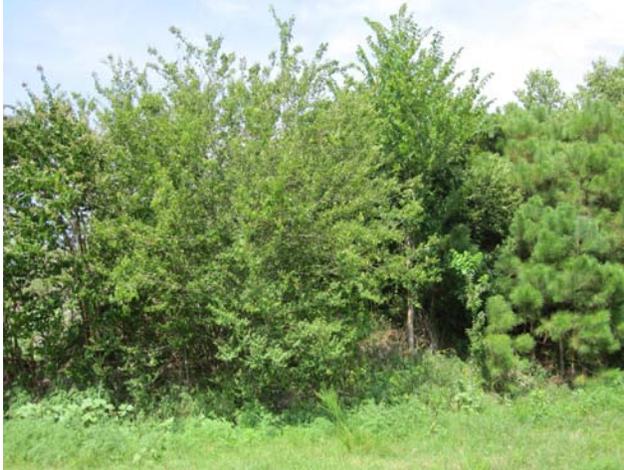
Trees and woody brush needing removal from sideslope

- 1) This facility is a Land-Clearing and Inert Debris Landfill Notification.
- 2) This facility is secured by a locked gate at the facility entrance and has controlled access for safety. The gate was locked and secured and no attendant was on-site during this audit.
- 3) Proper signage including the facility name and emergency contact number is required to be posted at the facility entrance. *Within thirty days of receipt of this report, please install proper signage at the facility entrance.
- 4) The access road to the facility is being managed properly at this time.
- 5) The landfill sideslopes have been covered with native warm season grasses and/or a natural coppice-type cover with some small trees and brush. *Please remove all trees and woody brush and mow the landfill and the access around the landfill for proper monitoring and maintenance of the landfill cap system.

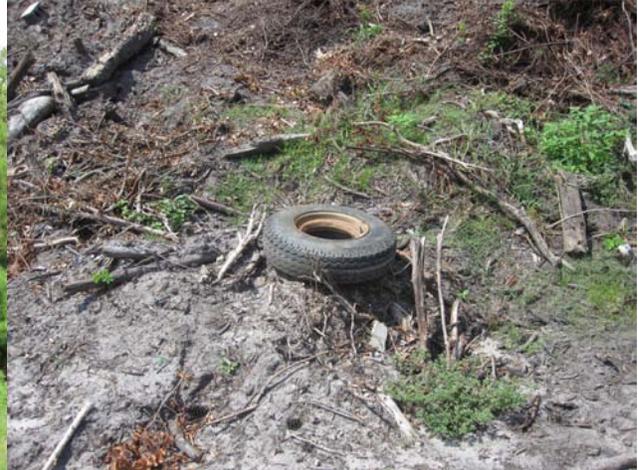
- 6) The waste type being disposed is LCID waste only; and overall no unacceptable waste streams were noted during this audit. However, one tire on a rim was noted at the working face. *Please remove and properly manage this unpermitted waste.

Unpermitted waste at the working face

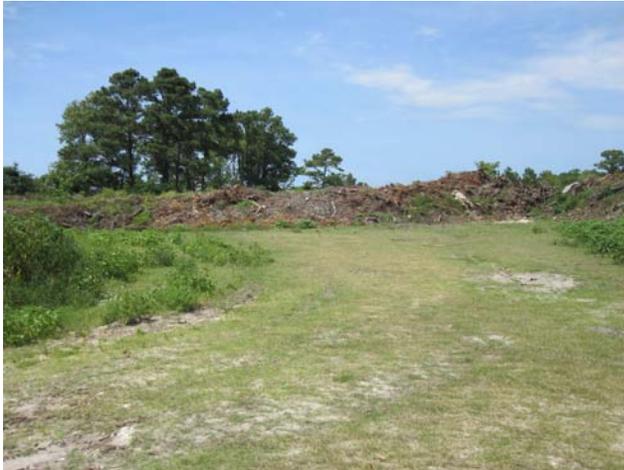
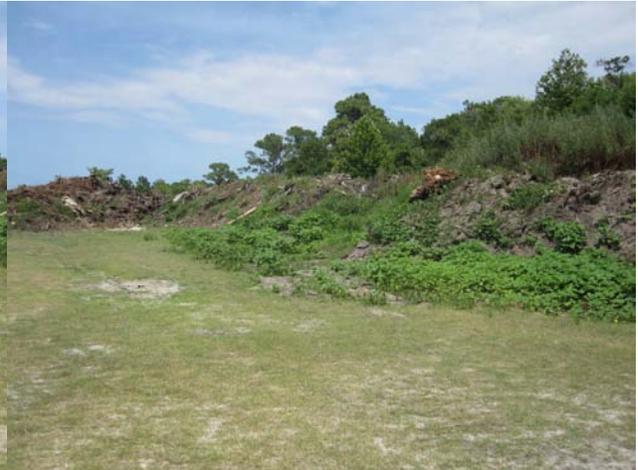
- 7) The active working face needs to be better defined. *Please ensure that one active working face is maintained and that it is covered monthly or when it reaches one acre in size, whichever occurs first.

Active working area
