**FACILITY COMPLIANCE AUDIT REPORT**  
**Division of Waste Management**  
**Solid Waste Section**

**Date of Audit:** May 12, 2011

Mayhew Dumping Service Notified LCID Landfill  
 119 Chuckwood Road  
 Mooresville, NC 28117

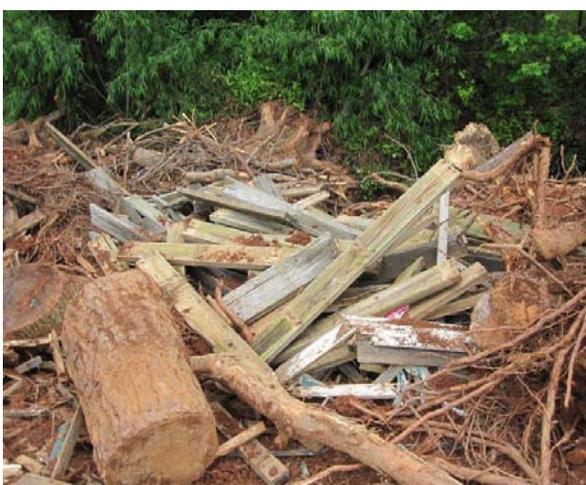
1. This audit was performed in reference to concerns expressed by Iredell County of land clearing waste being disposed of on the subject site.
2. A gate was provided at the entrance to the facility to prevent unauthorized entry.
3. **15A North Carolina Administrative Code 13B .0566(2) states: *The facility shall only accept those solid wastes which it is permitted to receive.*** During the inspection, construction and demolition waste was observed on the north and west portions of the landfill near a diversion ditch. This waste consisted of plywood, electrical wire, treated lumber, pvc pipe and painted wood which are all unacceptable for disposal at this facility.

View of treated lumber and painted wood.

**This material must be removed and disposed of at a facility permitted by the Division of Waste Management, Solid Waste Section. Once removal has been completed, copies of landfill receipts must be sent to:**

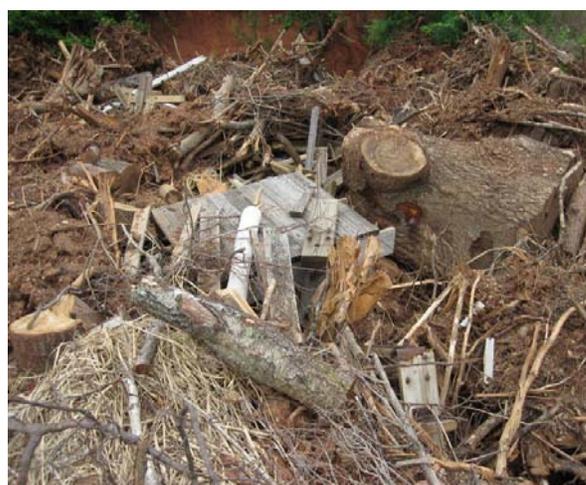
View of treated lumber and pvc pipe.
