FACILITY COMPLIANCE AUDIT REPORT
Division of Waste Management
Solid Waste Section

Date of Audit: 02/02/11

Grandfather Golf & Country Club Landfill, Newland
 Tax Parcel No. 1837 2082 7248
 Hickory Gap Road
 Newland, NC
 (Approximately 4-miles north of Newland, on the right, past Hickory Estates Lane.)

Comprehensive

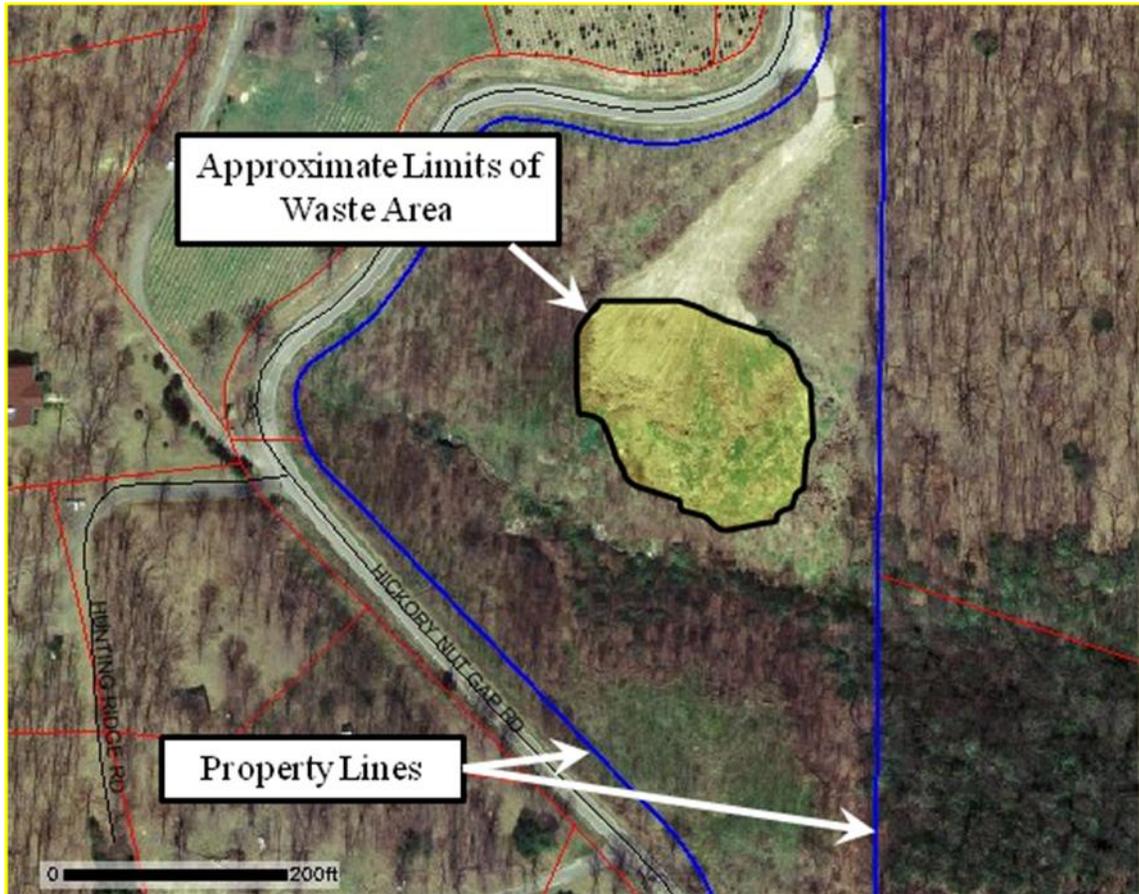
1. Site inspection was conducted to verify the location and status of the facility and to determine if facility is in compliance with the operational requirements.
2. Access to the site is properly controlled with a locked gate.
3. Based on the Avery County Geographic Information System (GIS) map of the landfill parcel, it appears that the required 100-ft. buffer from waste disposal areas to property lines is not being maintained on the eastern side of the facility. (Figure 1)

Figure 1. Avery County GIS Aerial of Tax Parcel No. 1837 2082 7248
Approximate Limits Area of Waste

4. As it is difficult to determine if 100-ft. buffer requirement is being adhered to without first knowing where the edge of waste and the property lines are located, please identify and mark the property line(s) and the waste limits.

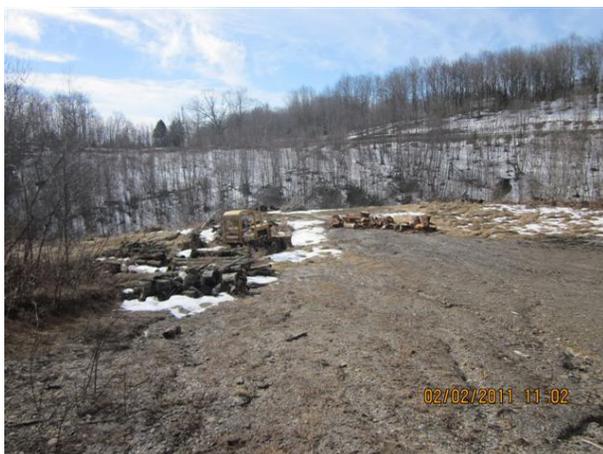
1. Looking (S) across the upper reaches of the waste area.

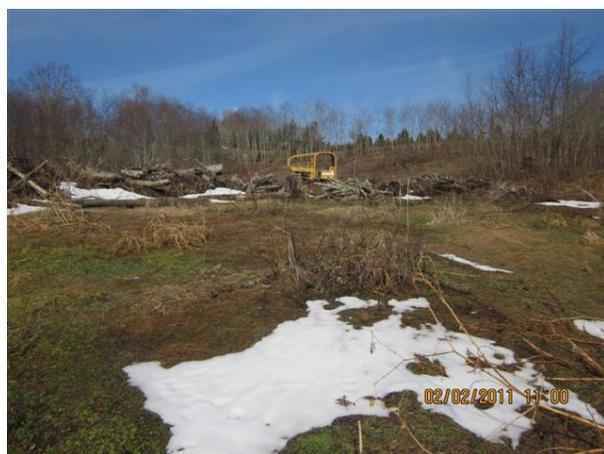
2. Looking (NW) from the eastern slope of the waste area.
