FACILITY COMPLIANCE AUDIT REPORT
Division of Waste Management
Solid Waste Section

Date of Audit: 04/25/11

Grandfather Golf & Country Club Landfill, Newland
 Tax Parcel No. 1837 2082 7248
 Hickory Gap Road
 Newland, NC
 (Approximately 4-miles north of Newland, on the right, past Hickory Estates Lane.)

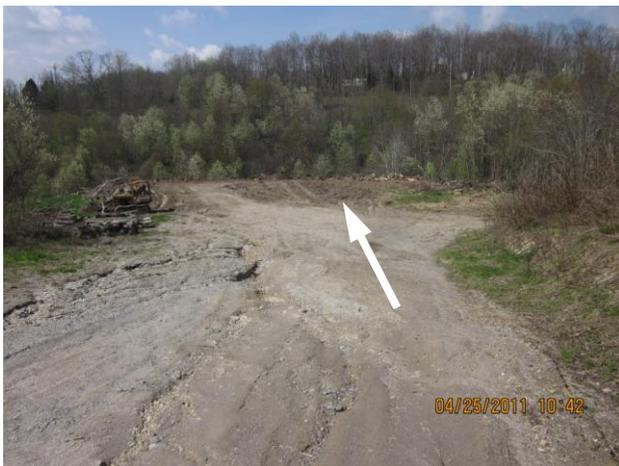
1. Follow-up site inspection to determine if facility has performed any of the actions recommended in the last audit report (2/02/11).
2. Access to the site is properly controlled with a locked gate.
3. The waste area appeared to have been recently compacted & graded. (Photo #1)
4. The northern portion of the eastern property line was “flagged” in three places. (Photos #2 - #4)
5. **Based the “flagging” of the eastern property line and the observed areas of waste, it appears that the required 100-ft. buffer from waste disposal areas to property lines is not being maintained on the eastern side of the facility.**

1. Looking (S) across the upper reaches of the waste area. Note the area that has been recently compacted & re-worked.

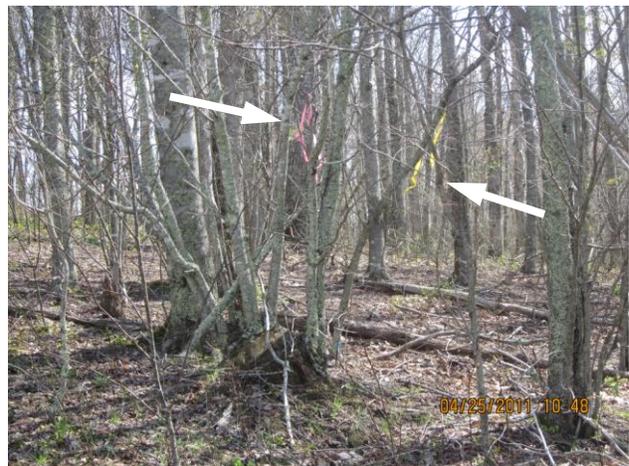
2. One of three locations of "flagging" used to mark the eastern property line.

6. As stated in the previous inspection report of 2/2/11, it is difficult to determine if 100-ft. buffer requirement is being adhered to without first knowing where the edge of waste and the property lines are located. **Within 30-days of your receipt of this report, identify and mark the entire length of the eastern property line as well as entire limits of waste.**

Any waste that is determined to be inside of the required 100-ft. buffer must be moved out of the buffer and into the permitted limits of waste.

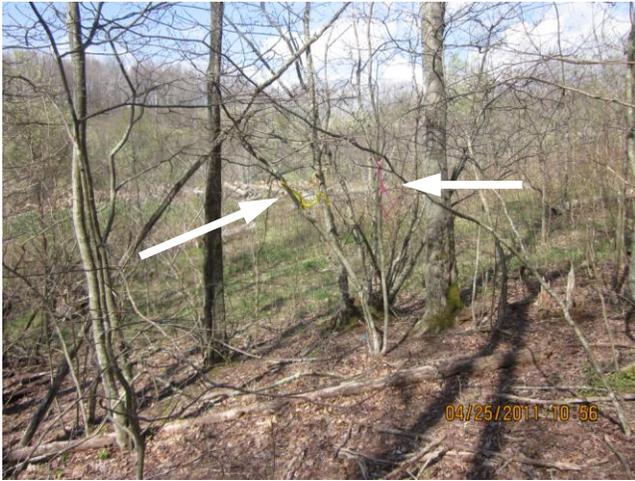
3. One of three locations of “flagging” used to mark the eastern property line.

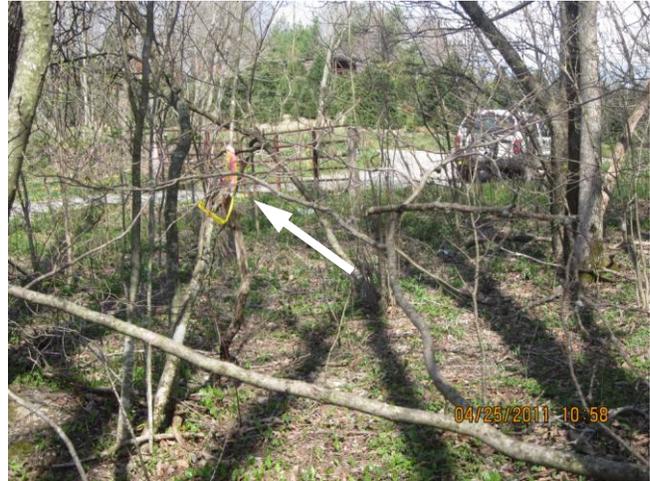
4. One of three locations of “flagging” used to mark the eastern property line.

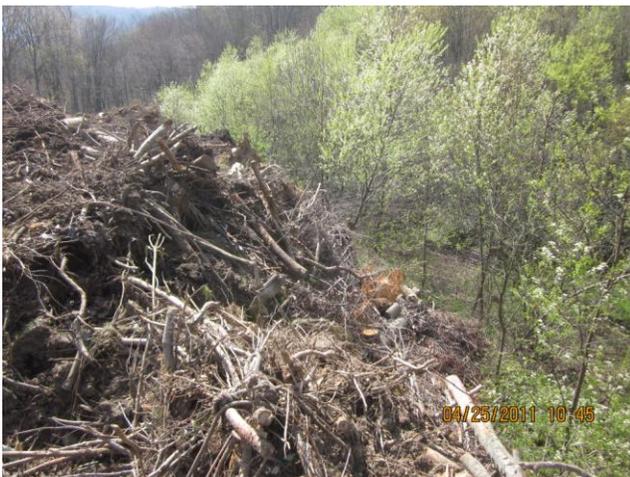
7. As stated in the previous inspection report of 2/2/11, it did not appear that adequate soil cover had been applied monthly, or when the active area reaches one acre in size, whichever comes first as required in 15A NCAC 13B .0566(4). Adequate soil cover means that the *entire landfill*, including the working face and the “headwall” shall be covered. (Photos #5 - #8)

Of particular concern is the “headwall” on the southern edge of the fill area. The “headwall” is approximately 12 to 16-feet high and, in places, it is almost vertical. Within 30-days of your receipt of this report, please ensure that all waste, including the “headwall” receives adequate soil cover. (Photos #5 & #6)

5. Looking (E) across the top of the headwall.

It is recommended that the “headwall” be re-sloped to ensure that the required soil cover can be safely applied such that it will remain in place and provide a stable foundation for the required vegetative ground cover.

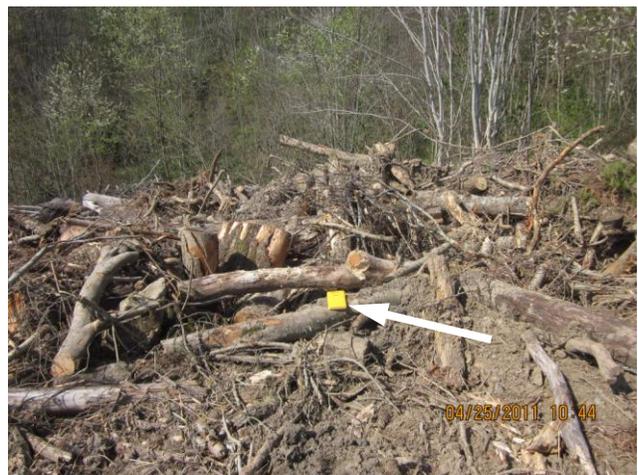
6. Looking (S) at the top edge of the “headwall”. Note the yellow field book (7 ½” X 4 5/8”) for scale.

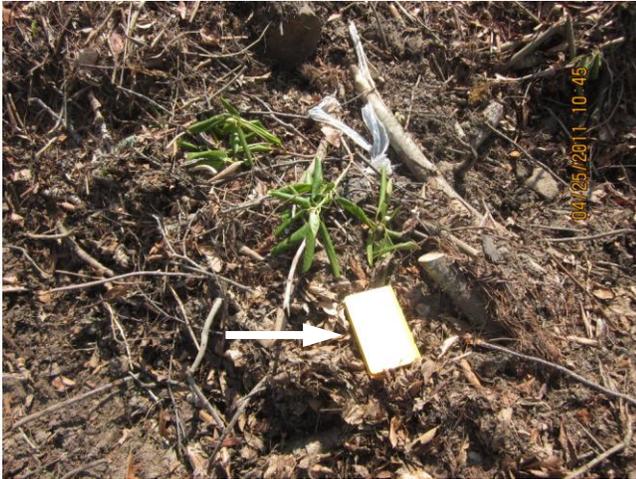
7. Waste near the “headwall” that needs to be covered with soil. Note the yellow field book (7 ½” X 4 5/8”) for scale.

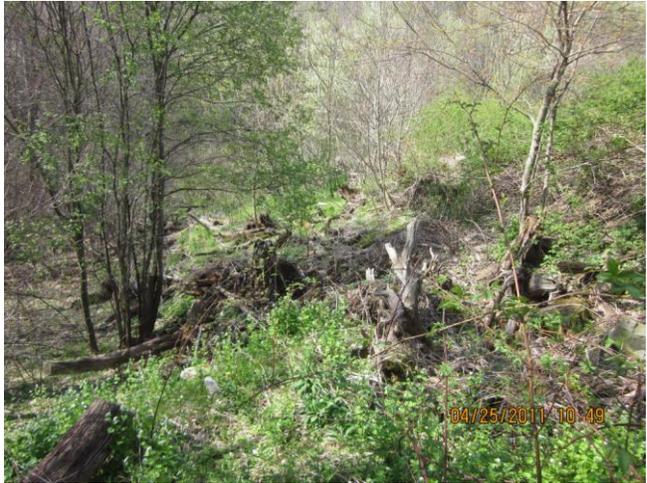
8. Stumps, limbs, and other waste on the eastern edge of the facility that needs to be covered with soil.
