FACILITY COMPLIANCE INSPECTION REPORT
Division of Waste Management
Solid Waste Section

Date of Site Inspection: December 14, 2011 **Date of Last Inspection:** October 17, 2011

Murray LCID Landfill
 5352 Friendship Rock Creek Road
 Snow Camp, NC 27349

Comprehensive Audit (to ensure that the notified land clearing and inert debris (LCID) landfill is in compliance with 15A North Carolina Administrative Code (NCAC) 13B .0563, .0564, and .0566)

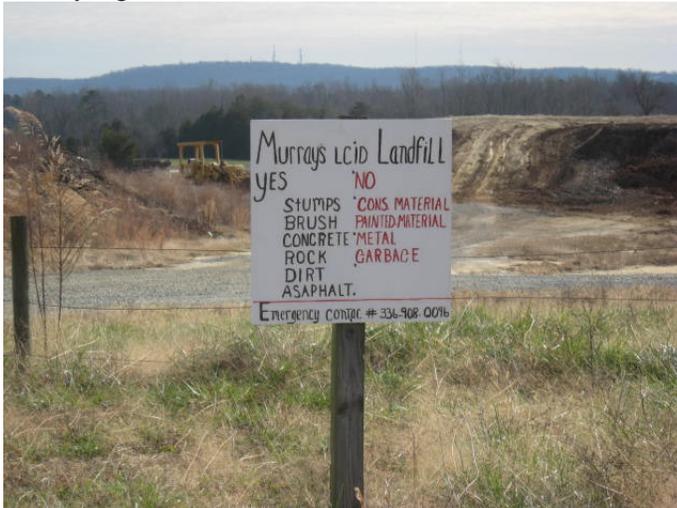
13. The facility has proper signage.

Facility sign

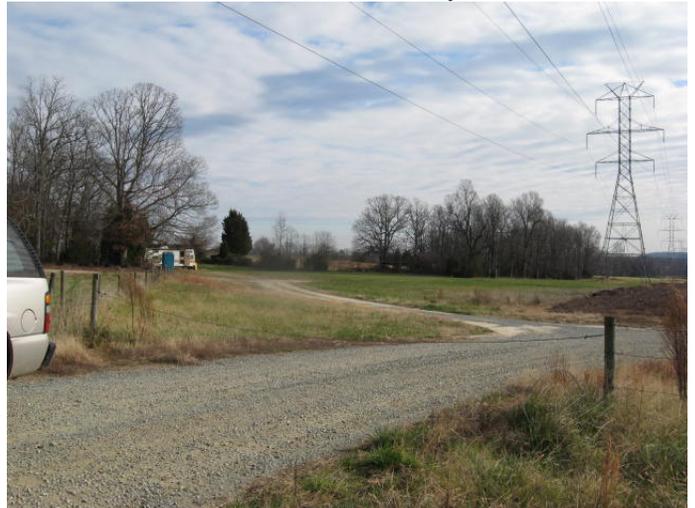
10. Sow grass seed on areas of the landfill no longer in operation.
11. Access roads are of all-weather construction.
12. The facility is secured by a steel cable.

Entrance to LCID landfill, secured by steel cable

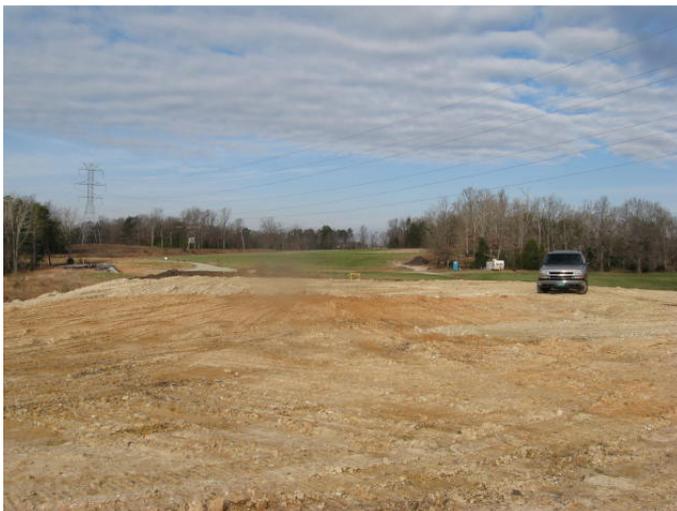
Adequate soil cover atop landfill area

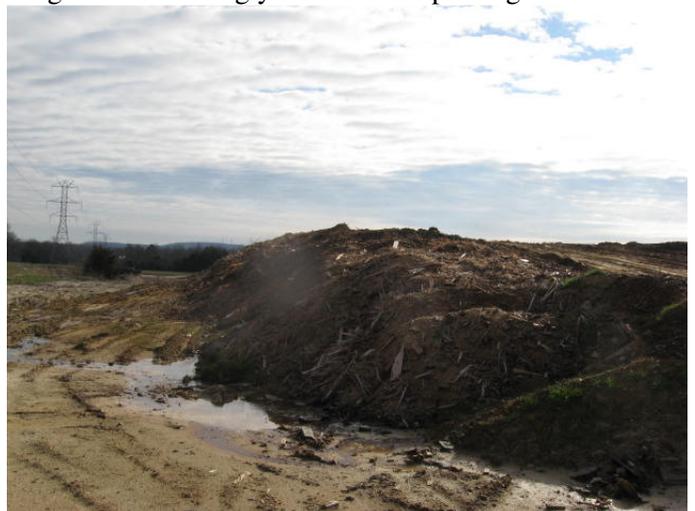
2. The LCID landfill is estimated to be < 1.5 acres.
3. Per 15A NCAC 13B .0566(4), "Adequate soil cover shall be applied monthly, or when the active area reaches one acre in size, whichever occurs first." The landfill side slopes need additional soil cover such that material does not protrude. The landfill contained adequate soil cover atop the fill area.

8. There was no indication of erosion.
9. An area of pooled water was observed on the left side of the landfill at the toe of the side slope, near the access road to the top of the fill area. Repair accordingly.

Area of side slope in need of soil cover, ensure it is graded accordingly to remediate pooling water

7. Side slopes should be graded and covered with soil such that a 3:1 slope ratio is obtained or a ratio of which no indication of erosion or runoff is observed.
