**FACILITY COMPLIANCE INSPECTION REPORT**  
**Division of Waste Management**  
**Solid Waste Section**

**Date of Site Inspection:** 14 May 2012

Beaufort County Closed MSW Landfill  
 1342 Hawkins Beach Road  
 Bath, NC 27808

0702-20120514INSP

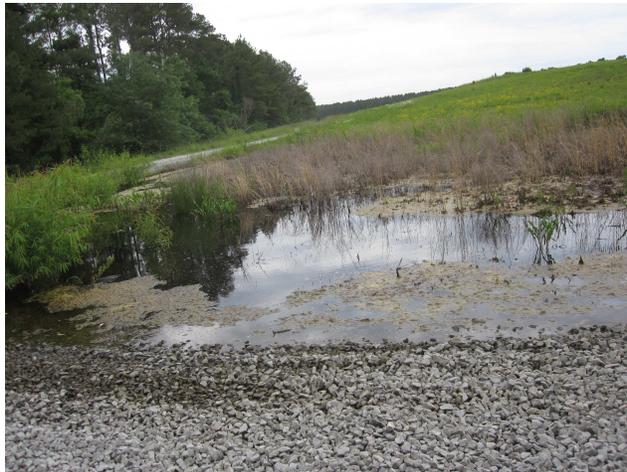
- 13) Water was noted as ponding at the toe of the landfill adjacent to the access road at the sharp bend of the northeast corner of the landfill. \*Within thirty days of receipt of this report, actions should be taken to promote the positive drainage of all surface waters away from the surface of the landfill and to prevent the ponding of water at the toe of all landfill sideslopes.

Ponding water at toe of landfill sideslope

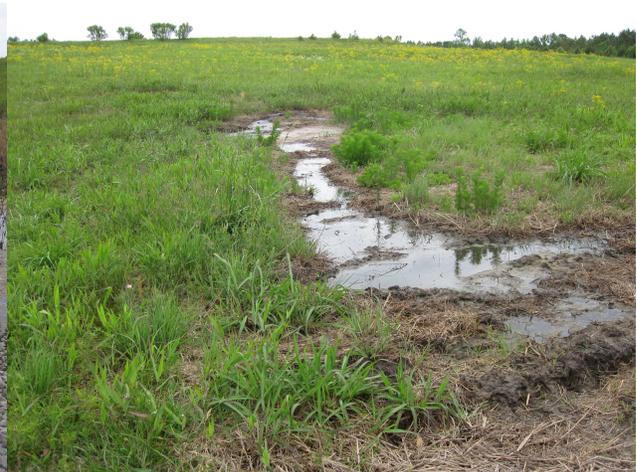
- grade, seed, and mulch these areas to establish a groundcover suitable to prevent erosion.
- 10) Leachate was noted as seeping in four areas on the northern sideslope of the upper lift approximately halfway up the lift in the center of the sideslope. No leachate was noted as leaving the disposal boundary. \*Within thirty days of receipt of this report, repair the landfill cap in the areas along the northern sideslope to prevent the further release of leachate from the landfill. All repaired areas should be graded at a slope not greater than 3:1, seeded, and mulched to establish a groundcover suitable to prevent erosion of the landfill cap system.

Leachate seeping from landfill sideslope
