FACILITY COMPLIANCE INSPECTION REPORT
Division of Waste Management
Solid Waste Section

Date of Site Inspection: 2 July 2012

Carteret County Closed MSW Landfill
 Landfill Road
 Newport, NC

1602-20120702INSP

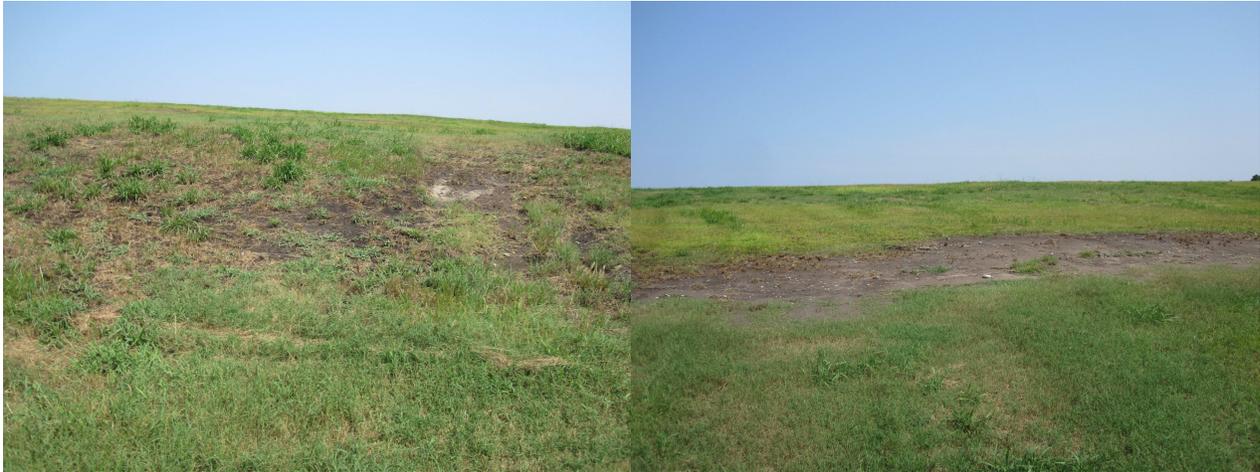
- 10) Areas of erosion were noted on the upper lift of the eastern landfill sideslope. *Please work to repair these eroded areas by grading, seeding, and mulching as necessary to establish a groundcover suitable to prevent erosion of your landfill cap

Eroded areas on the eastern sideslope in need of repair

system. All repaired areas should be graded at a slope not greater than 3:1.
