Re: LF Condensate Spill at the City of Durham Closed MSW Sanitary Landfill
Attn: Ervin Lane
Compliance Hydrogeologist
NC Department of Environment and Natural Resources
Division of Waste Management - Solid Waste Section
1646 Mail Service Center
Raleigh, NC 27699-1646
919-707-8288 (phone/fax)

Date: April 13, 2012

City of Durham Landfill

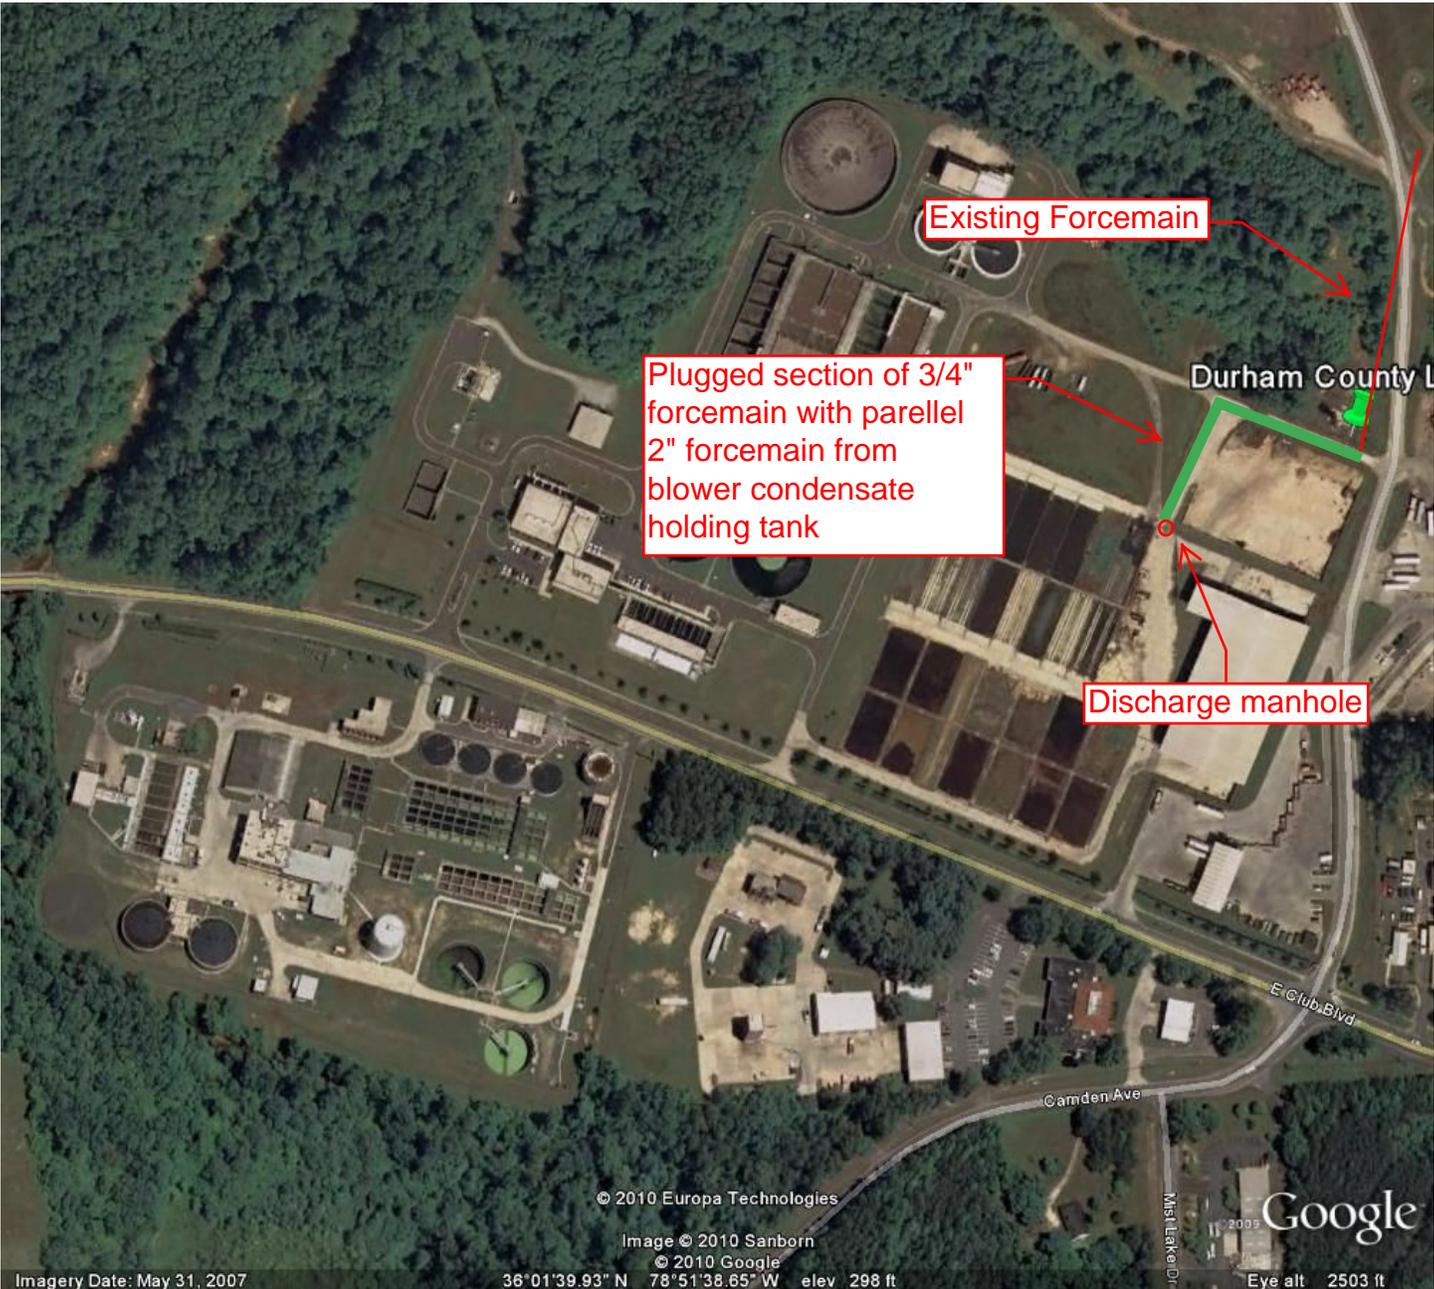
Existing Forcemain

Plugged section of 3/4" forcemain with pallel 2" forcemain from blower condensate holding tank

Discharge manhole

The attached figures show the location of the spill relative to the landfill, the temporary line and the section of pipe that was believed to be plugged. No root cause has been determined for the plugging of the original line. The City is going to abandon the old line in place and rely on the new line. A second report will follow shortly describing the reroute and the commissioning of the new stretch of line. Golder Associates are currently under contract to perform soil sampling and assessment services at the site of the spill.
