FACILITY COMPLIANCE INSPECTION REPORT
Division of Waste Management
Solid Waste Section

Date of Site Inspection: April 25, 2012

Town of Kernersville-Landfill
 7385 Freeman Road
 Kernersville, North Carolina 27284

Post Closure Inspection

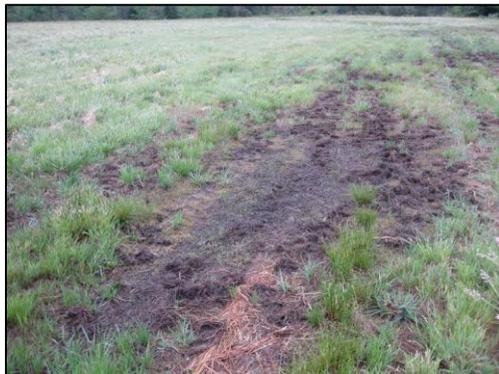
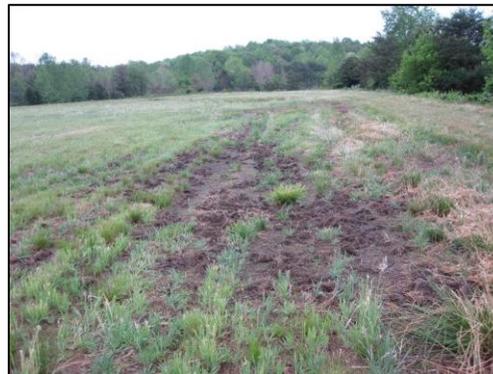
5. Large areas of bare vegetation were observed on the south side of the highest lift. This could be an indication of water ponding in these areas during rain events. These bare areas should be stabilized with a permanent groundcover and monitored to ensure that vegetation remains established.

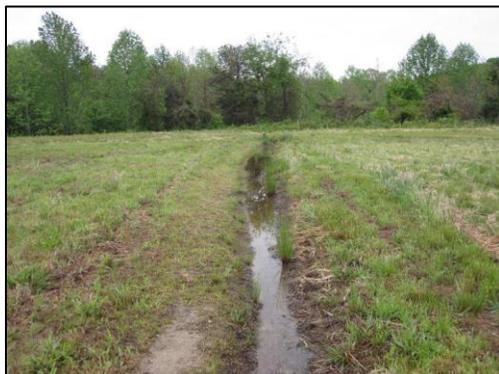
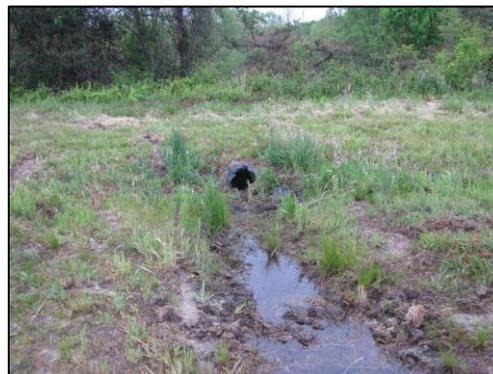
6. A large area of dead vegetation and standing water was observed at the southeast corner of the landfill within a swale leading to a slope drain. It appeared that water was no longer entering the pipe allowing water to pond within the swale. This area should be repaired and stabilized with a permanent groundcover. Please ensure that positive drainage is established to the pipe.

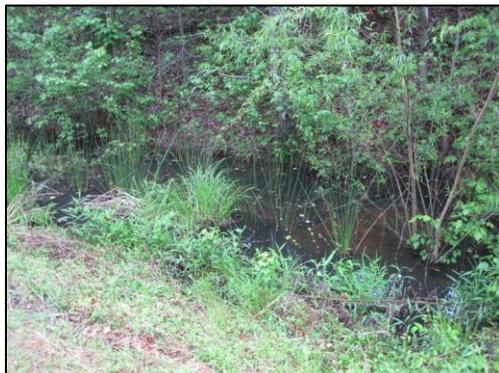
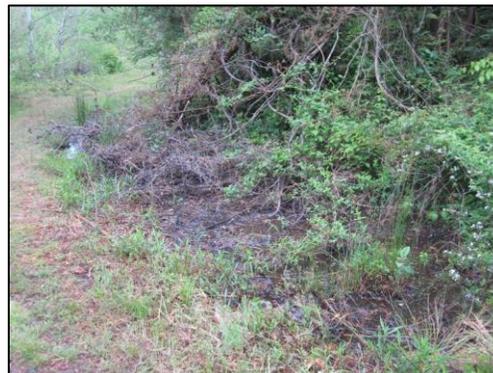
7. Severe ponding was observed within the ditchline located along the east and south sides of the landfill. Action must be taken to prevent future ponding.

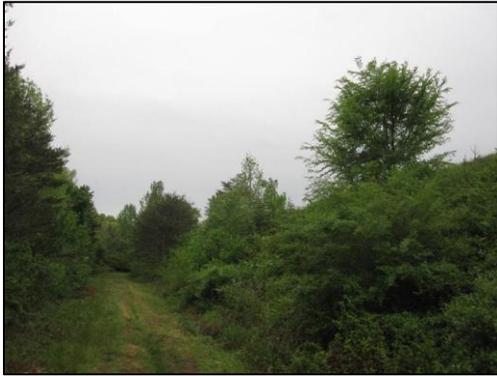
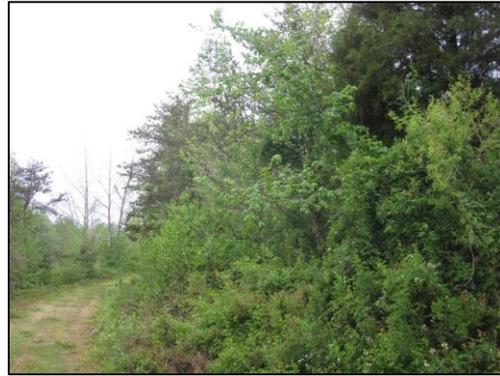
- 9. The slopes of the landfill could not be thoroughly inspected due to the establishment of dense trees and brush. This condition can lead to a significant risk of the landfill cap becoming compromised by up-rooted trees and plants, resulting in increased water filtration. The presence of trees, woody plants and other excessive vegetation can also limit, if not prevent, the inspection of the landfill for possible problems such as leachate seeps, generation of landfill gases, erosion of the cap and movement of sediment off the site.

Therefore, it is recommended that the Town of Kernersville develop a Corrective Action Plan to address the trees and woody vegetation on the landfill. This plan should include a schedule and plan for removal of brush and woody undergrowth, removal of dead and diseased trees, removal of remaining trees, stump removal and subsequent localized reconstruction of the cap, re-vegetation in compliance with applicable Rule(s), periodic visual inspection of the landfill cap, maintenance and mowing and investigation and documentation of any damage to the cap. The landfill will be reevaluated in the fall or winter of 2012 by which time a plan may become mandatory.
