February 7, 1994

Re: Response of DEHNR Comments
Halifax County Ash Monofill
Construction Record Documentation Report
H&S No. 3716

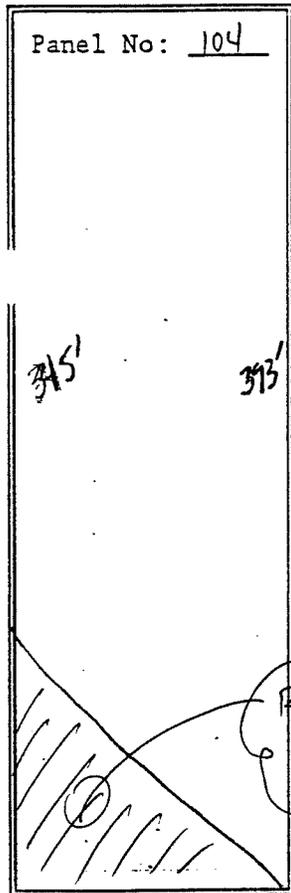
PROJECT NAME HALIFAX ASH MONOFILL PANEL NO. 104
 PROJECT NO. 3716 GEOMEMBRANE TYPE HDPE
 CONTRACTOR BARNHILL CONTRACTING INSTALLER ENVIRONMENTAL DESIGN
 DATE PLACED 11-23-93 SUBGRADE CONDITION OK
 WEATHER CONDITIONS SUNNY ; 70°
 DEPLOYMENT METHOD PULLED WITH LOADER

1. Darker copies of reports for panels 87, 88, 92, 94, 97, 98, 100-106, 111, 126-128, 130, and 134 are attached.
2. For Panels 104-111, cross hatched areas indicate where adjacent panels subsequently overlapped the panel in question.
3. Panels 112 and 115 represent areas indicated as questionable by the technician when the panel was first deployed. Later review by the Resident Engineer indicated that no repair was necessary. The questionable areas were crossed out and noted with "OK SAS" by the Resident Engineer on the Panel forms.
4. Geomembrane seaming equipment was monitored for set and actual temperatures during prewelds and prior to seaming each seam. Major fluctuations in actual temperature were recorded during seaming if observed.

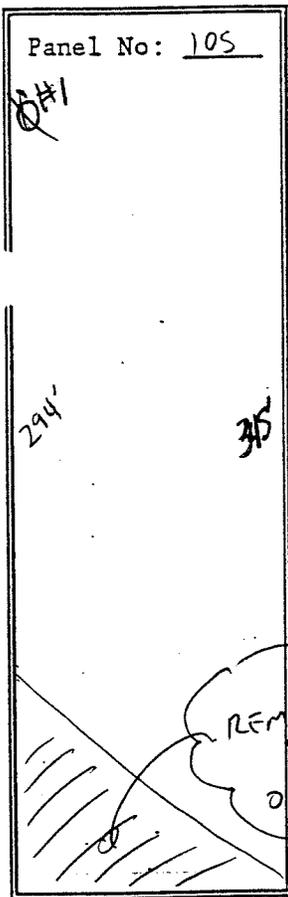
PROJECT NAME HALIFAX ASH MONOFILL PANEL NO. 105
 PROJECT NO. 3716 GEOMEMBRANE TYPE HDPE
 CONTRACTOR BARNHILL CONTRACTING INSTALLER ENVIRONMENTAL DESIGN
 DATE PLACED 11-23-93 SUBGRADE CONDITION OK
 WEATHER CONDITIONS SUNNY 70°
 DEPLOYMENT METHOD PULLED WITH LOADER

DATE	DEFECT	DEFECT DESCRIPTION	REPAIR DATE	REPAIR TYPE	APPROVED BY
11-24-93	1	CREASE	11-30-93 (P)	PATCH	SAS

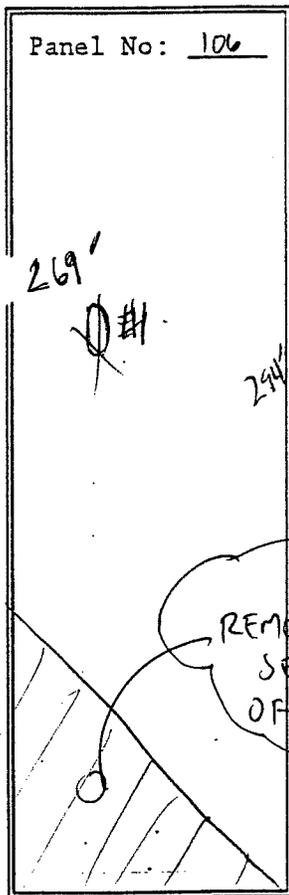
PROJECT NAME HALIFAX ASH MONOFILL PANEL NO. 106
 PROJECT NO. 3716 GEOMEMBRANE TYPE HDPE
 CONTRACTOR BARNHILL CONTRACTING INSTALLER ENVIRONMENTAL DESIGN
 DATE PLACED 11-23-93 SUBGRADE CONDITION OK
 WEATHER CONDITIONS SUNNY ; 70°
 DEPLOYMENT METHOD PULLED WITH LOADER

DATE	DEFECT	DEFECT DESCRIPTION	REPAIR DATE	REPAIR TYPE	APPROVED BY
11-23-93	# 1	CREASE	11-30-93 (PS)	PATCH	SAS

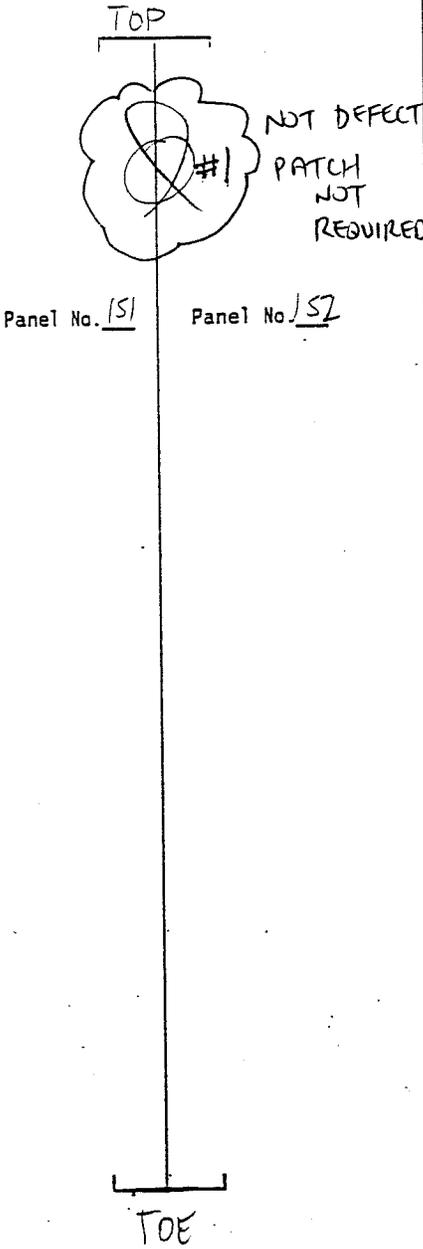
SEAM NO. 151-152
 SEAM LENGTH 39'
 COMMENTS BURN THRU
 WELDING UNIT NO. 327
 TIME WELDED 5:00 a.m. p.m.

1. Seams 7-8, 9-8, 15-14, 18-19, 48-49, 51-52, 64-63, 142-143, 151-152 represents questionable areas marked by the technician when the seam was being welded. Later review by the Resident Engineer indicated that a repair was not needed. This has been clarified on revised Seam Inspection Forms, which are attached.

REPAIR NO.	DEFECT TYPE	DATE/NOT TYPE	APPROVED BY
#1	BURN THRU		SX

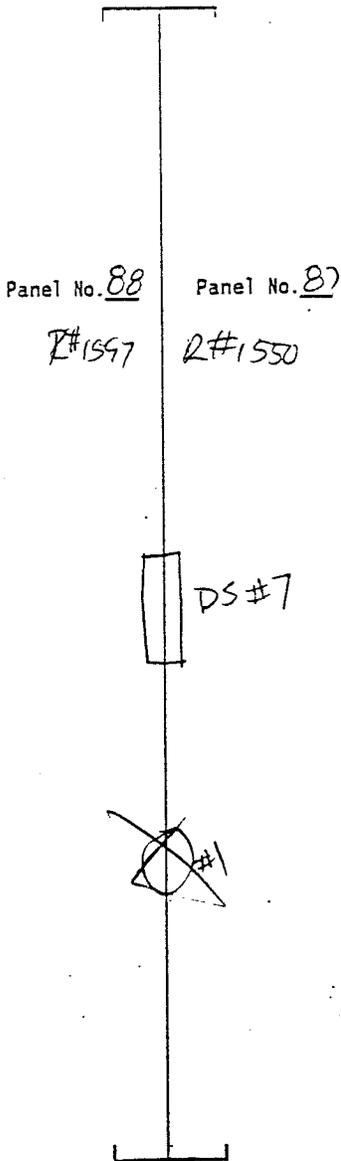
SEAM NO. 87-88
 SEAM LENGTH 389
 COMMENTS REPAIR
 WELDING UNIT NO. 851
 TIME WELDED 10:45 (a.m./p.m.)

REPAIR NO.	DEFECT TYPE	DATE/NOT TYPE	APPROVED BY
#1	CUTOUT IN TRUCK	11-29 (PJ)	SAS
DS #7		11-25 (PJ)	CAJ
