**BLUE RIDGE PAPER PRODUCTS, INC.
CANTON, NORTH CAROLINA**

**CONSTRUCTION DOCUMENTATION
FOR LANDFILL NO. 6
CELL 6A-EAST CLOSURE**

OCTOBER 2003

- STATEMENT OF COMPLIANCE
- QA/QC MATERIAL TEST RESULTS
- DAILY CONSTRUCTION REPORTS
- SITE PHOTOGRAPHS
- RECORD DRAWINGS

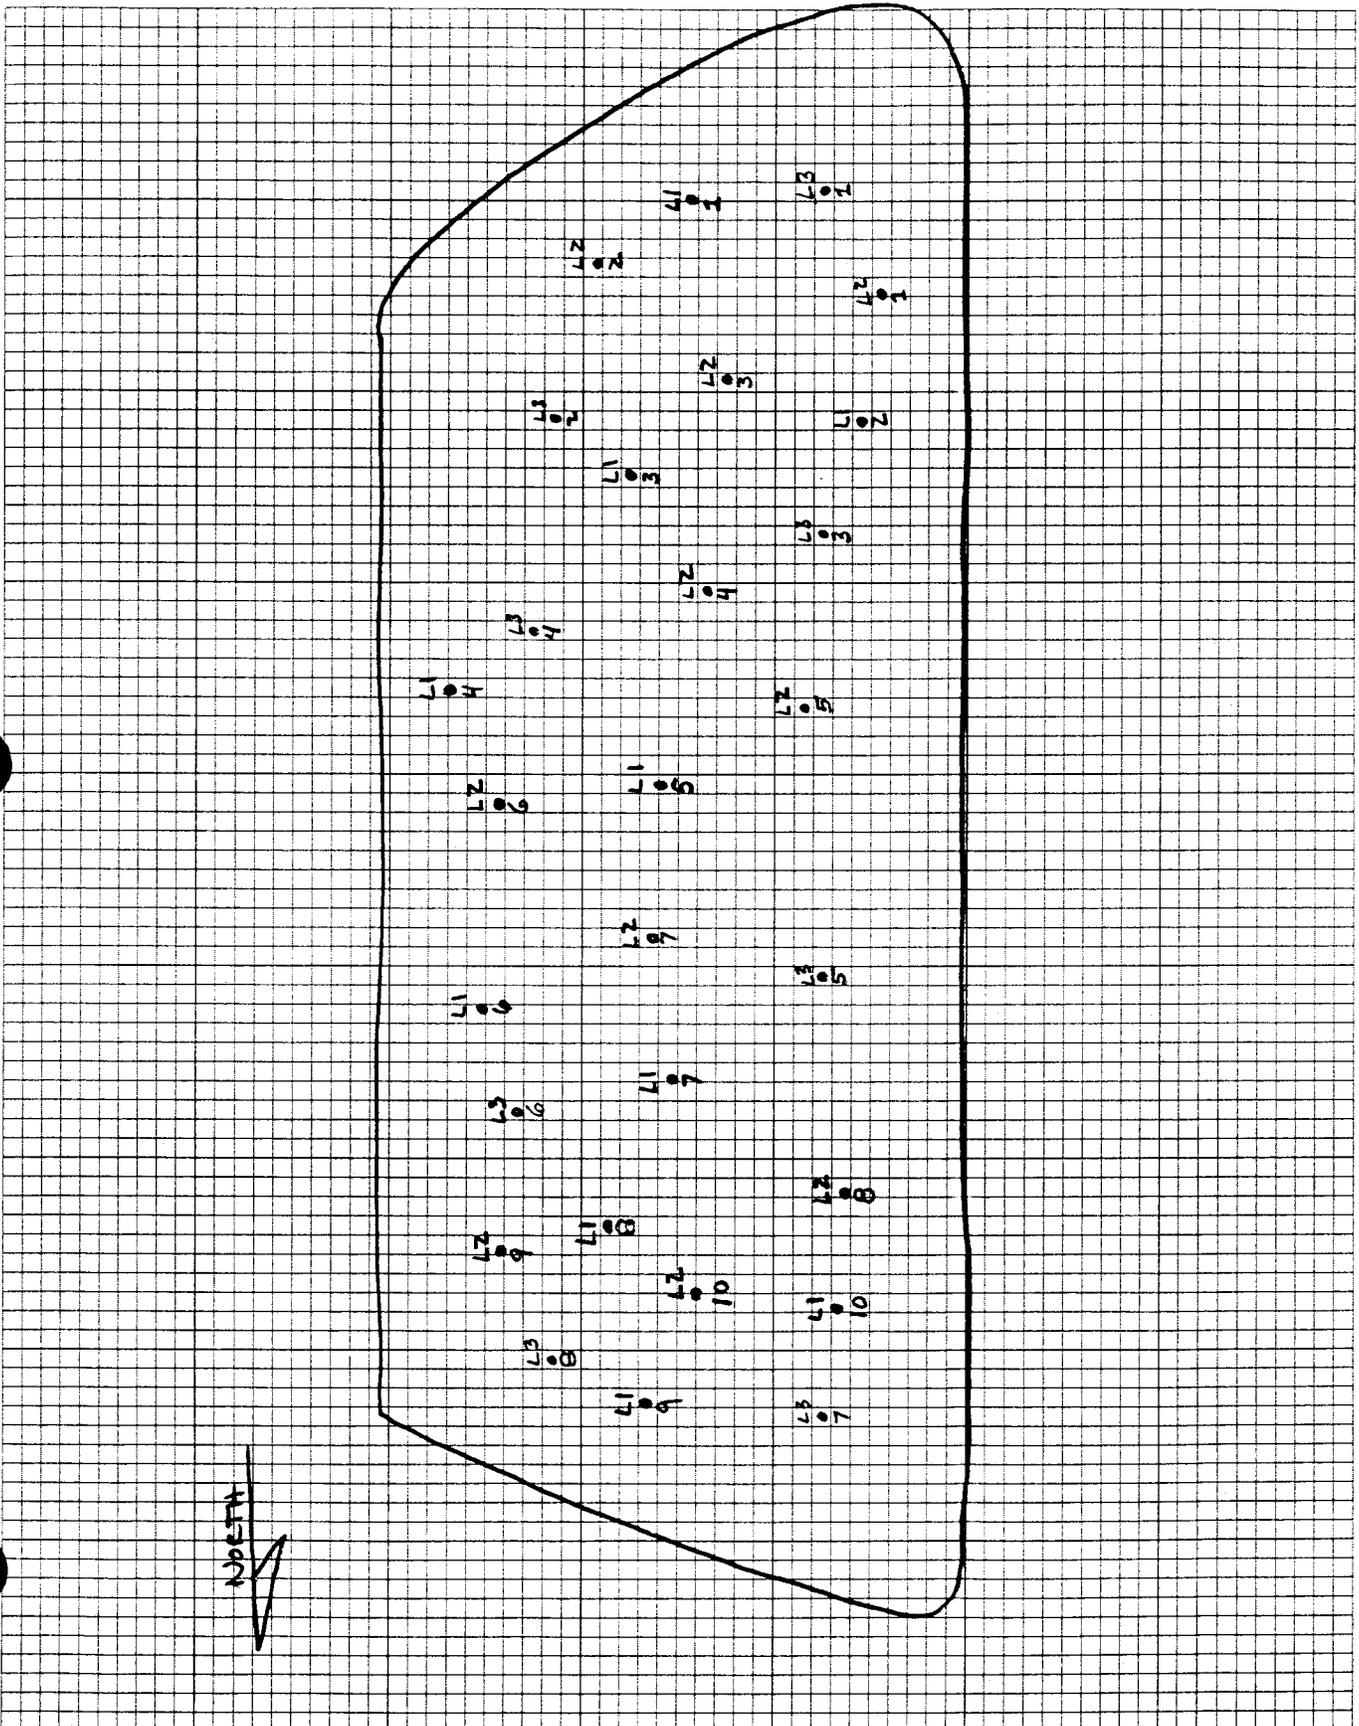
NORTH SLOPE COMPACTION TEST LOCATIONS.

TEST NO	LOCATION	T. WT.	S. WT.	WET DENS.	W. WT.	WT. M.	DRY DENS.	MAX DENS.	% COMP.	% REQ.	LIFT
		MOLD	VOL.		D WT.	%M.					
L3 22	North slope - Locations on	745.9	532.6	113.7	4.03	.61	96	101.4	94	90	3
		213.3	17.85		3.42	18					
L3 23	Attached Sketch	738.4	524.7	111.9	3.55	.58	94	101.4	92	90	3
		213.7	17.25		2.97	19					
L3 24	↓	759.4	545.1	116.3	3.33	.58	96.1	101.4	94	90	3
		214.3	17.55		2.75	21					
L3 RE-TEST	South slope Above Access rd - Fr. road	726.7	513.4	109.6	3.47	.53	92.9	101.4	91	90	3
		213.3	17.85		2.94	18					
L3 RE-TEST	East bank low Moisture - Area water and Compacted gran	729.6	516.3	110.2	4.26	.64	93.4	101.4	92	90	3
		213.3	17.25		3.62	18					
L1 30	North slope between Blowout area and	732.7	518.4	110.6	4.40	.77	91.4	101.4	90	90	1
		214.3	17.85		3.63	21					
L1 31	Paving used Ditch.	739.4	525.7	112.2	3.47	.58	93.5	101.4	92	90	1
		213.7	17.25		2.84	20

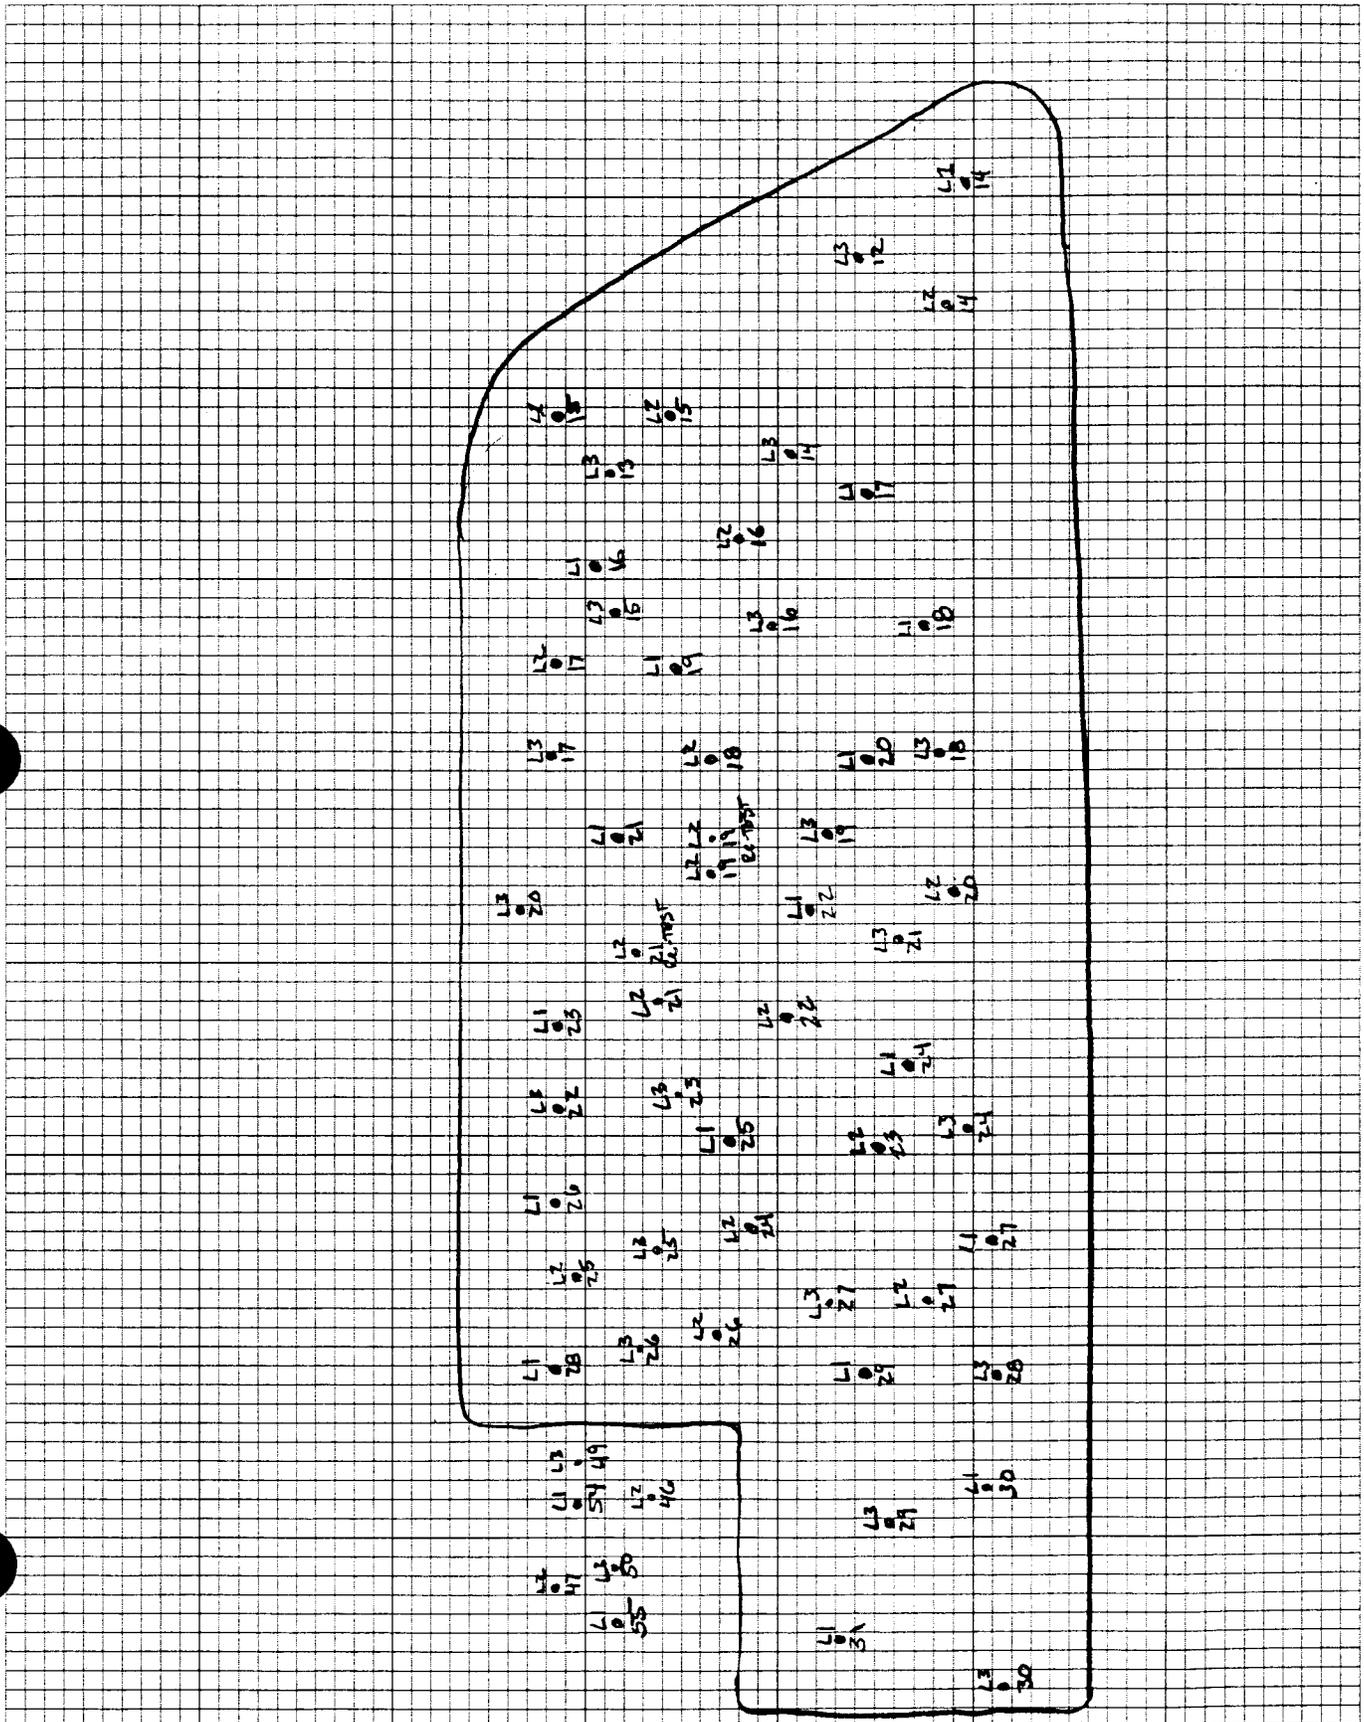
PROJECT
SOUTH SLOPE ABOVE ACCESS RD
COMPACTION TEST LOCATIONS

Third lift completed on the south slope above the access road. Moisture was a little low in a couple of spots, including the third lift. Area will be watered and re-compacted with sheeps-foot when it arrives.

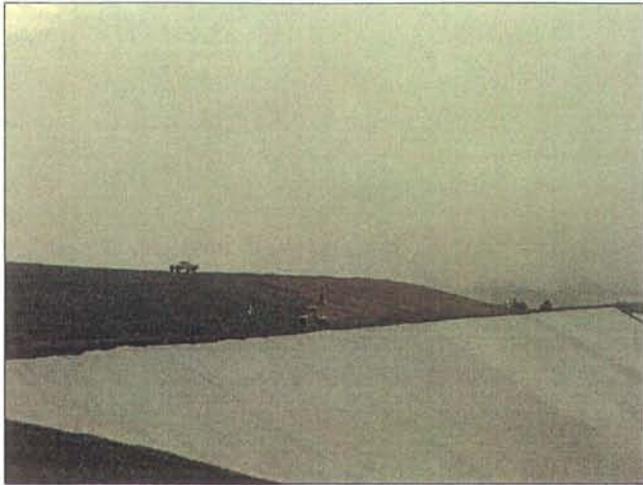
West slope

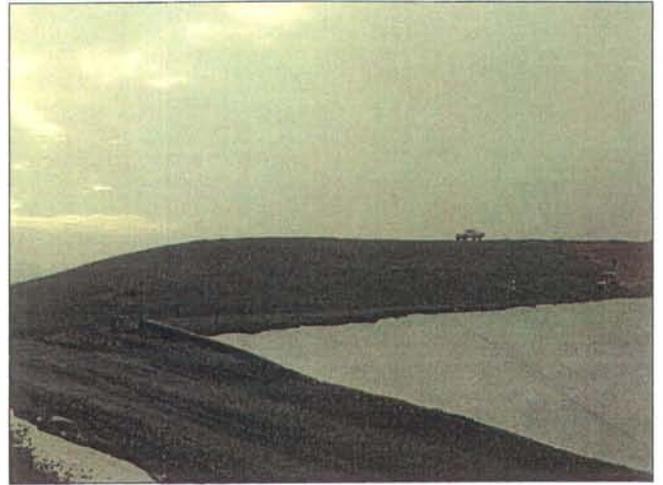
West Slope, North West corner

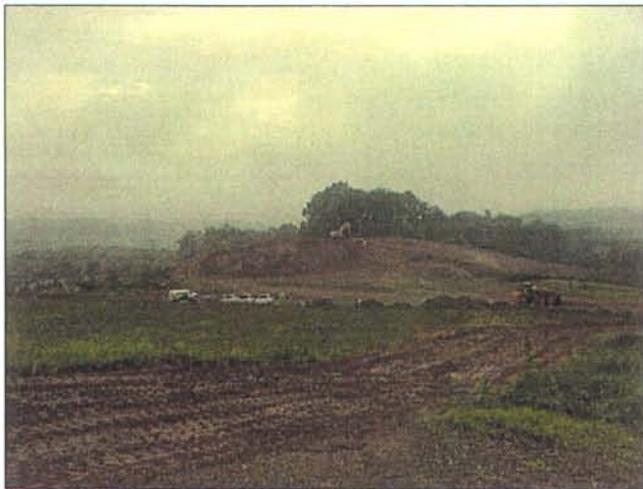
Borrow area, week 1

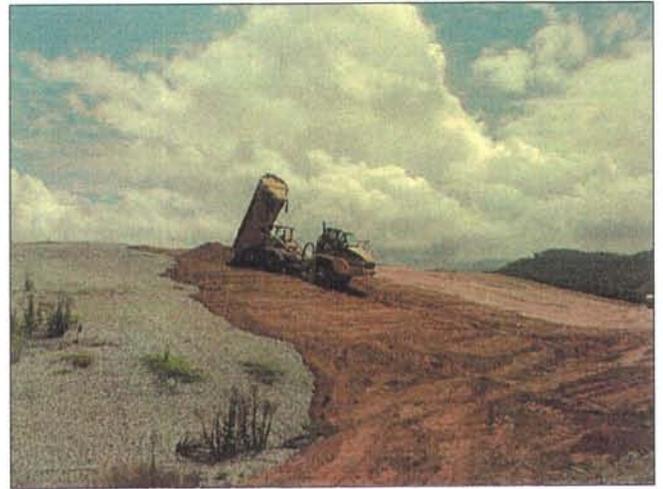
West slope cover soil installation

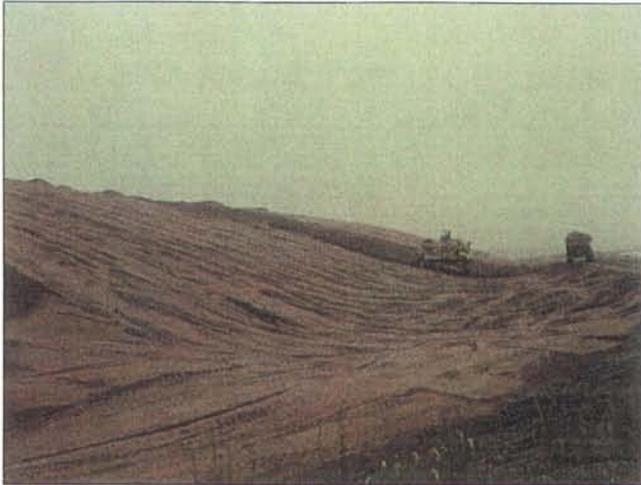
West slope lift #2

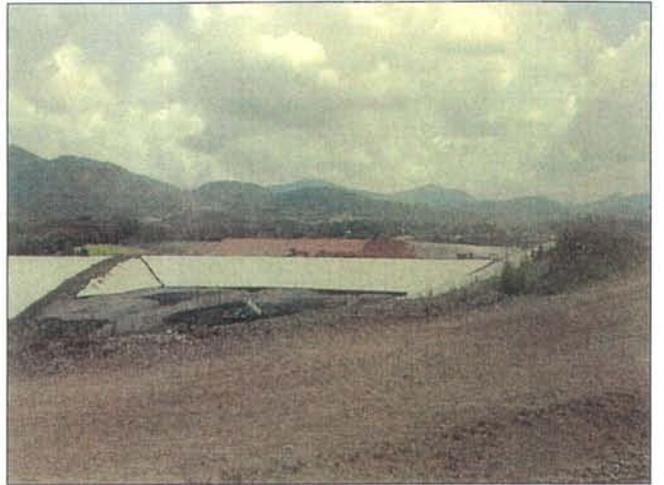
West slope overall progress week #1

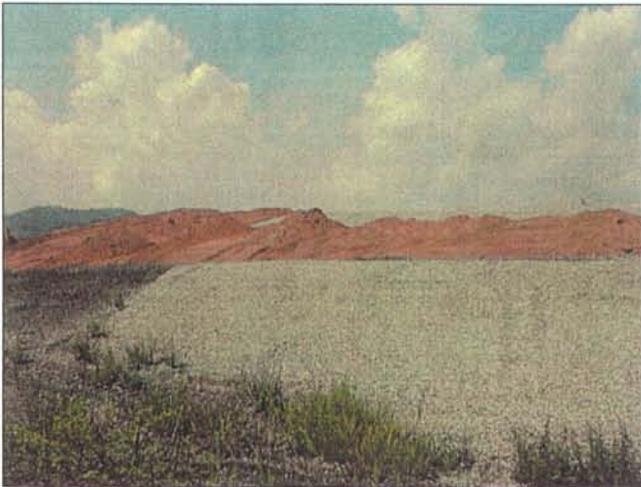
South slope cover above access road

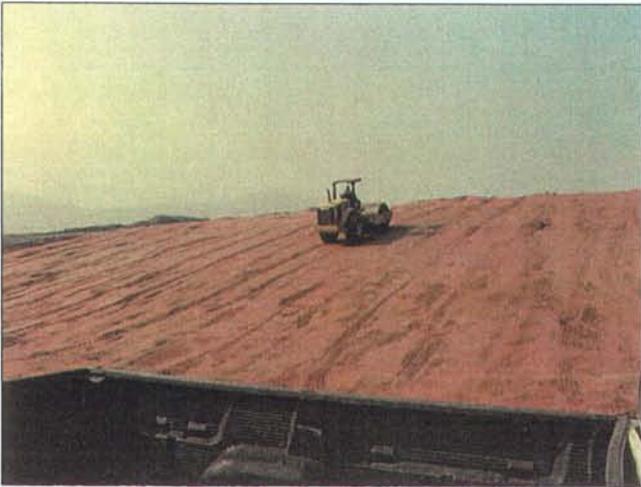
North slope

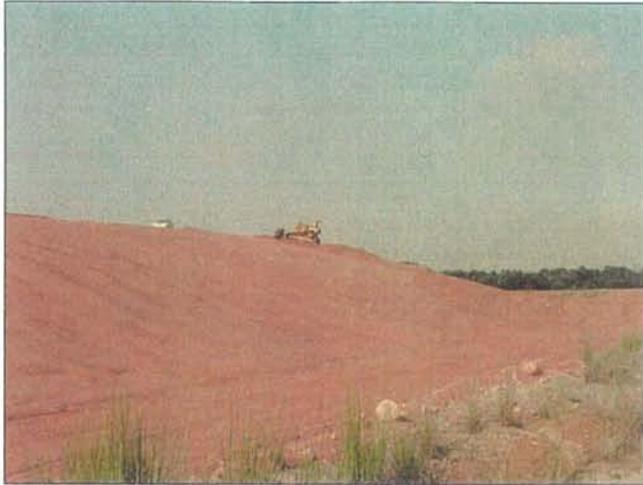
North slope cover soil installation

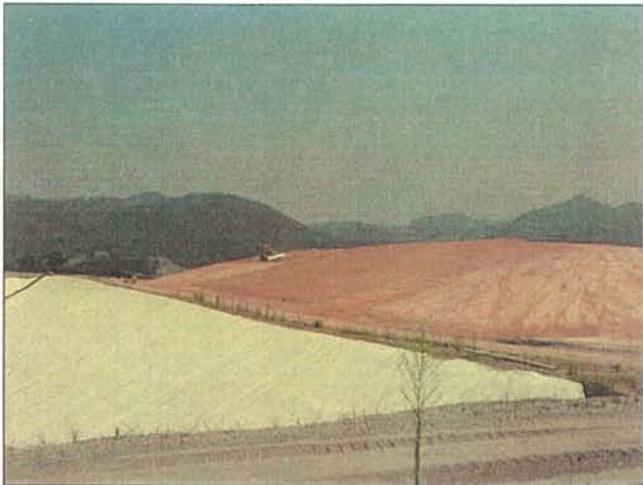
Finnish grade west slope

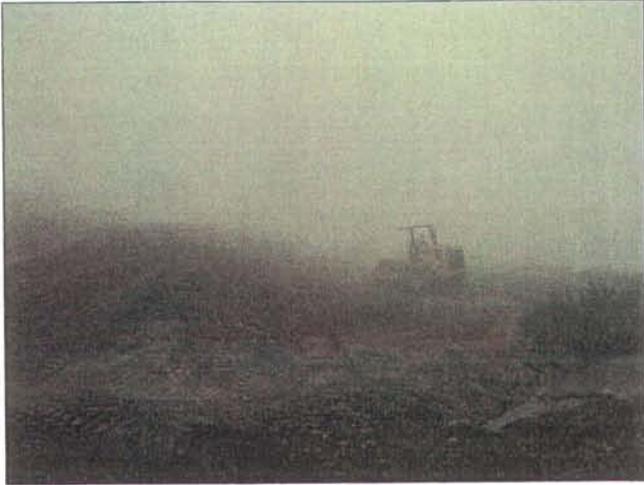
North slope compaction

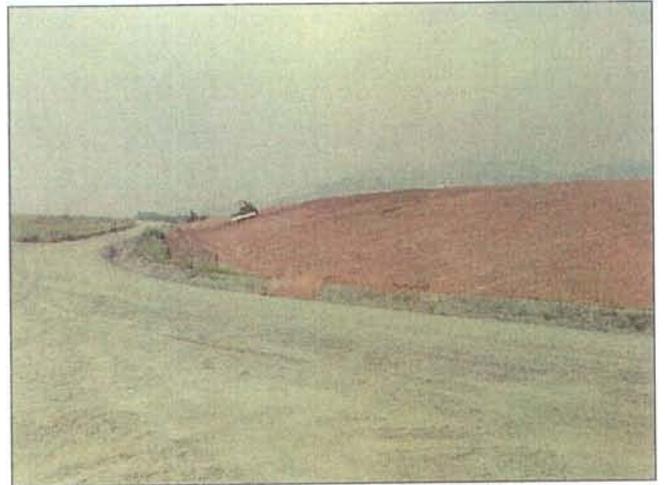
South east slope cover soil installation

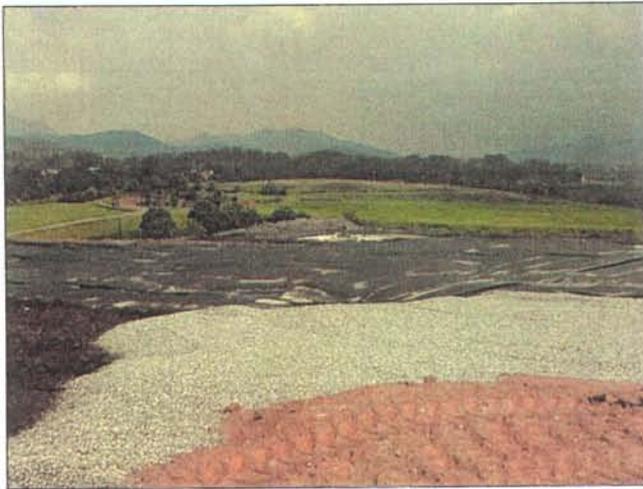
Top of cell East end prior to completion

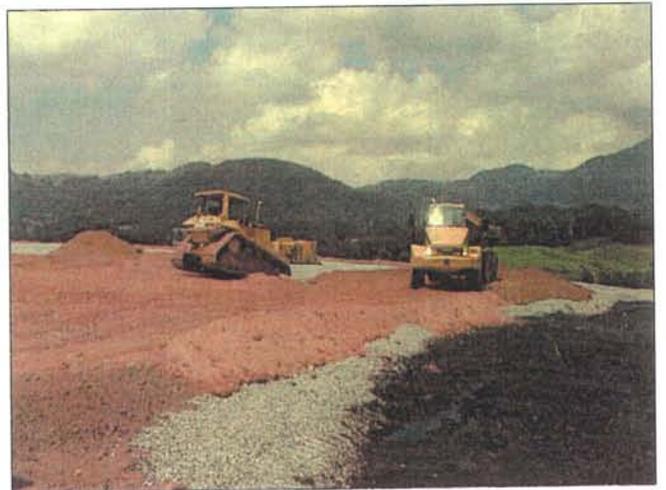
Top of cell lift #1

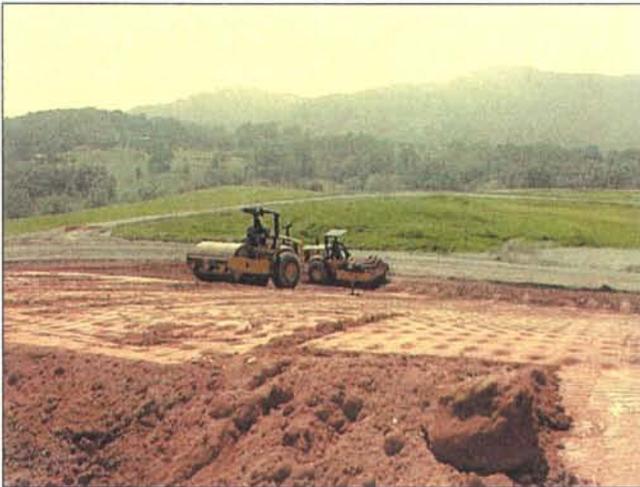
Compaction on South slope

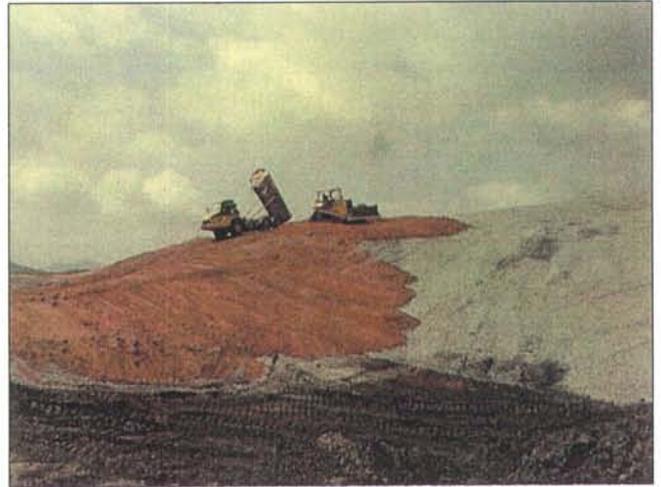
Cover soil installation above chimney drain

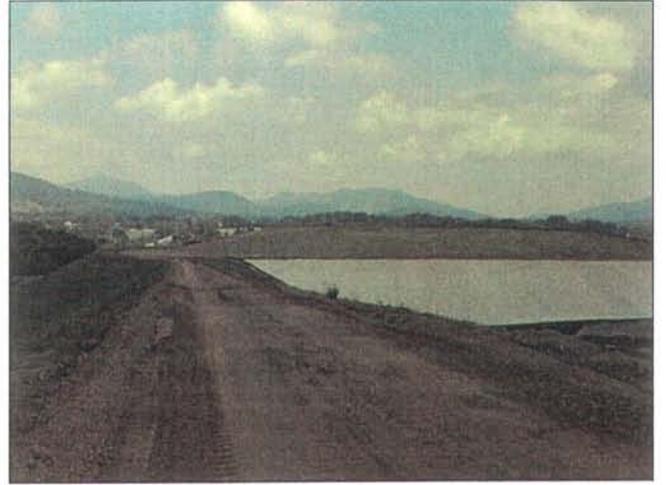
Hydro-seed on west slope

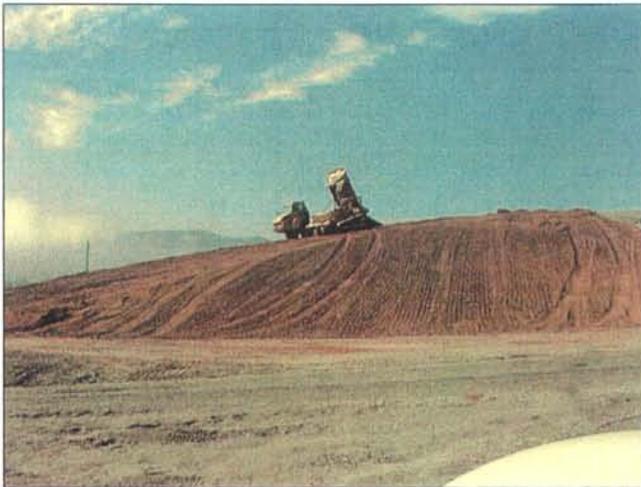
cover soil installation north east corner

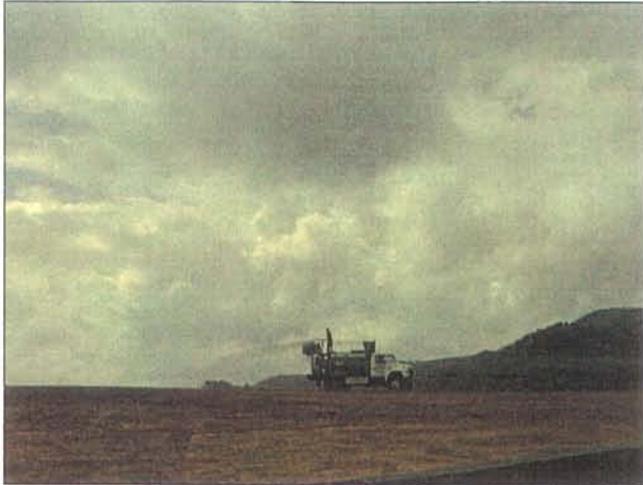
Hydro-seed top of cell-west end

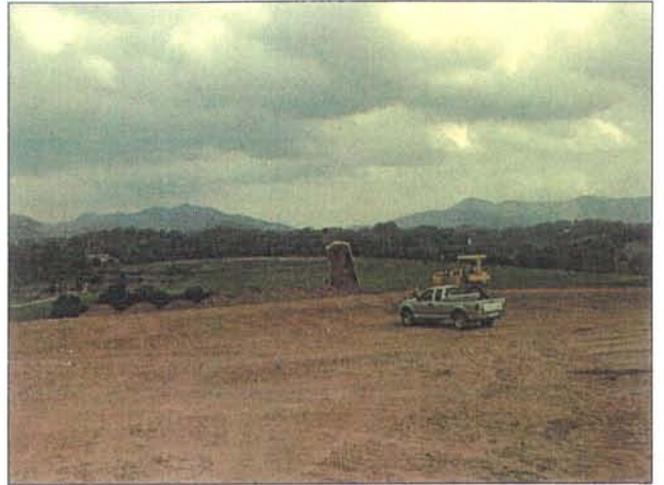
Final lift top of cell

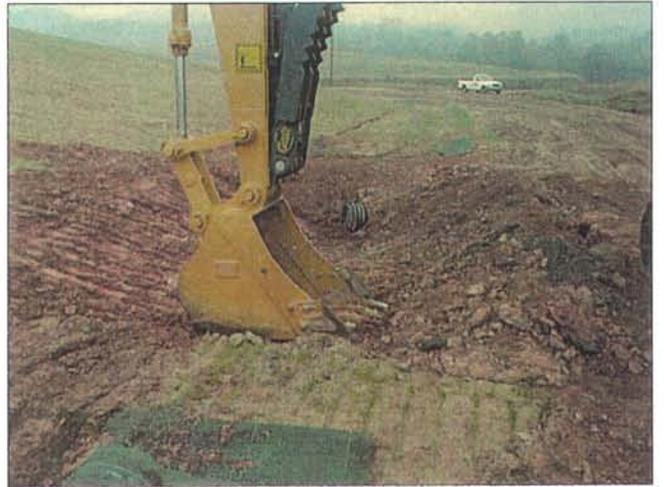
Inlet basin construction south side

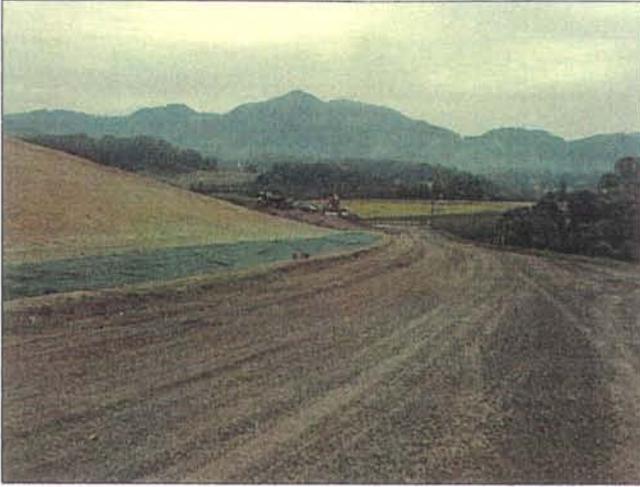
Completed ditch line south east corner

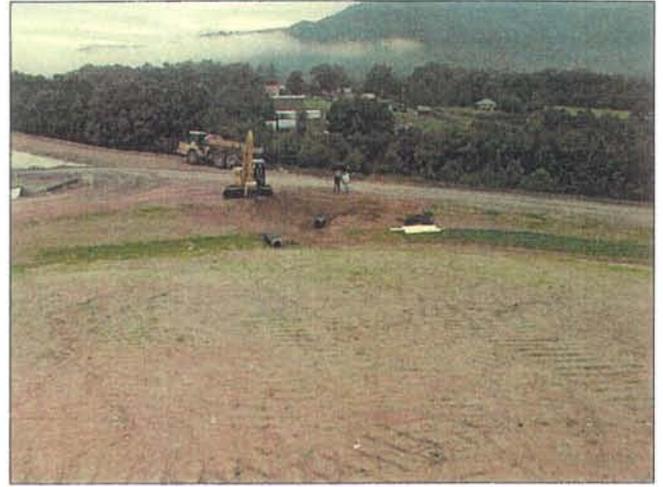
Pipe inlet location-north west corner

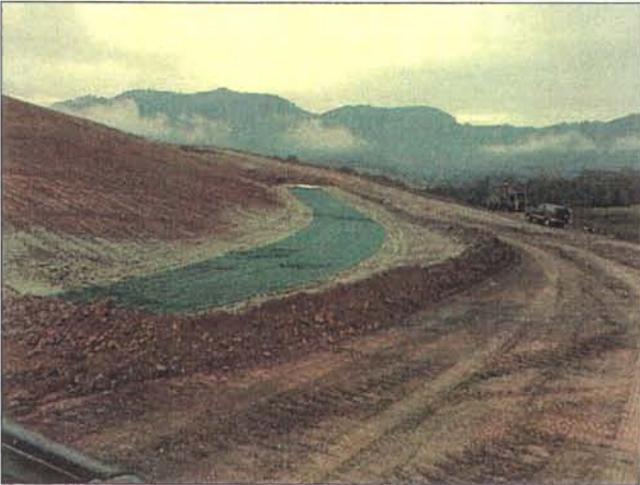
Completed ditch line north east corner
