RE: Notification
Leachate Seep and Repair
White Oak MSW Landfill
Haywood County, North Carolina
Permit #44-07

LEACHATE SEEPAGE REPAIR

WHITE OAK LANDFILL
HAYWOOD COUNTY, NORTH CAROLINA

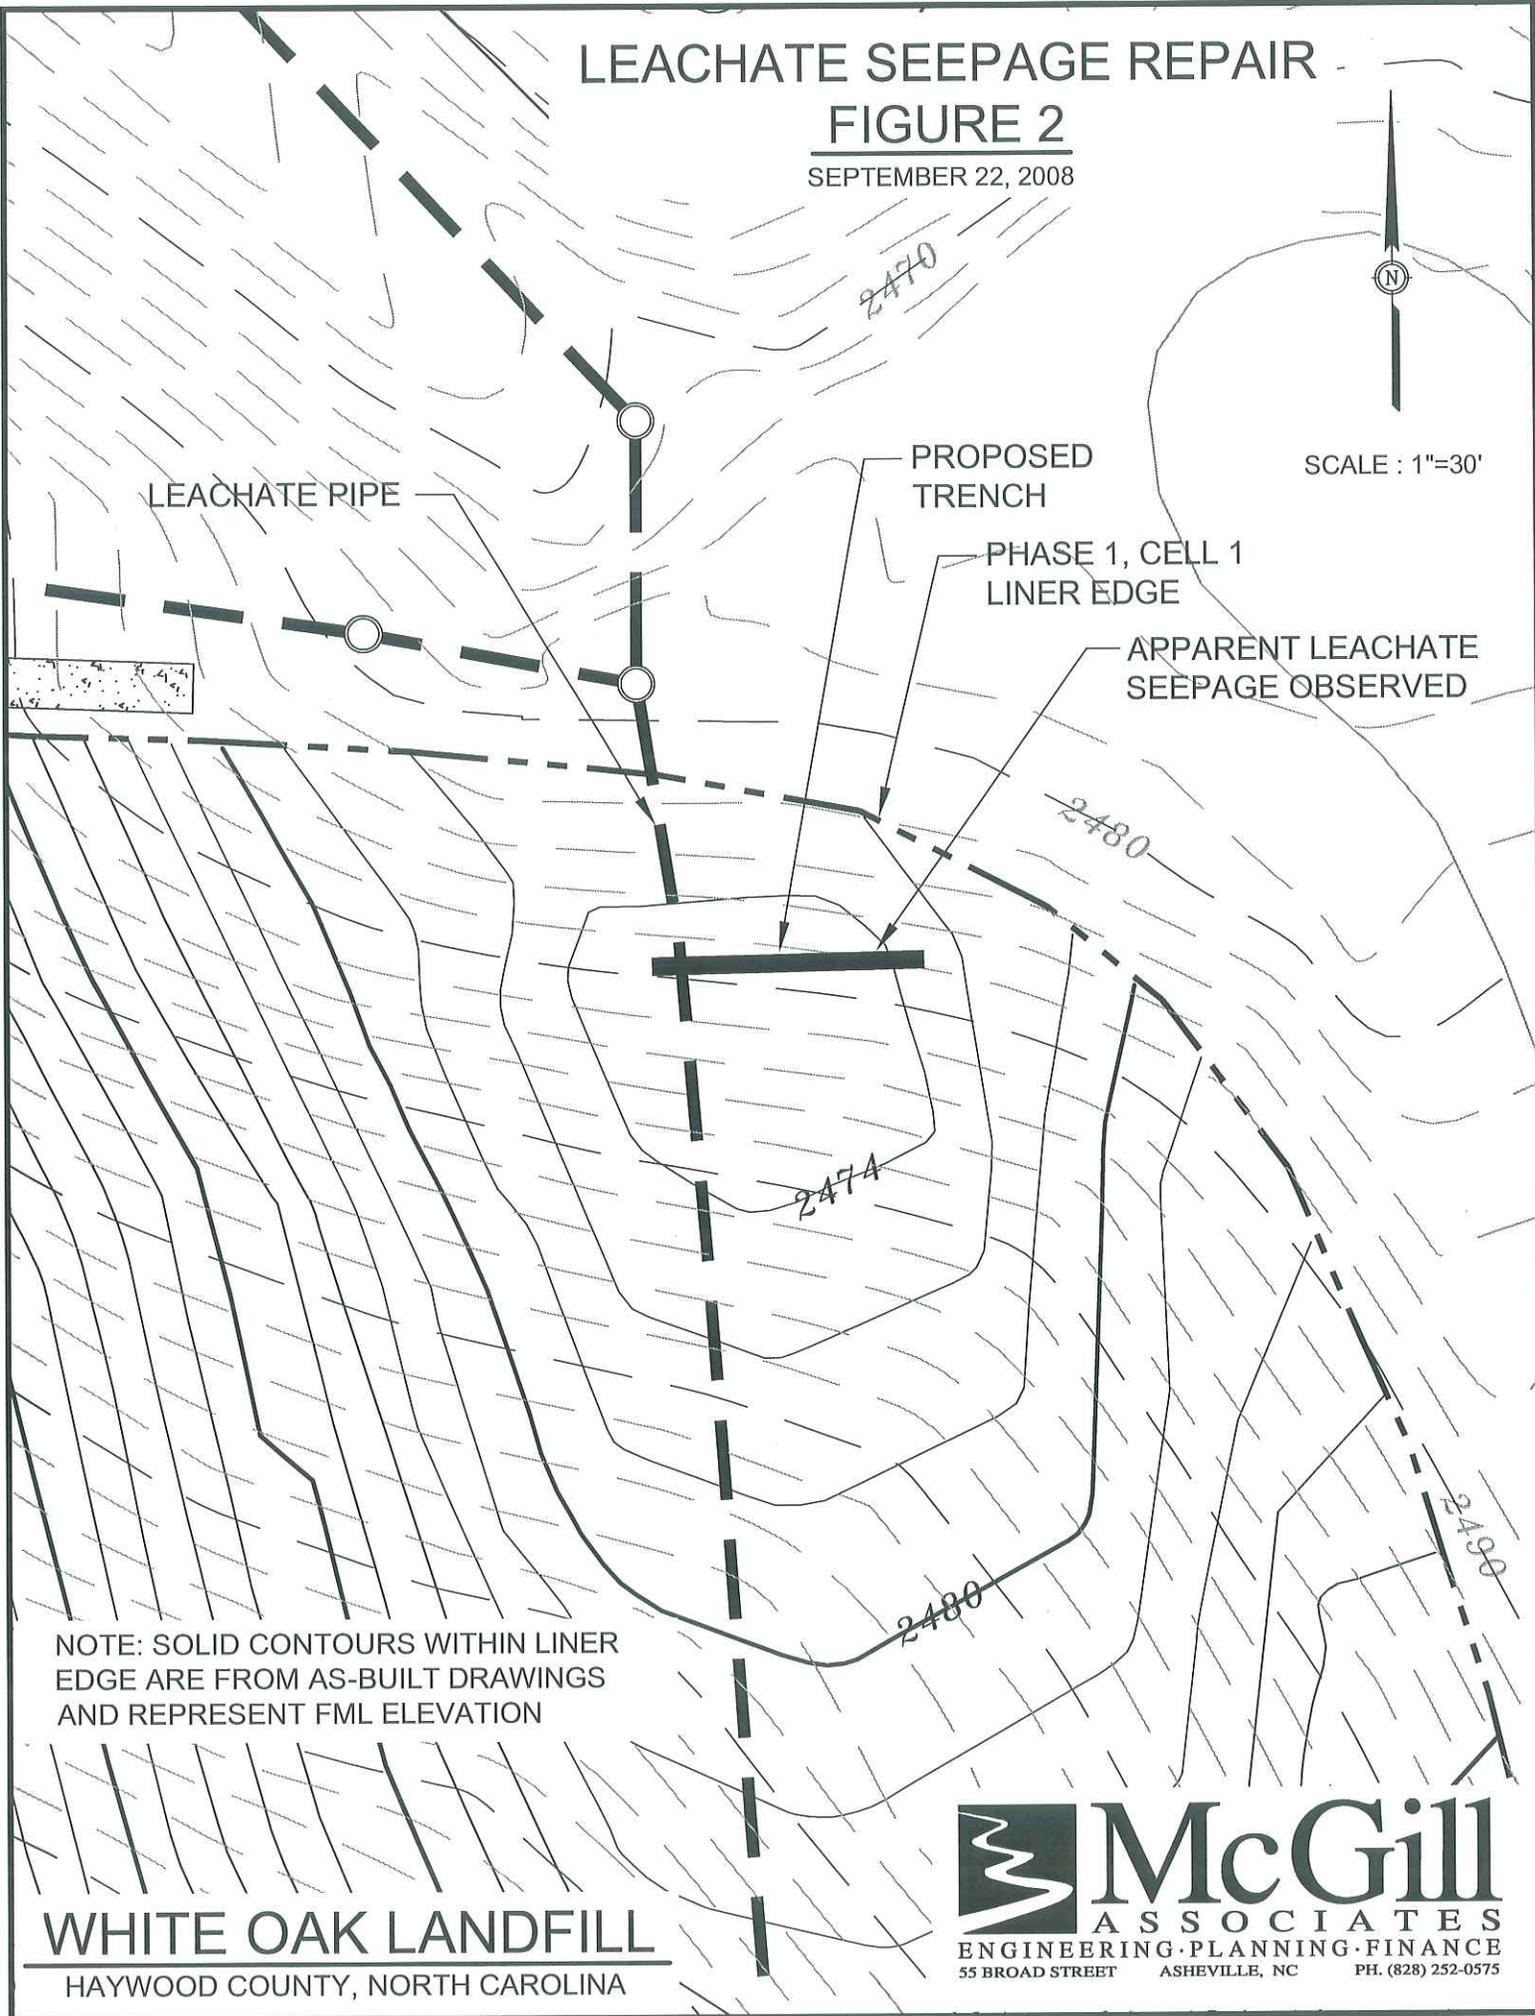
FIGURE 2

On behalf of Haywood County, this is to notify your office of an apparent leachate seep at the White Oak MSW Landfill. Landfill personnel observed the apparent seep, which was a small wet area, on Monday September 22, 2008. The proximity of the seep to the liner edge required prompt action to ensure that leachate did not leave the lined landfill area. The County contacted McGill Associates to assist with the repair of the problem. On Tuesday, September 23, 2008 McGill Associates survey personnel went to the site to confirm the location of the liner edge in the vicinity of the seep and to verify existing ground elevations. As-built drawing information provided by the County and prepared by Perry M. Alexander Construction Co., September 17, 1993 was the basis for liner edge confirmation and depth to liner calculations. In order to turn down the apparent pocket of leachate, McGill Associates proposed installing a trench type drain for the conveyance of leachate away from the apparent seep area towards the MSW Phase 1 sump area, a distance of approximately 40 feet.

The existing ground elevations of the proposed alignment of the trench were carefully surveyed and this information was compared to the as-built elevations for the flexible membrane liner. There is a minimum 4-foot separation between the bottom of the trench and the liner in the vicinity of the leachate seep. The separation is a minimum of 5 feet for the remainder of the trench. Trench excavation began on Tuesday, September 23rd. McGill Associates personnel observed the excavation to ensure that the native soils drainage layer, which is 2 feet above the liner, was not breached by the excavation of the trench. Critical elevations at the bottom of the trench were surveyed to verify separation elevations. The County proposes to install approximately 3 to 4 feet of railroad ballast stone in the bottom of the trench. The gradient of the trench is towards the sump area. In addition to the gravel trench, the County proposes to install a 18-inch riser pipe in the vicinity of the sump to provide future access to the sump area for locating a leachate pump, should the need arise. A minimum of 2.5 feet of compacted native

soils will be installed over the drainage stone. Grass will be sown upon completion of the grading work.

The installation of the trench will allow any future pockets of leachate a conveyance path to the sump area. Landfill personnel will continue to monitor the area to ensure that leachate does not leave the lined landfill area. The County will perform annual cleaning of leachate system piping in the next month, which will ensure that leachate properly drains from the landfill. Please don't hesitate to contact us if you have any questions regarding this maintenance work at the White Oak Landfill.
