**FACILITY COMPLIANCE INSPECTION REPORT**  
**Division of Waste Management**  
**Solid Waste Section**

**Date of Site Inspection:** February 9, 2012    **Date of Last Inspection:** October 13, 2011

Onslow Container Service  
P.O. Box 9  
Deep Run, NC 28525  
NCSR 1511/ Bland Howell Rd.

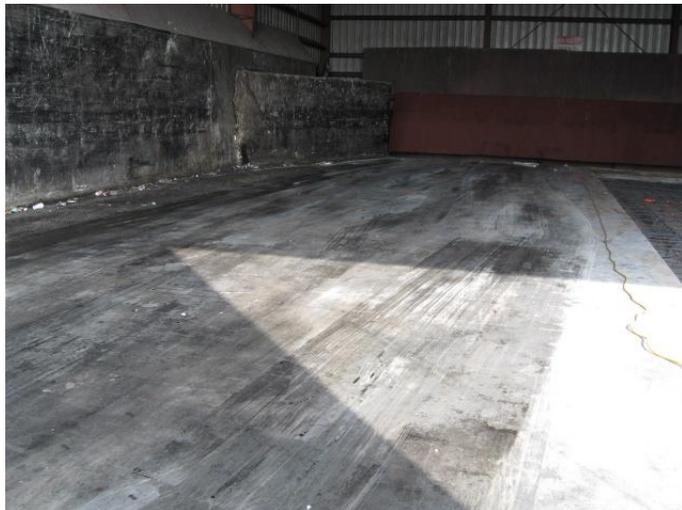
Tipping floor is kept clean.

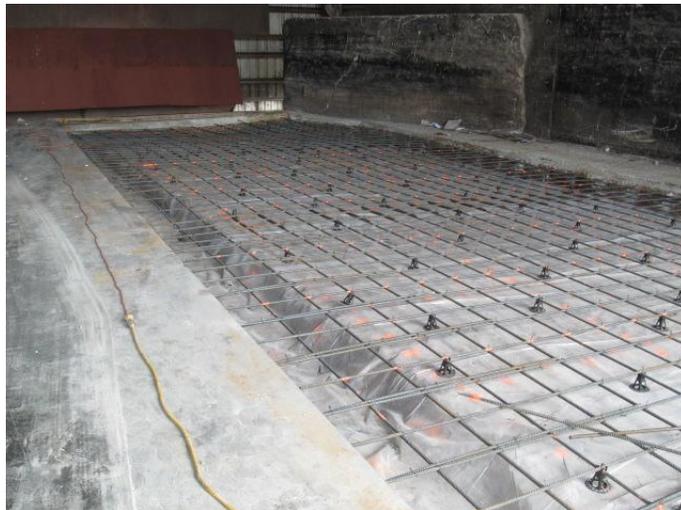
Owner is replacing the floor in sections.

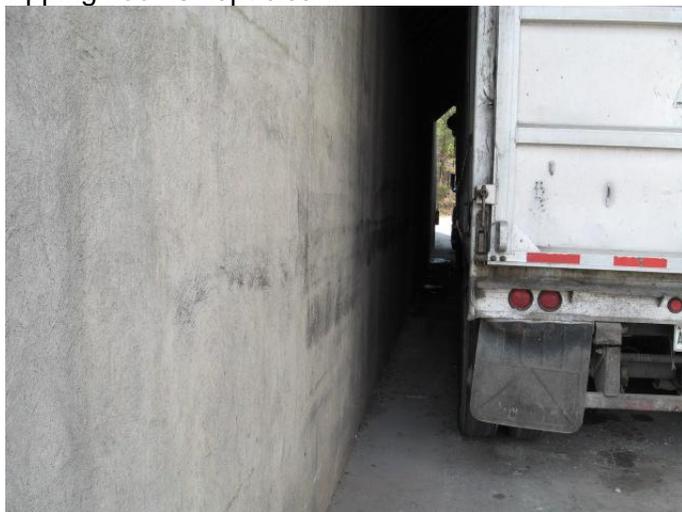
Truck bay is kept clean.

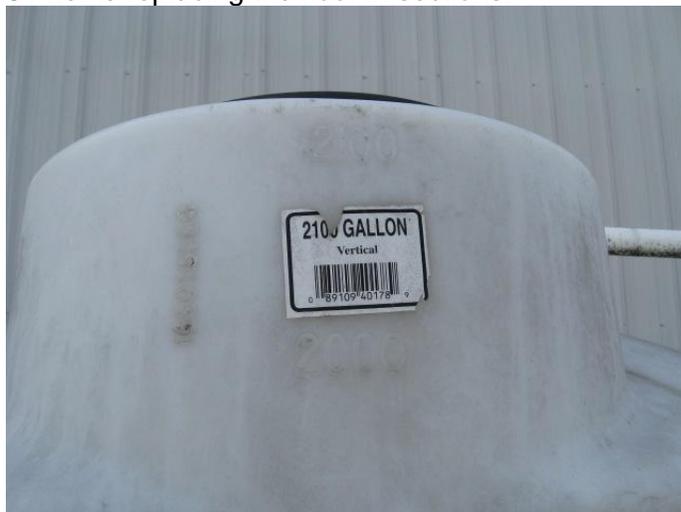
8. Leachate is currently being collected in a 2,000 gallon tank and pumped as needed. The leachate is hauled to the City of Kinston's WWTP for proper disposal.
9. All access roads are paved with no erosion problems.
10. The facility is very well managed.
11. Pictures taken during the visit are as follows:

Leachate tank.
