FACILITY COMPLIANCE INSPECTION REPORT
Division of Waste Management
Solid Waste Section

Date of Site Inspection: 20 January 2012 **Date of Last Inspection:** 9 January 2012

Larry Styron LCID Landfill
Herring-Smith Road
Newport, NC 28570

Site visit to review continued measures taken in response to 2 January 2012 fire event

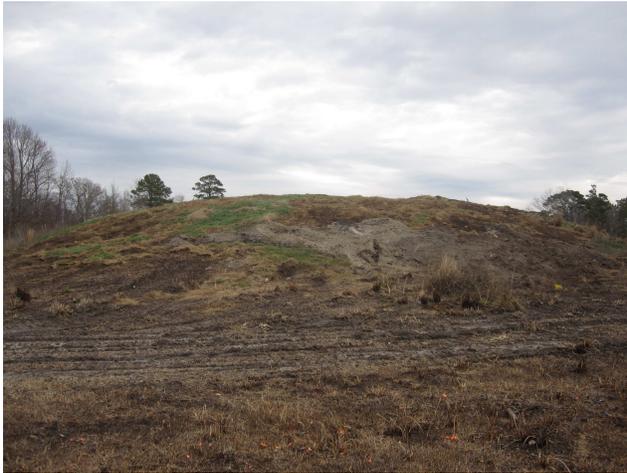
- 9) Soil has been stockpiled on-site for use in cover maintenance adjacent to the old landfill access ramp.
- 10) More soil has been placed in the voids and areas of settlement where smoke was observed emanating from the landfill during the previous audits.

- 11) No smoke was observed to be emanating from around the repairs made in the landfill cap.
- 12) *Due to the danger of cave-in, special care should be taken with any heavy equipment use on or around the landfill.

Soil placed in settlement area
