**FACILITY COMPLIANCE AUDIT REPORT**  
**Division of Waste Management**  
**Solid Waste Section**

**Date of Audit:** 27 July 2011

Garner LCID Site  
 Lake Road  
 Havelock, NC 28557

N1060, 072711  
 Page 2 of 2

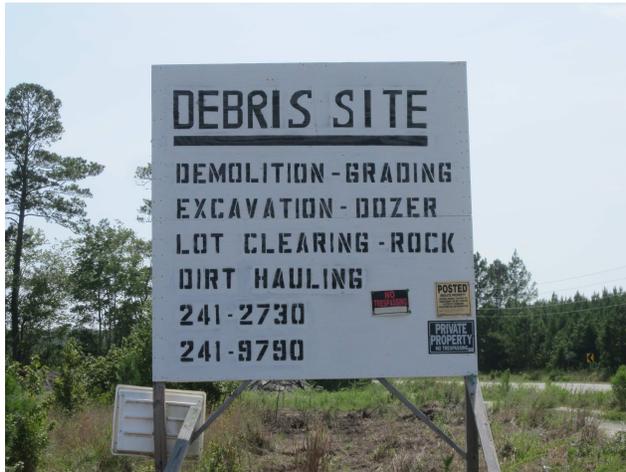
Signage posted at the facility entrance

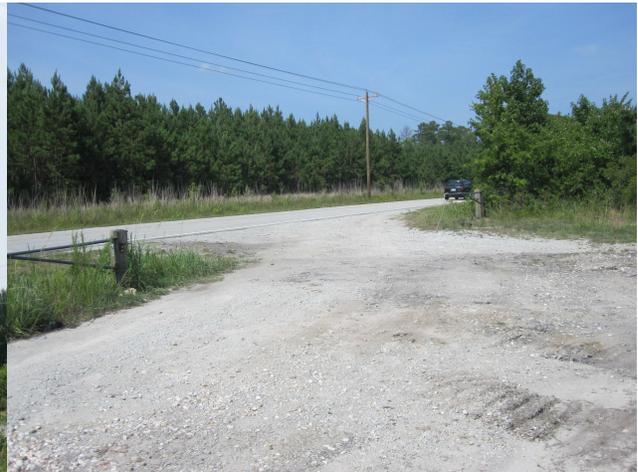
- 1) This facility is a Land-Clearing and Inert Debris Landfill Notification.
- 2) This facility is secured by a locked gate at the facility entrance and has controlled access for safety. The gate was unlocked and no attendant was on-site during this audit. \*Please ensure that the gate is locked and the facility is secured whenever there is no attendant on-site.
- 3) Proper signage including the facility name and emergency contact number has been posted at the facility entrance.
- 4) The access road to the facility is being managed properly at this time.
- 5) The waste type being disposed is LCID waste only and no unacceptable waste streams were noted during this audit.
- 6) \*Please ensure that all waste is covered monthly, or when the active working area reaches one acre in size, whichever occurs first.

Open security gate at the entrance

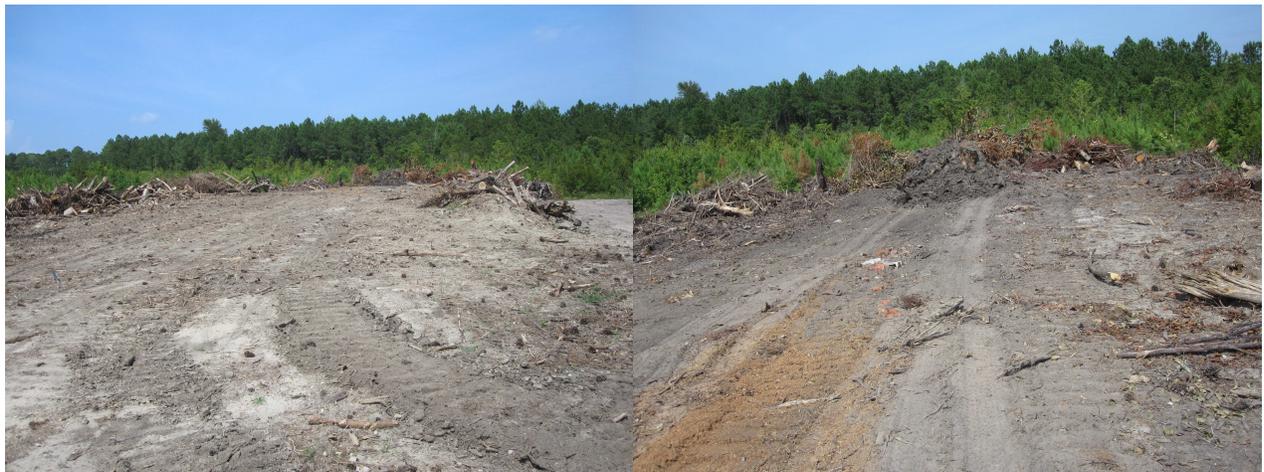
Active working area
