FACILITY COMPLIANCE INSPECTION REPORT
Division of Waste Management
Solid Waste Section

Date of Inspection: 6 August 2012

Beaufort County Closed MSW Landfill
 1342 Hawkins Beach Road
 Bath, NC 27808

0702-20120806INSP

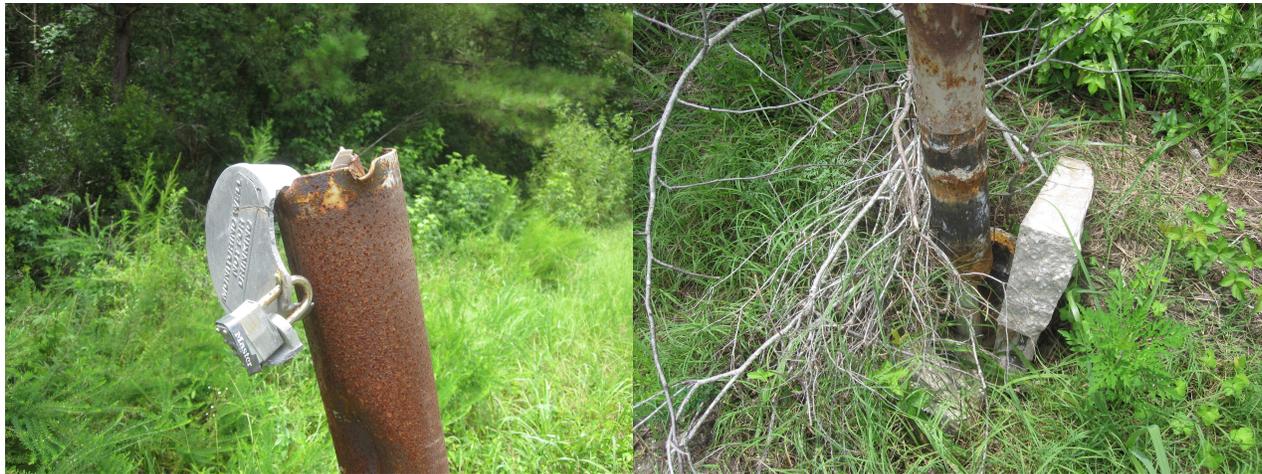
- 12) Facility monitoring wells were reviewed during this Facility Compliance Inspection. One of the wells on the western perimeter was observed to have been damaged by maintenance equipment. The well cap and the concrete pad at the base of the well need to be repaired. *Within thirty days of receipt of this Facility Compliance Inspection Report, please repair this well and ensure that the cap is secured in place with a functioning lock.

Monitoring well damaged by maintenance equipment.

- 13) *To prevent future equipment damage, it is recommended that all monitoring wells be painted with high visibility paint.
 - 14) No ponding water was observed during this Facility Compliance Inspection.
