Solid Waste Management Facility Cell 6 Construction Quality Assurance Report

Volume 1

January 2006

Subject: Buncombe County, North Carolina
Buncombe County Solid Waste Management Facility
Cell 6 Construction Quality Assurance Report
Permit No. 11-07

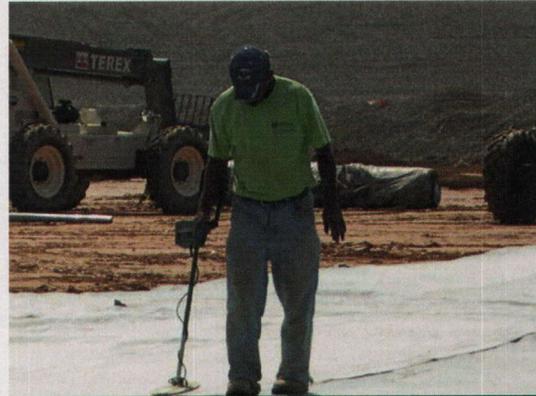
Hallaton personnel aligned panels with the adjacent panel to ensure proper overlap for seaming purposes. After each panel deployment, CDM conducted a visual observation of the panel for physical defects. Along with a visual inspection, a metal detector was used to sweep the GCL panels following installation to locate broken needles resulting from the GCL manufacturing process. All positive responses were investigated by cutting the GCL and probing into the low permeability liner. The metal wire fragments found were within the low permeability liner material and did not appear to be the result of broken metal needles imbedded within the GCL.

Photo of metal detector inspection.

The small sections of GCL that were removed were patched with a larger underlying piece of GCL and granular bentonite was placed along the edges. GCL damages and failures were recorded on the damage/failure log in Appendix B-8a (Phase 1) and Appendix B-8b (Phase 2). During the installation of the GCL, there were no damages.

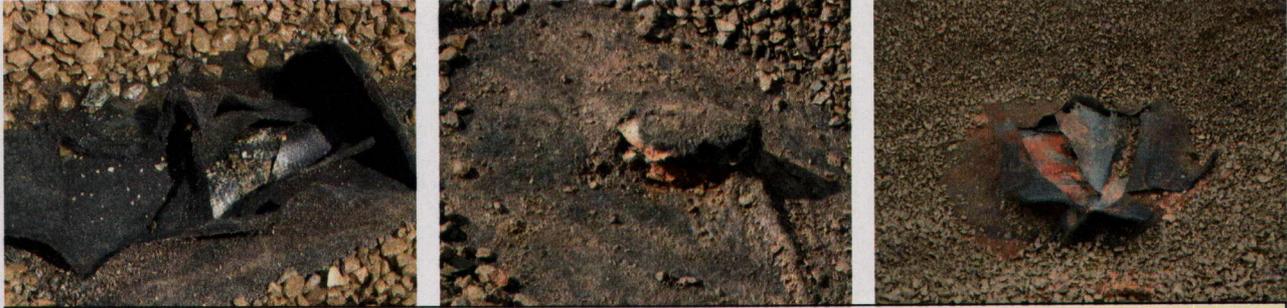
One leak was detected. The leak was an approximate 4-foot long gash, which appeared to result from contact with the blade of the dozer used to deploy the protective cover. Hallaton exposed the area, performed vacuum testing and patched the area using an extrusion weld. Leak Location Services, Inc. provided a follow-up test on the patched area which resulted in a no leak response. The Phase 1 report prepared by Leak Location Services, Inc. is provided in Appendix C-14a.

Typical liner damages found by electro leak detection.

Three leaks were detected. The location and description of each leak is included in Appendix C-14c. Hallaton exposed each area, performed vacuum testing and patched the areas using an extrusion weld. Leak Location Services, Inc. provided a follow-up test on each patched area which resulted in a no leak response.

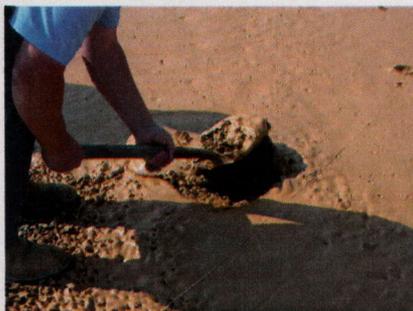
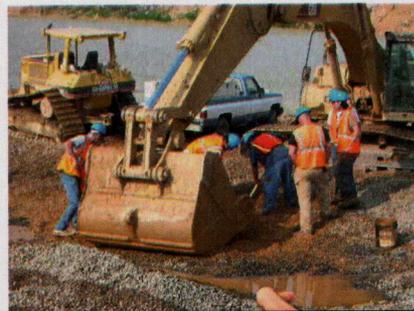
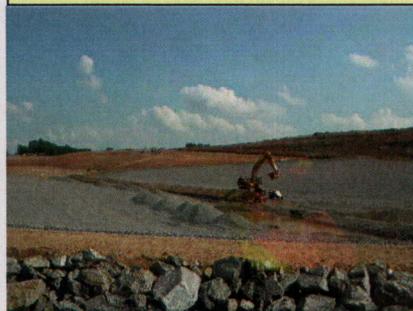
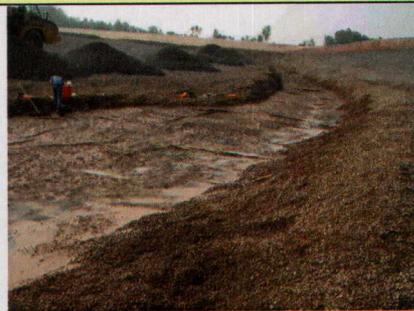
On June 23, 2005, an approximate 1.5-inch rain event occurred in the course of one hour that breached the Phase 1 interim berm and flooded the completed composite liner system at the low sump area of Phase 1. As a result, the 24-inch protective cover rock layer was inundated with silt and sand. At CDM's direction, the Contractor proceeded with the remediation of the protective cover rock layer by removing the soil laden rock (see Page 7 of this Section). In the process of removing sediment contaminated protective cover rock, five damages to the HPDE liner were visually identified. These damages were repaired and tested in accordance with the Contract Documents and the Contractor proceeded with placement of clean protective cover rock.

June 23, 2005 breach of rainwater into Phase 1 and remediation activities.

Following placement of protective cover rock, CDM directed the Contractor to perform leak location detection in areas that received traffic during the remediation. Using electro leak location detection, one additional damage to the HDPE liner was

located and subsequently repaired in accordance with the Contract Documents. Appendix C-14b includes the documentation for the six HDPE liner damages and includes damage locations, repair logs, and the certified leak detection report.

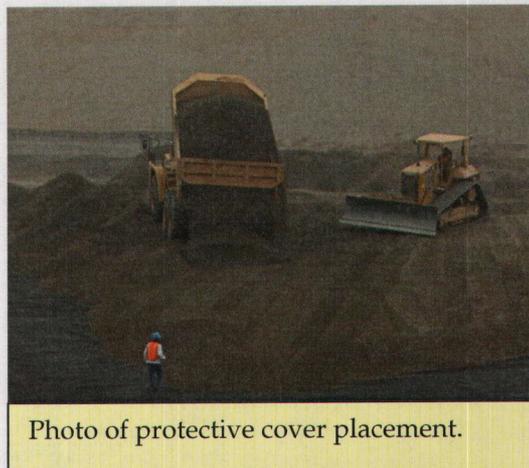
On June 23, 2005, an approximate 1.5-inch rain event occurred in the course of one hour that breached the Phase 1 interim berm and flooded the completed composite liner system at the low sump area of Phase 1. As a result, the 24-inch protective cover rock layer was inundated with silt and sand. At CDM's direction, the Contractor proceeded with the remediation of the protective cover rock layer by removing the soil laden rock (see Section 5, Page 5-7). In the process of removing sediment contaminated protective cover rock, five damages to the HPDE liner were visually identified. These damages were repaired and tested in accordance with the Contract Documents and the Contractor proceeded with placement of clean protective cover rock.

Following placement of protective cover rock, CDM directed the Contractor to perform leak location detection in areas that received traffic during the remediation. Using electro leak location detection, one additional damage to the HDPE liner was located and subsequently repaired in accordance with the Contract Documents. Appendix C-14b includes the documentation for the six HDPE liner damages and includes damage locations, repair logs, and the certified leak detection report.

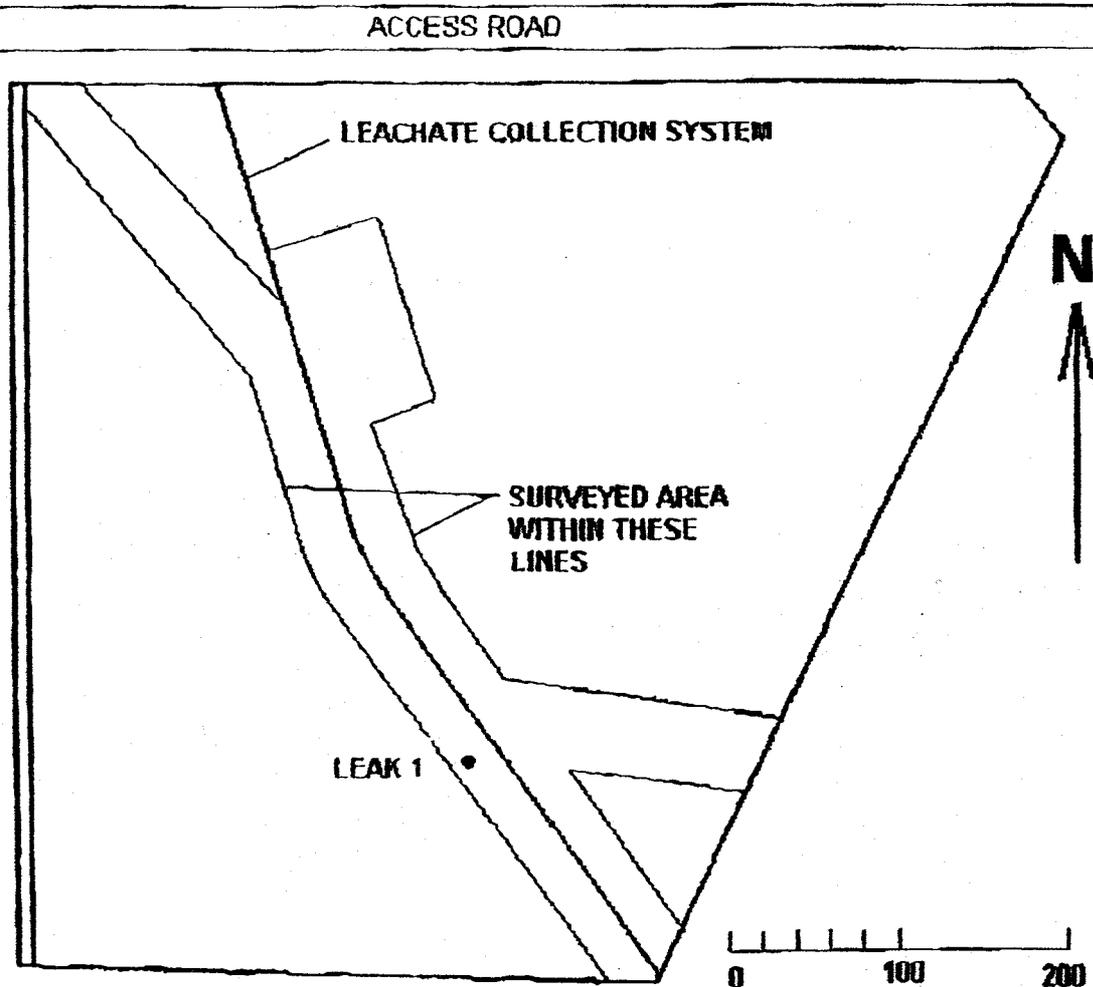
FIGURE 1. APPROXIMATE LOCATION OF THE LEAK

On the first survey, one leak was found. The areas surveyed included a 60 by 120-foot area and the areas adjacent to the leachate collection system south of the 60 by 120-foot area. Figure 1 shows the approximate location of the leak. The leak was a 3.5-foot by 1.5 foot tear. Measurements were made to document the leak detection sensitivity. A 0.25-inch artificial leak was buried in the soil and leak location survey lines were run along both sides of the artificial leak. These tests showed that the artificial leak could be easily detected from 10 feet away. Therefore, the effective survey area extended 10 feet on each side of the leak location survey lines. So the effective survey area for the 60 by 120 foot area extended 10 feet on either side, so it was actually 80 feet by 120 feet. Two leak location survey lines were taken along and 5 feet on each side of the center drainage berm. The effective survey area overlapped at the center of the berm and extended 35 feet on both sides of the berm.

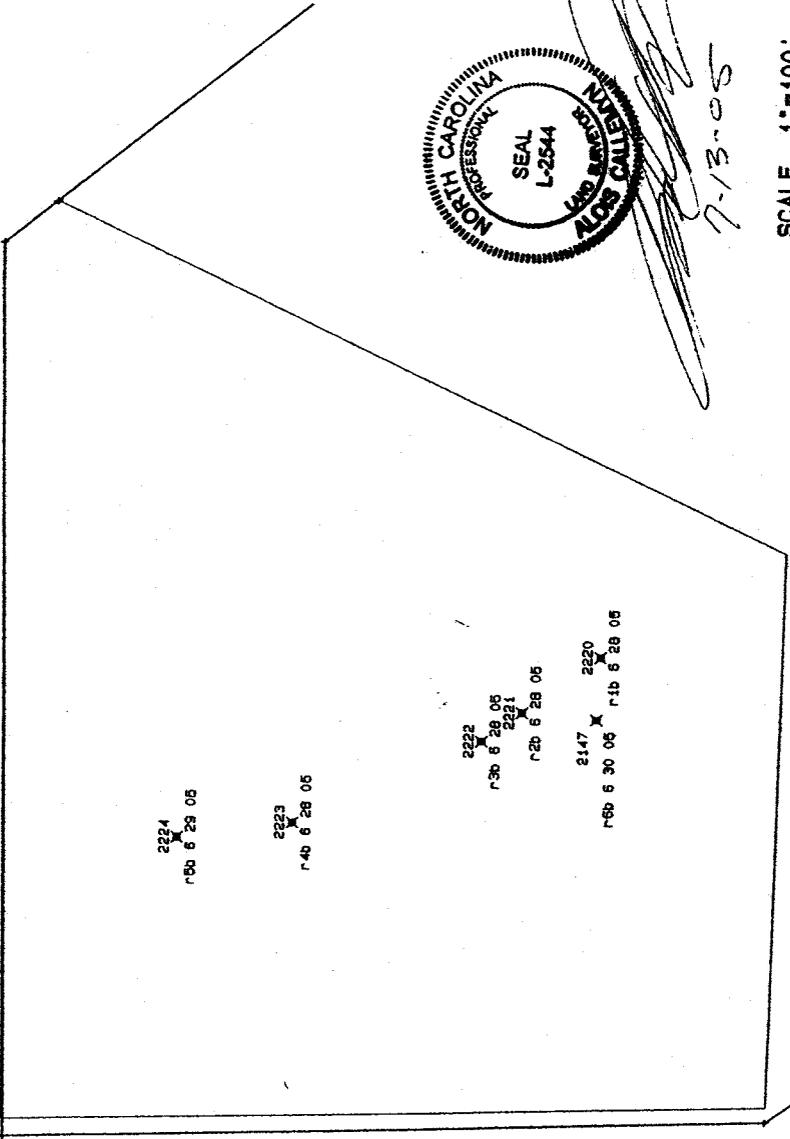
Buncombe County S.W.M.F.
Cell 6 Phase 1
Liner Repair Locations As Per
Russel Sandborn Supervisor
Hallaton, Inc.
7/07/05

8:45	R127	Surveyed by Thalle	SM	X7	470/550	Yes	Pass	Material damage cause by equipment removing mud & contaminated stone.	
9:45	R128	Surveyed by Thalle	SM	X7	470/550	Yes	Pass	Material damage cause by equipment removing mud & contaminated stone.

10:30	R129	Surveyed by Thalle	SM	X7	470/550	Yes	Pass	Material damage cause by equipment removing mud & contaminated stone.	
11:30	R130	Surveyed by Thalle	SM	X7	470/550	Yes	Pass	Material damage cause by equipment removing mud & contaminated stone.	
<u>6/29/05</u>

9:15	R131	Surveyed by Thalle	SM	X7	470/550	Yes	Pass	Material damage cause by equipment removing mud & contaminated stone.	
<u>6/30/05</u>									
4:45	R132	Surveyed by Thalle	SM	X7	470/550	Yes	Pass	Material damage cause by equipment removing mud & contaminated stone.	
COMMENTS:

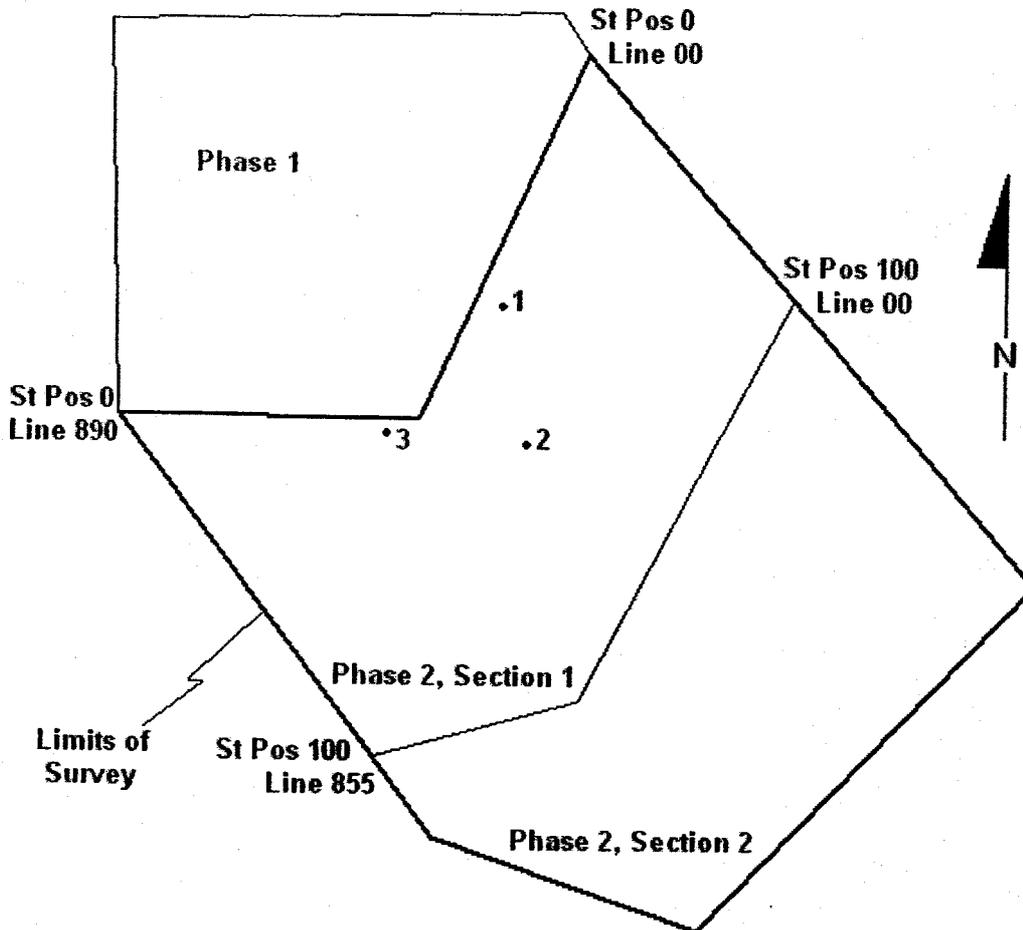
FIGURE 1. APPROXIMATE LOCATIONS OF THE LEAKS

Three leaks were found. Table 1 lists the approximate locations and descriptions of the leaks. Figure 1 shows the approximate locations of the leaks found in Cell 6, Phase 2. Measurements were made to document the leak detection sensitivity. A 0.25-inch artificial leak was buried in the soil and leak location survey lines were run along both sides of the artificial leak. These tests showed that the artificial leak could be easily detected from 10 feet away.

Leak	Location	Description
1	Line 345 at 33 feet	Triangular cut approximately 2 feet by 2 feet by 1.5 feet
2	Line 445 at 87 feet	Tear with rough edges approximately 3.5 inches
3	Line 575 at 6 feet	Semi-circular tear approximately 6 inches in diameter
