FACILITY COMPLIANCE INSPECTION REPORT
Division of Waste Management
Solid Waste Section

Date of Site Inspection: 30 January 2013

Craven County Landfill
 7400 Old Highway 70
 New Bern, NC

2503-20130130INSP

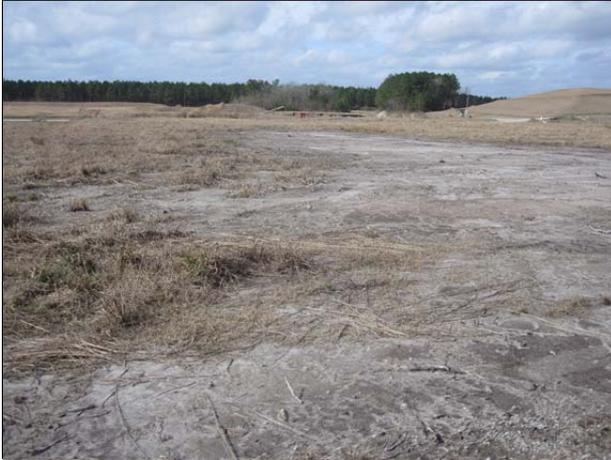
- 10) Groundwater monitoring is being conducted as required. The most recent monitoring event was conducted on 30 November 2012 by Environment One, Inc of Greenville, NC.
- 11) All environmental monitoring reports and facility maintenance logs are maintained at the Craven County Solid Waste & Recycling Director's office.
- 12) Overall this facility has a well-established and maintained cover crop of native warm season grasses. However, some areas of sparse cover were observed throughout the landfill. *Please seed and mulch these bare areas to establish a groundcover suitable to prevent erosion of your landfill cap system.

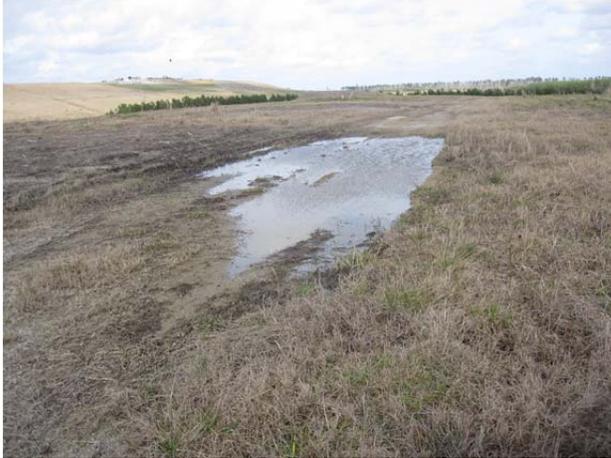
- 13) The landfill cover crop is mowed annually.
- 14) Ponded water was observed in several areas around the landfill. *Please fill and grade these areas to promote positive drainage of all surface waters away from the landfill. All filled areas should be graded at a slope not greater than 3:1 and seeded and mulched to establish a cover crop suitable to prevent erosion of your landfill cap system.
